Thomas C. Passios Elementary School

1025 Massachusetts Avenue
Lunenburg, MA 01462

Property Condition Assessment

February 6, 2018

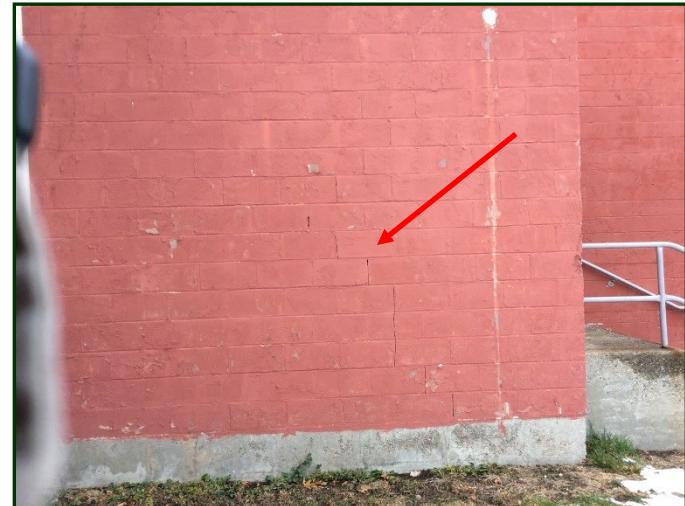
Photo #2: Crack in the south facing wall at the entry stair.

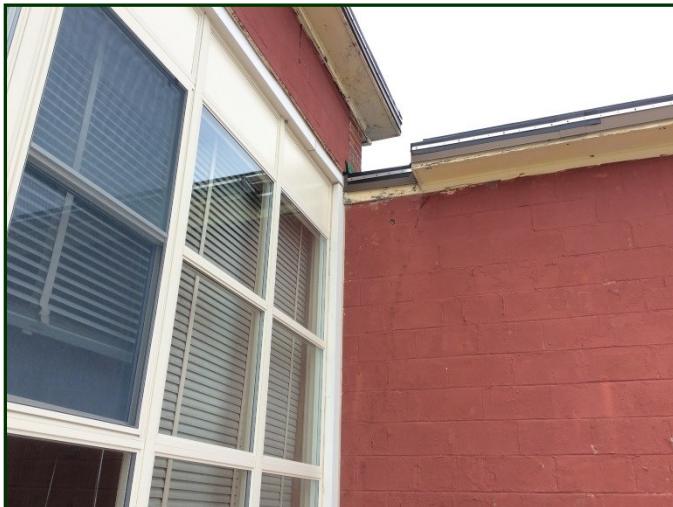
Photo #3: : Roof to wall intersection at the Cafeteria entry.
Note the peeling paint at the eaves.

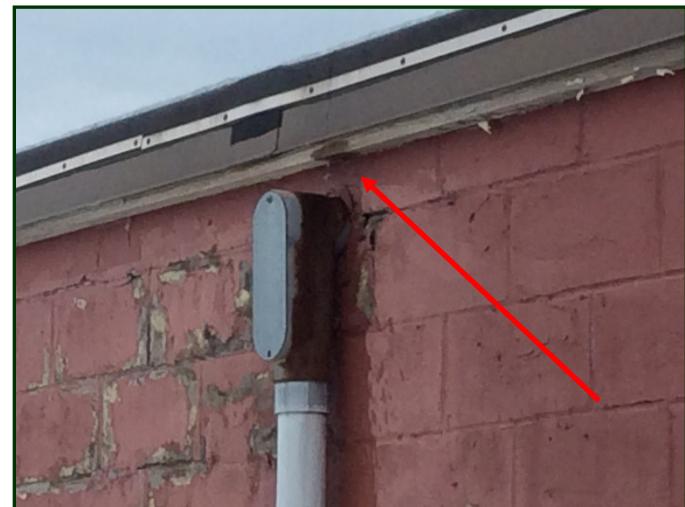
Photo #6: Detail of the emergency power conduit in the north wall. Note the water draining from the roof down the face of the wall.

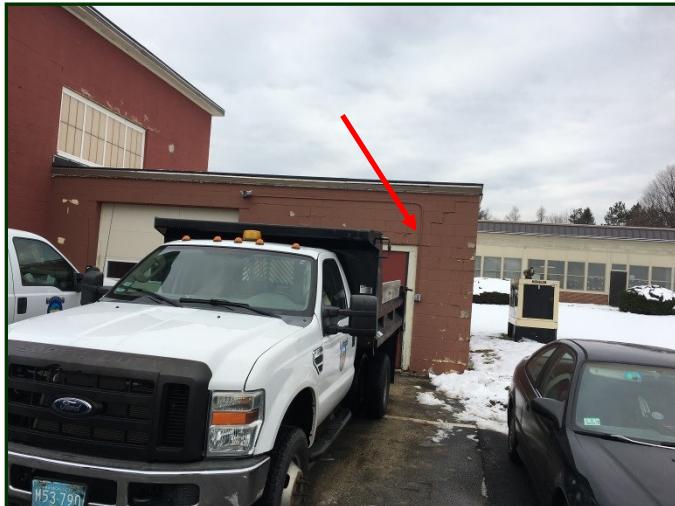
Photo #7: Maintenance garage facing east. Note the crack in the CMU wall originating from the door head.

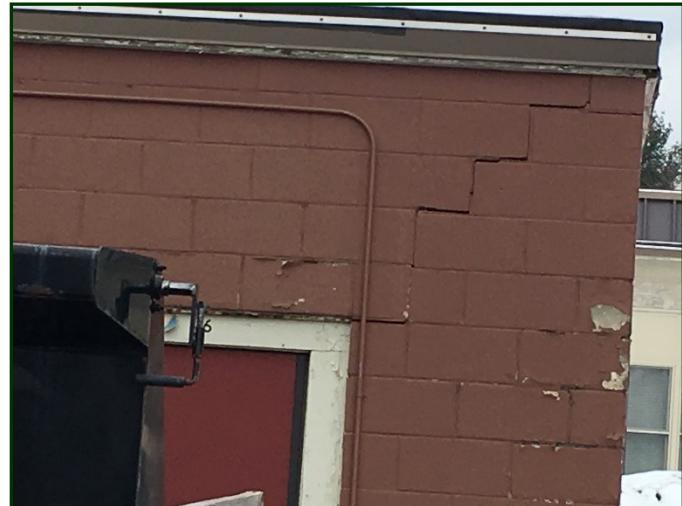
Photo #8: Detail photo of the cracked CMU at the garage.

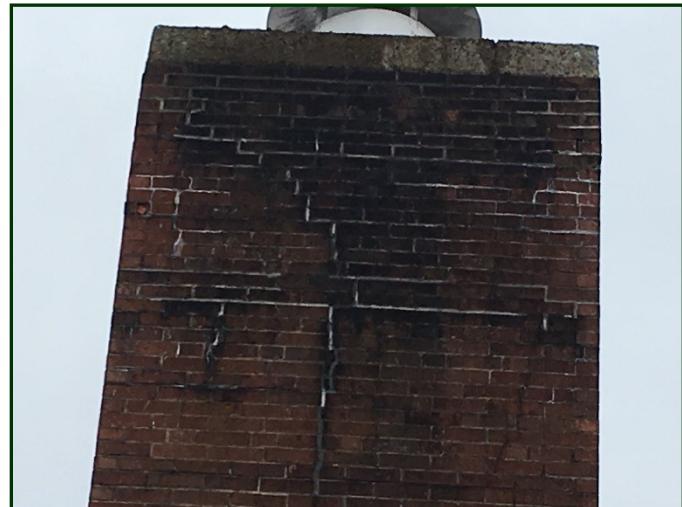
Photo #10: Chimney detail showing previous caulk repairs and some mortar cracking.

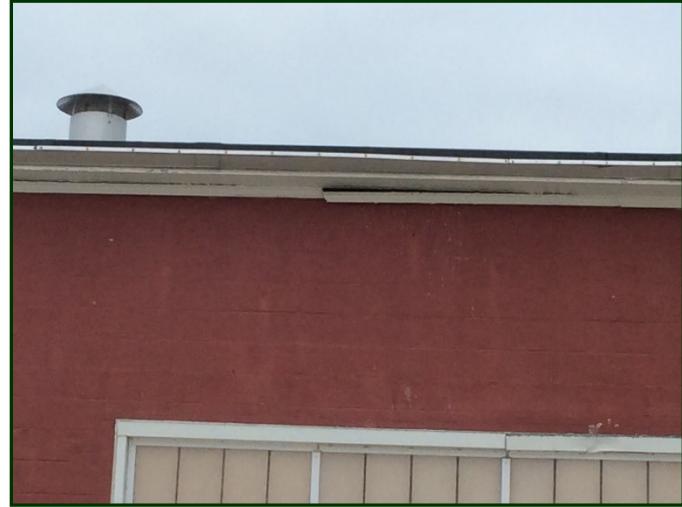
Photo #12: Loose soffit board at the Mechanical Room eave on the west façade.

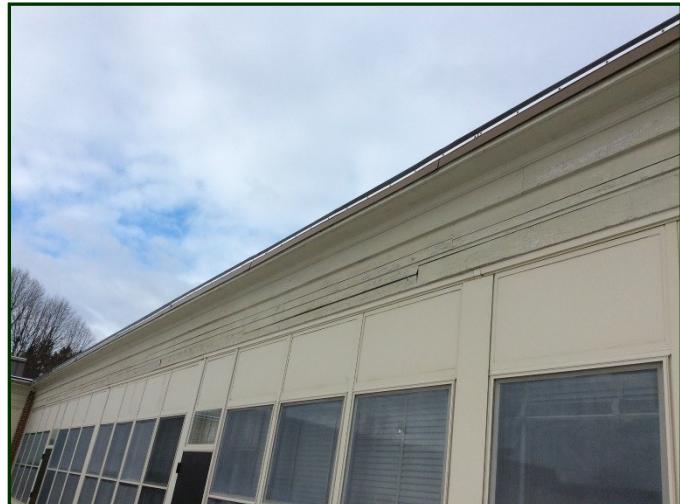
Photo #14: Wood trim over the window transoms on the north wing at the east courtyard. Note the loose board and peeling paint.

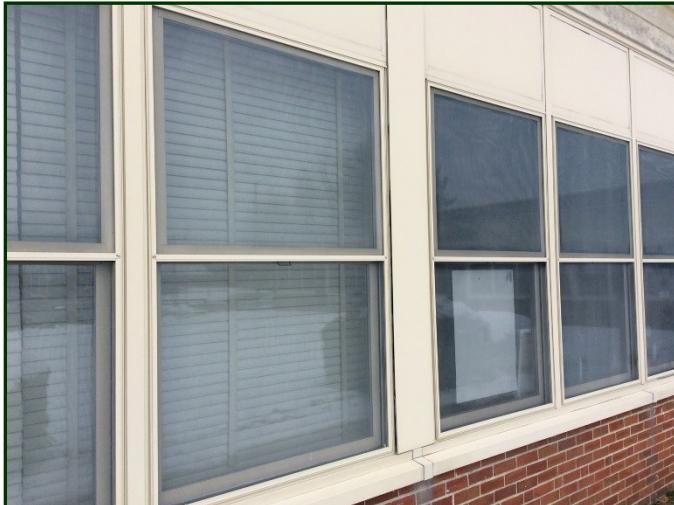
Photo #15: Detail view in a loose fascia panel in the window system.

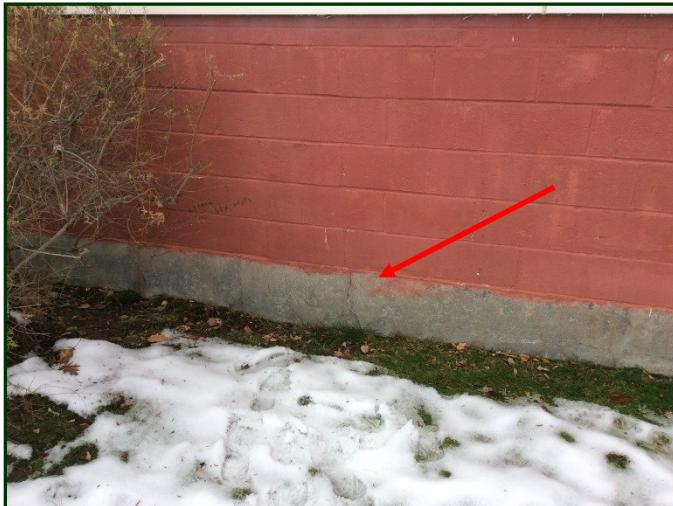
Photo #19: The east façade of the Cafeteria. Note the crack at the foundation.

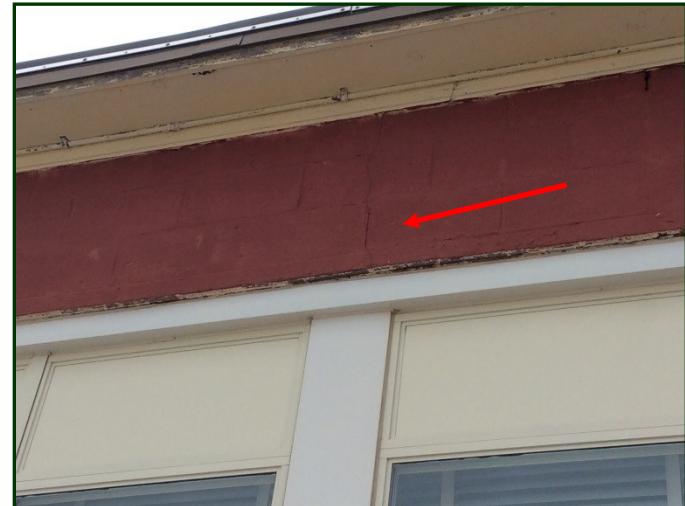
Photo #20: The east façade of the Cafeteria. Note that the crack in photo 19 continued to the top of the wall.

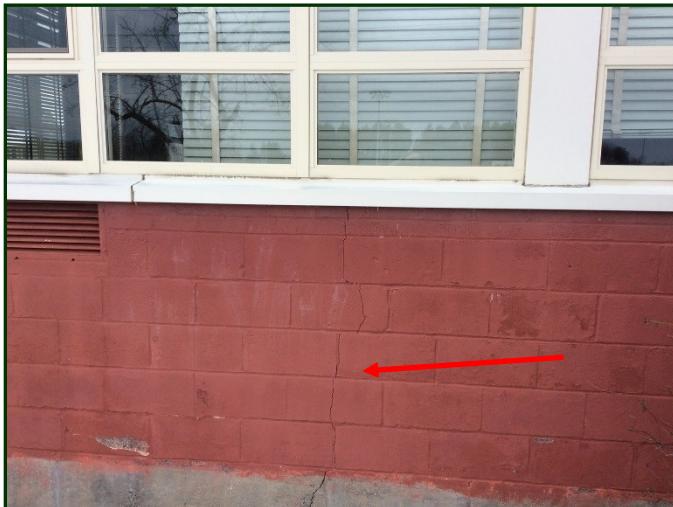
Photo #21: The east façade of the Cafeteria, Note the crack that was observed to run from foundation to top of wall.

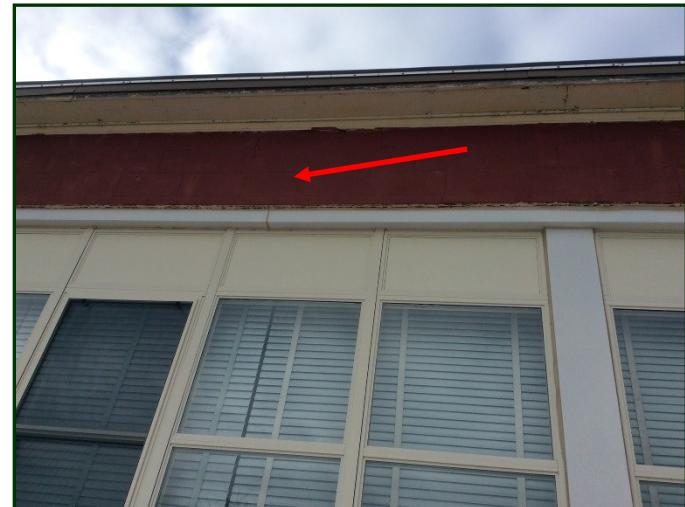
Photo #22: The top of wall at the same crack in photo 21.

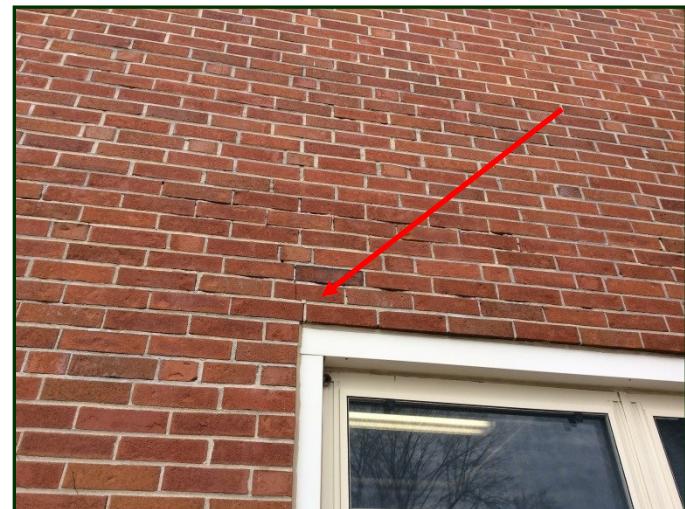
Photo #24: Detail of the window head of the window in photo 23. Note the cracked brick and the deteriorating mortar.

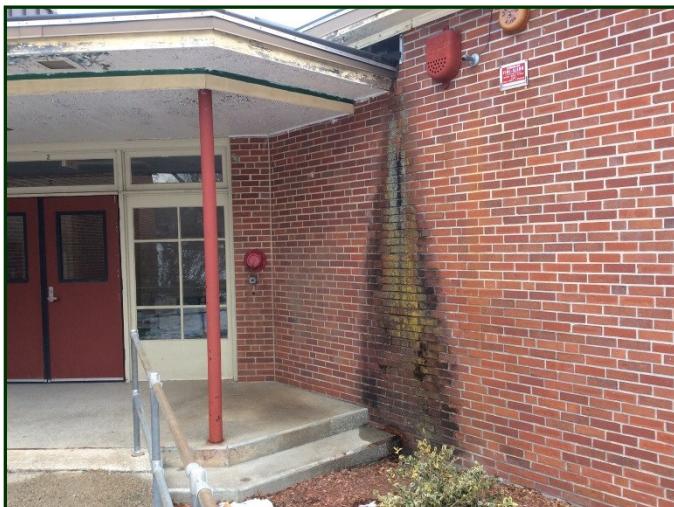
Photo #29: The secondary entrance at the southwest corner of the building. Note the staining originating from the canopy/wall intersection.

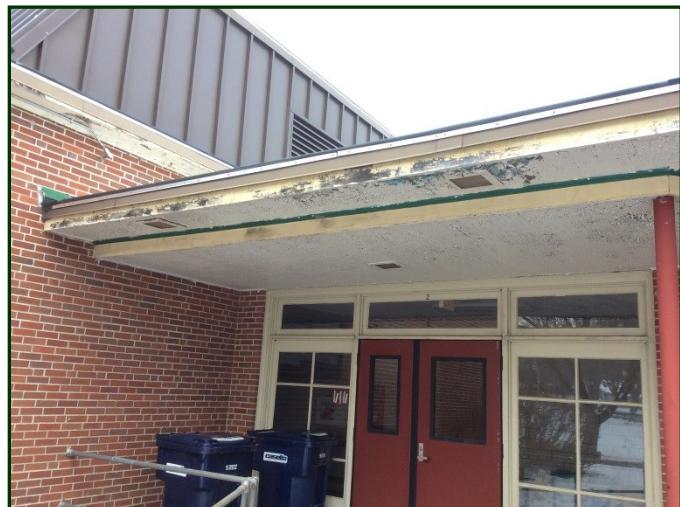
Photo #30: Detail of the canopy. Note the peeling paint and staining at the soffit and fascia.

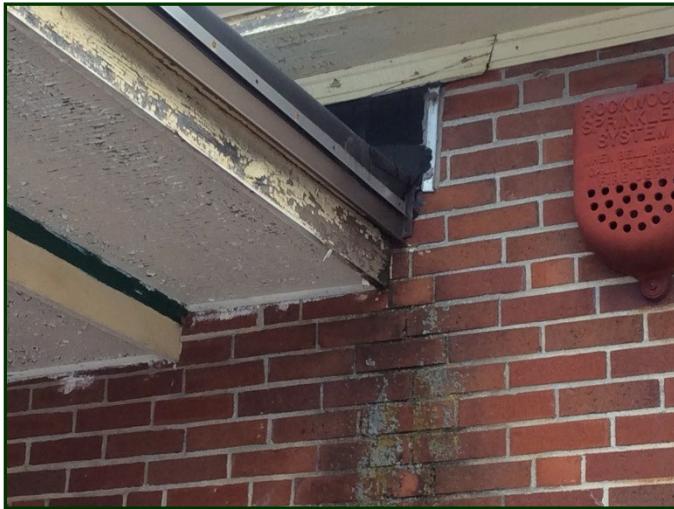
Photo #31: Detail of the canopy intersection at the brick wall. Note the deteriorating mortar under the soffit.

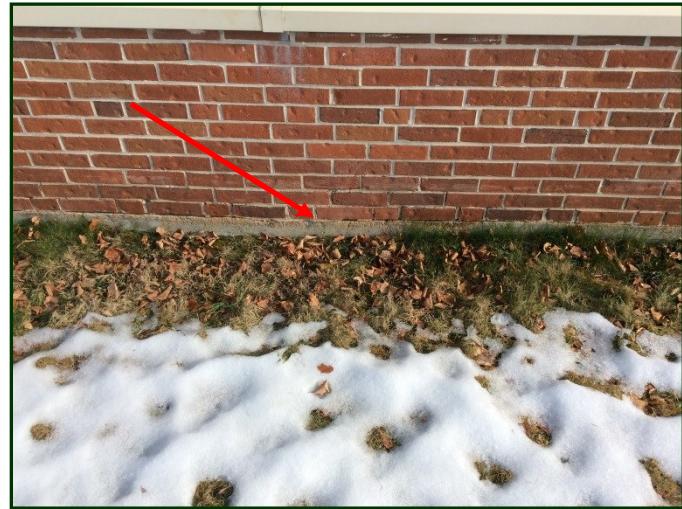
Photo #32: Detail of deteriorated mortar at the base of the wall in the west side courtyard.

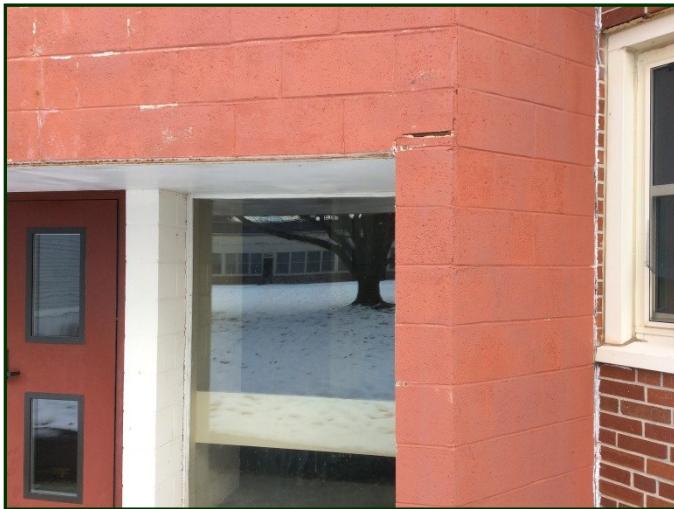
Photo #33: The building entry at the west courtyard at the north wing. Note the cracked masonry at the lintel.

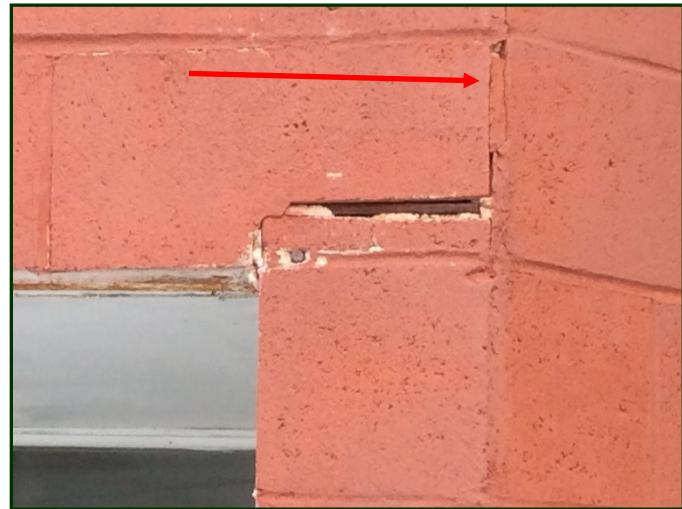
Photo #34: Detail of the lintel in photo 33. Note the exposed metal and deteriorated mortar.

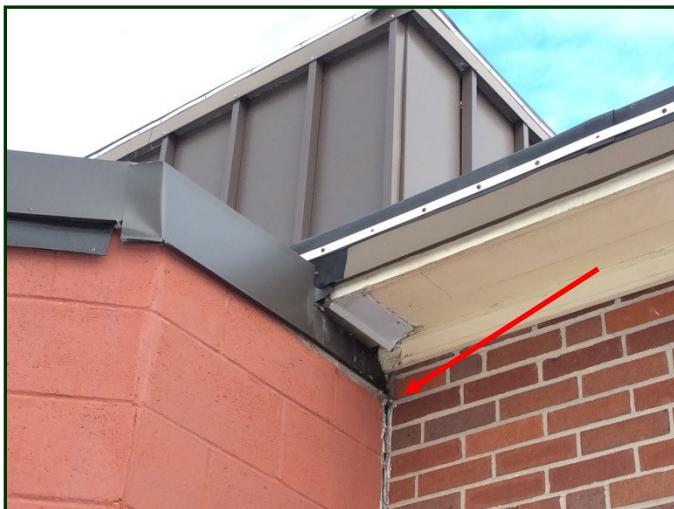
Photo #35: Intersection of CMU and brick walls at the west courtyard. Note the repairs at the soffit and the deteriorated mortar at the material transition.

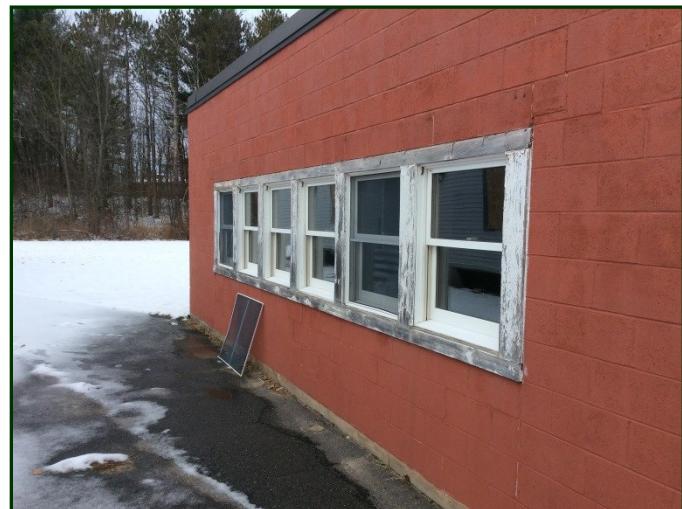
Photo #36: The west façade of the north wing. Note the peeling/missing paint at the wood window trim.

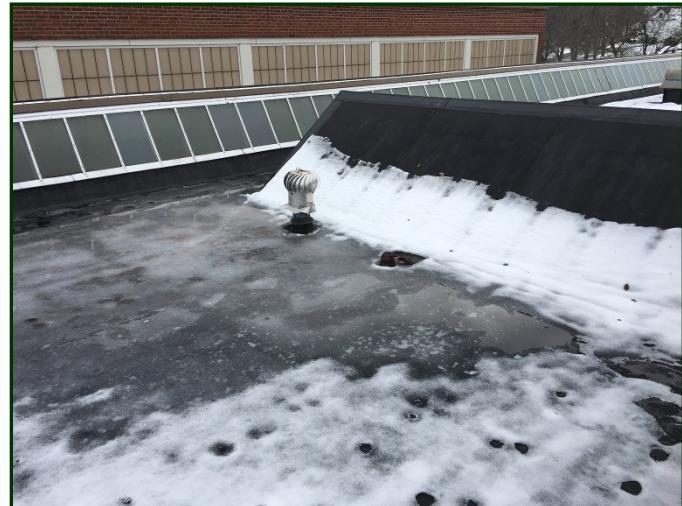
Photo #38: Roof section at the buildings central corridor showing the EPDM on the backside of the clerestory windows. Note the missing roof drain cover.

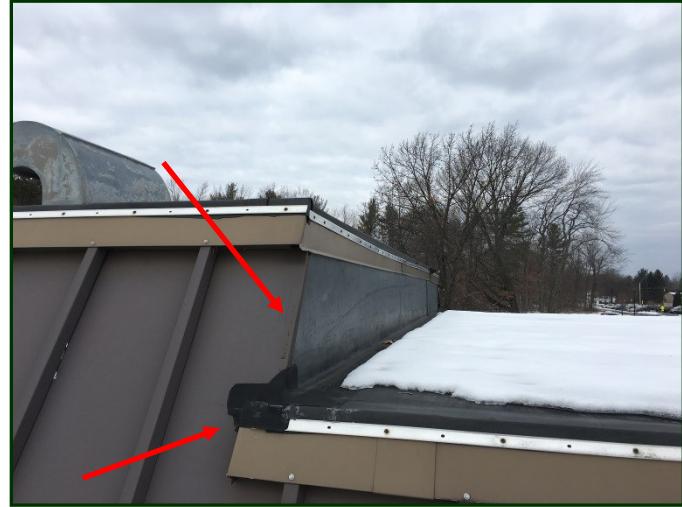
Photo #40: Detail of the standing seam panel. Note the slight rust and patch over the termination bar.

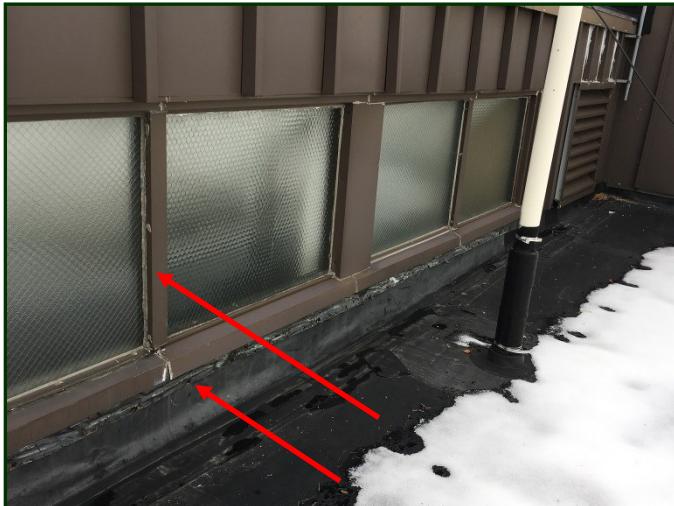
Photo #43: The clerestory windows at the north wing. Note the brittle sealant and rusted fasteners at the counterflashing.

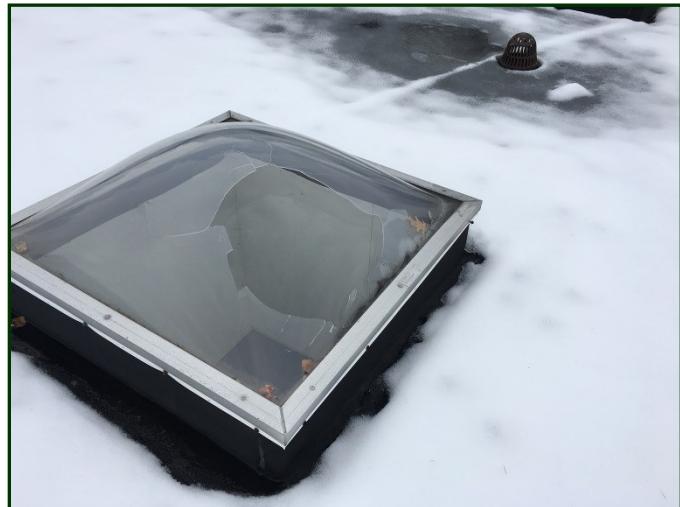
Photo #46: Detail of the skylight in photo 45 that exhibited a broken acrylic dome.

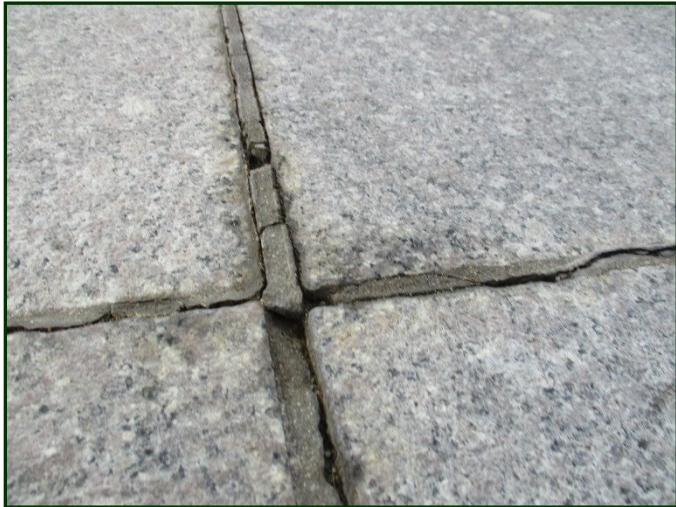
Photo #95: Close-up view of photo #94 with deteriorated mortar joints at large granite pavers

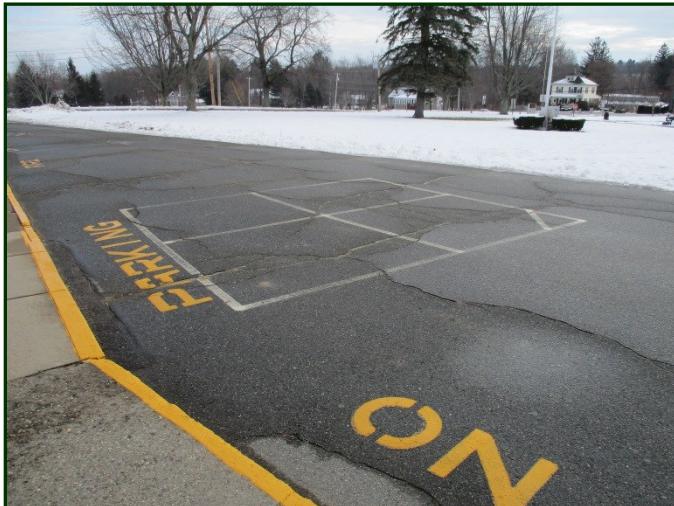
Photo #97: Asphalt-paved driveway with random cracking - south side of building (looking east)

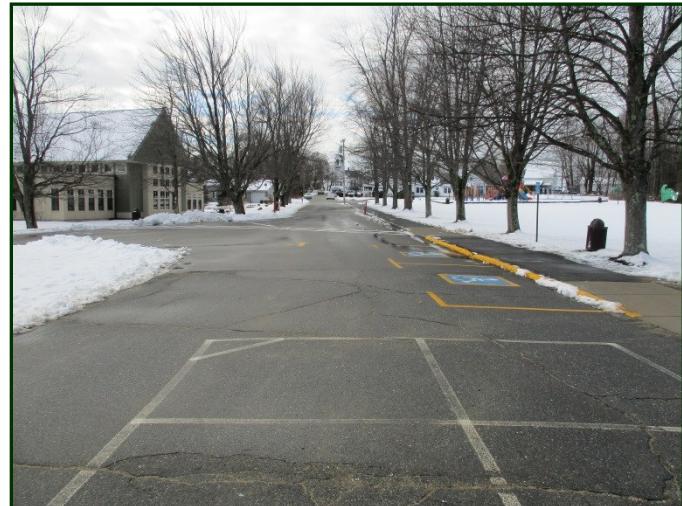
Photo #98: Asphalt-paved driveway with random cracking - south side of building (looking west)

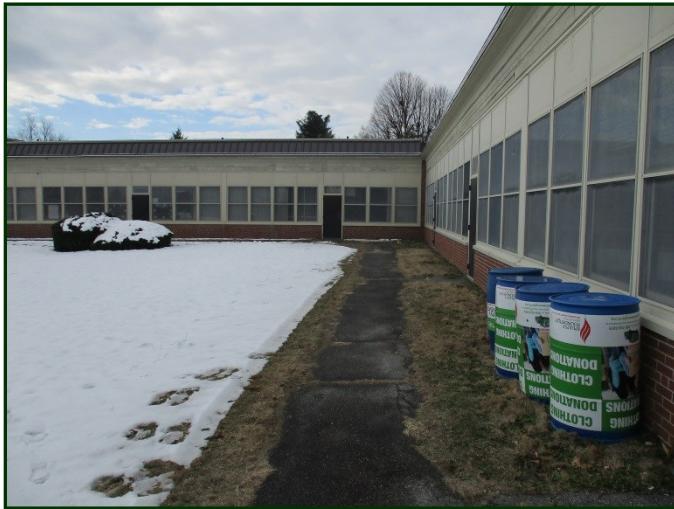
Photo #103: Deteriorated asphalt-paved sidewalk at south side of north wing

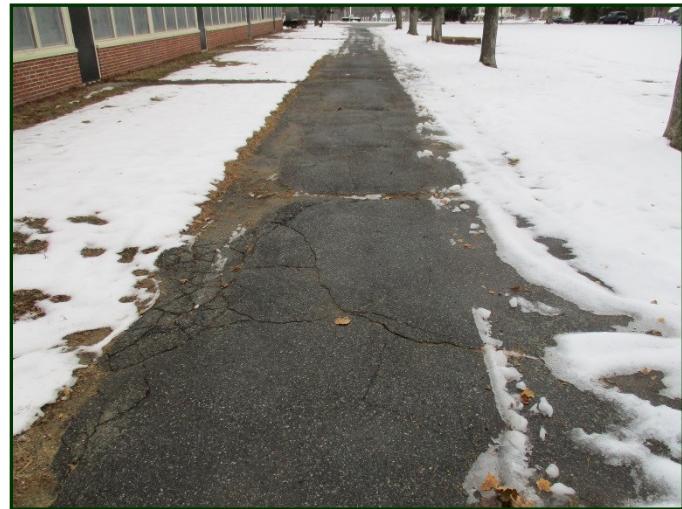
Photo #106: Deteriorated asphalt-paved sidewalk at south side of west wing

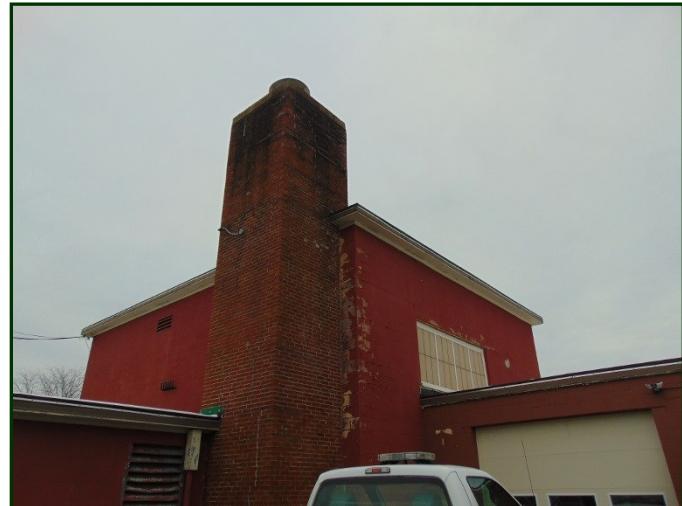
Photo #110: View of the brick chimney on the east side of the building. Note staining around chimney.

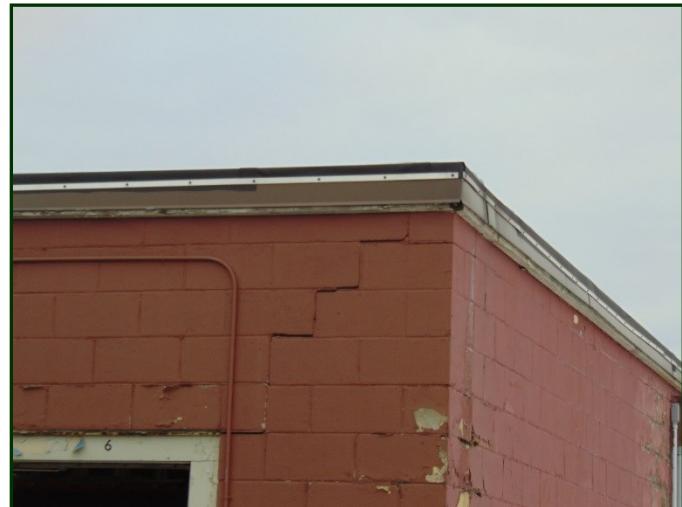
Photo #112: View of a step crack in the maintenance shop CMU wall.

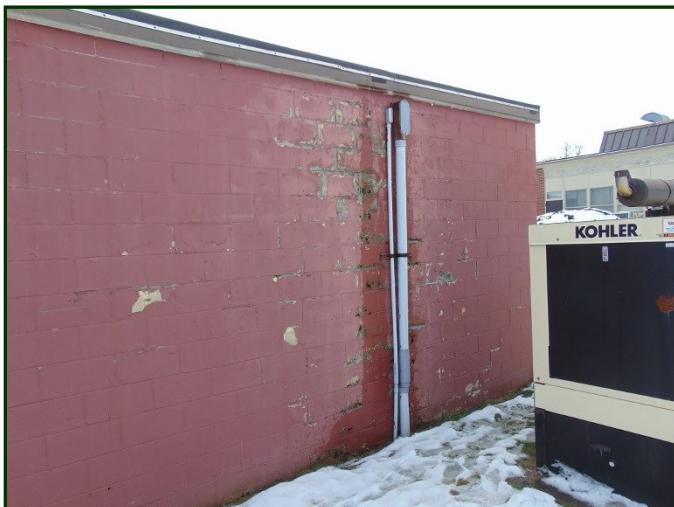
Photo #113: View of deteriorated CMU block on the north elevation of the maintenance shop.

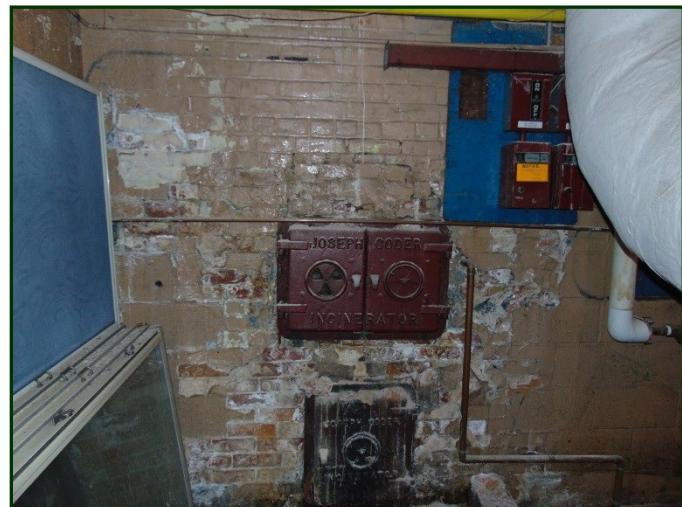
Photo #114: View of the brick chimney from the interior. Note the peeling paint and deteriorated mortar joints.

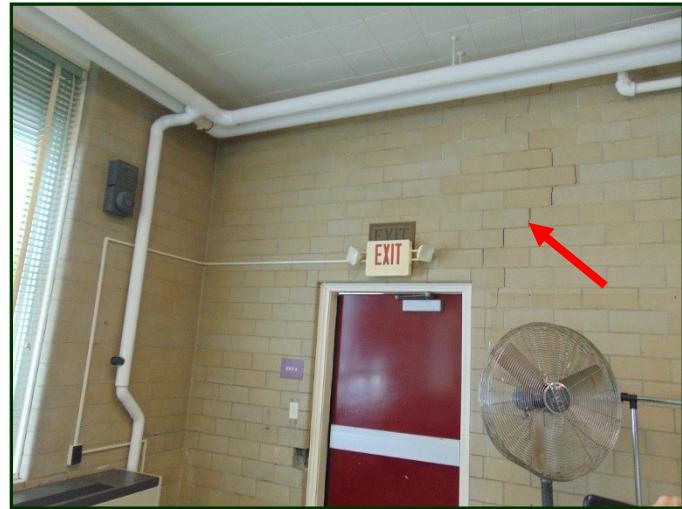
Photo #116: View of a step crack in the cafeteria.
