## Final Report for Design Services for the Reuse of the TC Passios Building, Lunenburg, MA

**Prepared For:**  
The Town of Lunenburg, MA

**Prepared by:**  
DiGiorgio Associates, Inc.  
529 Main Street, Suite 3303  
Boston, MA 02129

**March 19, 2021**

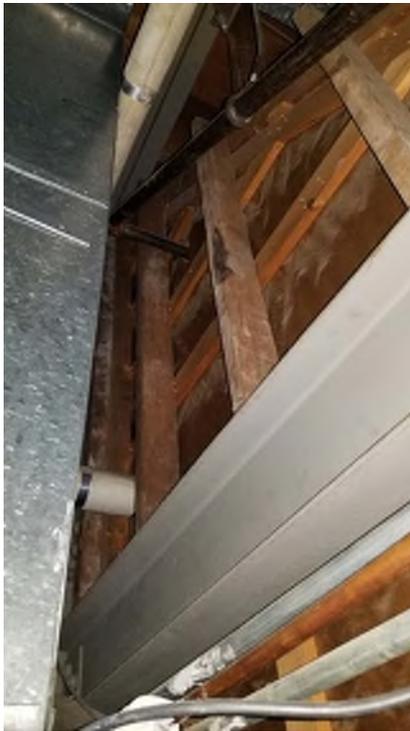
**Photo 1** Wood framed partition above ceiling.

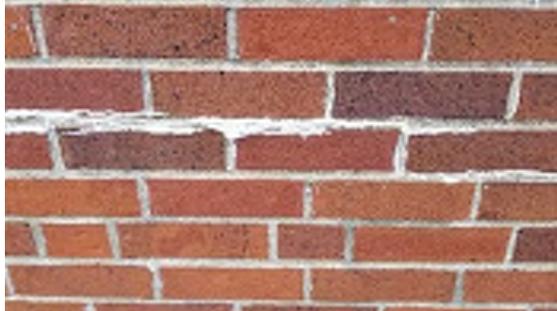
5. The brick veneer is in relatively good condition with localized areas showing signs of efflorescence, cracked bricks, and deterioration of the mortar. The mortar is worn and cracked in about 17% of the wall area and requires the joints to be repointed and cracked bricks replaced. Exposed steel window and door lintels should have rust removed and be repainted with an epoxy paint or galvanizing coating system.

**Photo 4** Efflorescence on brick veneer.

2. It is also recommended that a limited amount of exterior brick repointing be performed, to prevent accelerated deterioration and water infiltration. The mortar is worn and cracked in about 17% of the wall areas and requires the joints to be repointed and cracked bricks replaced. Exposed steel window and door lintels should have rust removed and be repainted with an epoxy paint or galvanizing coating system. All sealant joints associated with the masonry should be replaced.

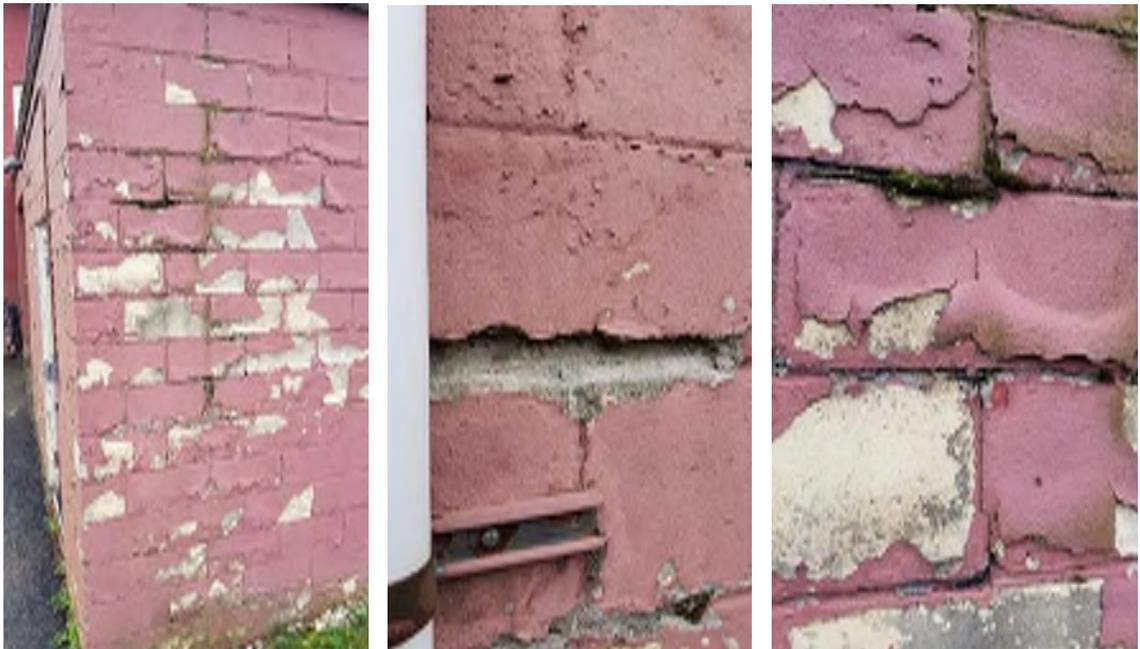
6. The CMU block is in poor condition as seen in numerous areas (boiler room, garage, 1975 addition). Deterioration was observed at mortar joints, as well as compromised face shells. Lastly, algae growth and paint peeling were observed in some areas. It is believed a non-breathable paint was used which would have sealed moisture in the CMU block walls and cause accelerated deterioration and freeze-thaw damage (See Photos No. 05-07).

From left to right: **Photo 5, Photo 6, and Photo 7** Paint peeling, algae growth, mortar joint and CMU block deterioration on maintenance garage. Similar conditions exist on the 1975 addition.

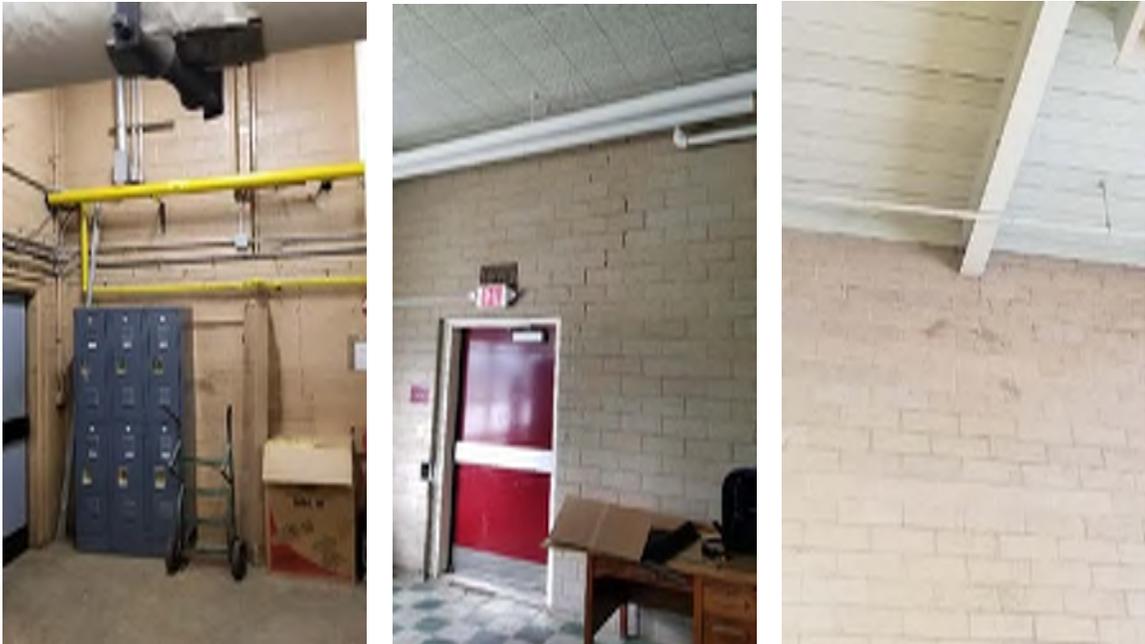
7. Various localized areas contained cracking in the brick and CMU, which is believed to be due to shrinkage from temperature changes and loss of moisture. The locations of cracking were at window/ door openings, beam bearing locations, and other miscellaneous locations (See Photos No. 08-10).

From left to right: **Photo 8** CMU block cracking below existing window opening; **Photo 9** Cracks in mortar joint around door in Cafeteria; **Photo 10** Cracks in mortar joint and block at beam bearing locations at Gymnasium.

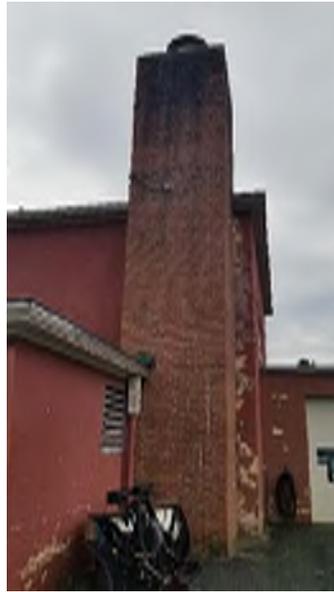
8. Some areas showed accelerated deterioration in the brick and CMU mortar. These areas include the brick chimney, the maintenance garage, and 1975 addition. The shared and/or adjacent walls to the chimney also showed paint spalling, mortar deterioration, brick and block deterioration, and efflorescence (See Photos No. 11-13).

**Photo 11** Masonry chimney.

5. Boiler Room Chimney: Based on the planned building renovations, the existing chimney will not be required for the new heating system. Due to the poor condition of the masonry chimney, it is recommended that it be demolished down to the ground and the interfacing wall and roof areas be repaired.

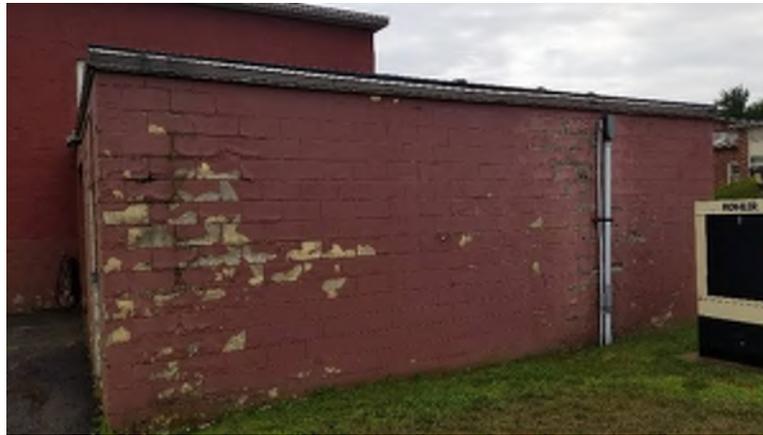
**Photo 13** Maintenance garage.

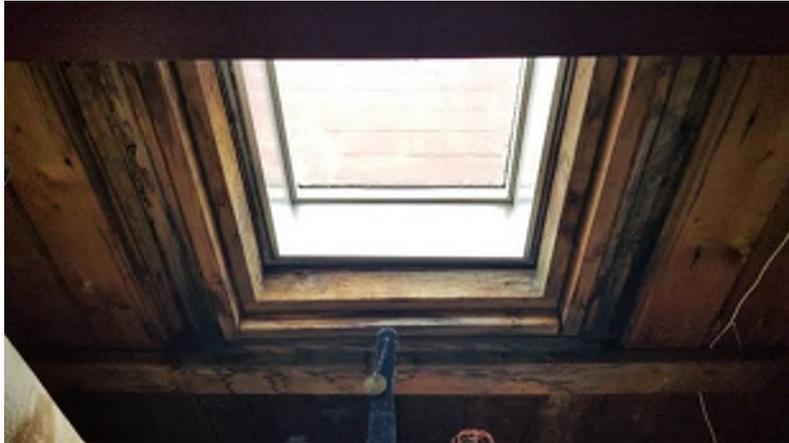
9. In addition, improper framing support was observed at a skylight in the "Tool Room" (adjacent to the Boiler Room), and signs of moisture on the framing was also observed in this area (See Photo No. 14).

**Photo 14** Moisture infiltration and improper framing at skylight in “Tool Room”.

1. The primary recommendations pertain to the skylight framing and masonry chimney. These issues pose a life safety concern. The existing framing for the skylight is atypical and poses structural concern. The framing also shows signs of excessive moisture likely from skylight leaks. It is recommended that the opening be reframed with new wood framing members and a new skylight be installed. Refer to comments below pertaining to the chimney.

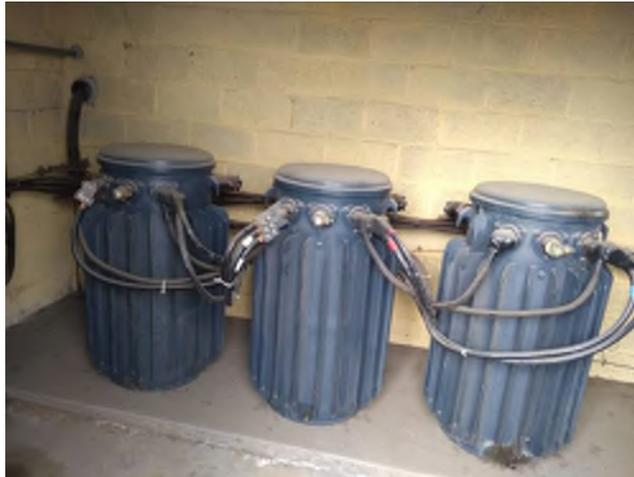
**Photo 16** Existing transformers located in vault.

- (vii) Determination of PCB-based coolant in the existing power transformers in the transformer vault should be made, and if identified, its environmental impact should be assessed (see photo 16 herein). This assessment should be performed during the final design phase of this project.

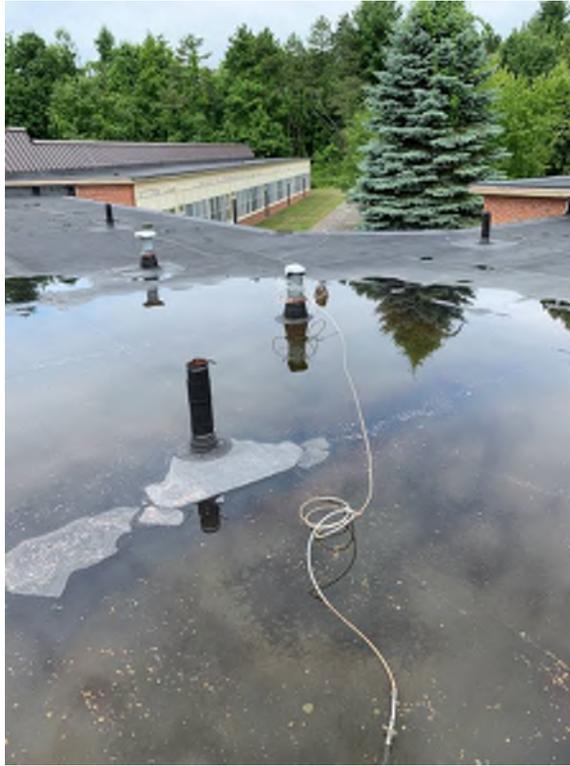
- (vii) Roof drains are poorly installed allowing water to pool on the roof (see photo). There are no overflow drains for the roof. Several entrance vestibules do not have roof drains or scuppers. It is recommended to correct the poor installation of the roof drains, add roof drains at each of the entrance vestibules, and provide overflow drains or scuppers as required.

**Photo 15** Poor installation of existing roof drains.

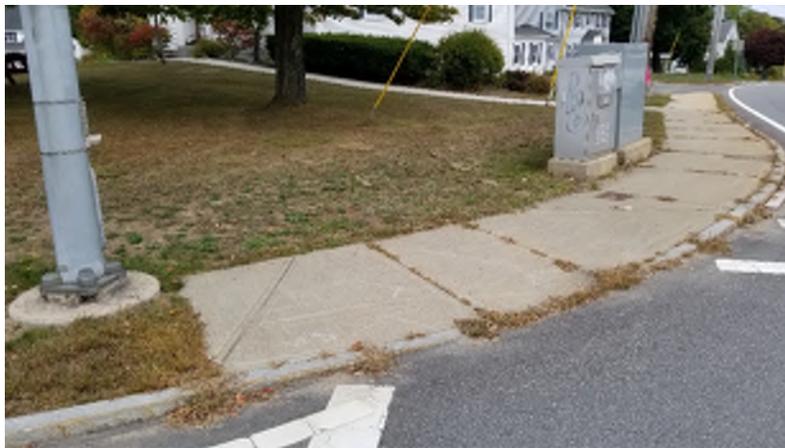
1. Sidewalks in poor condition: Sidewalks, at this intersection, are cracked with vegetation growing through joints, as shown in Figure 2, creating trip hazards to pedestrians

Figure 2: Sidewalk at Massachusetts Ave & Lancaster Ave

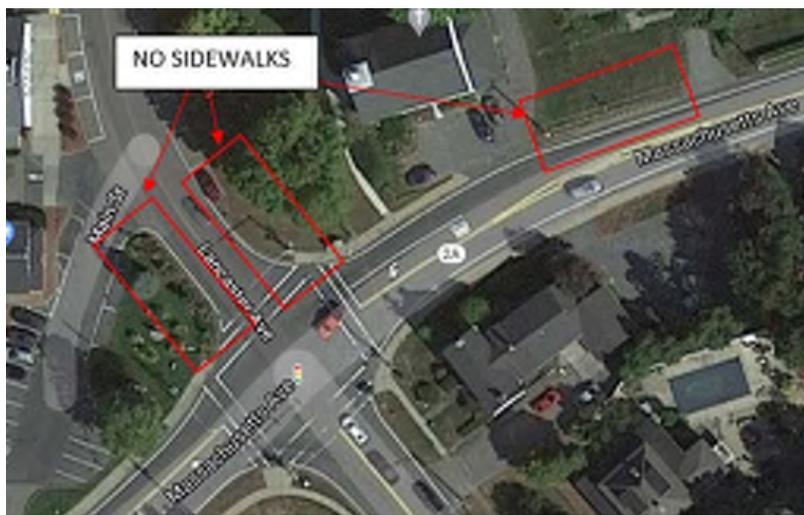
2. Lack of a sidewalk on North side of intersection: As shown in Figure 3, the sidewalks are discontinued in the north side direction of Massachusetts Avenue and Lancaster Avenue. The pedestrian have to hazardingly walk on the lawn or share the travel lane with vehicles.

Figure 3: Satellite image of Massachusetts Ave & Lancaster Ave

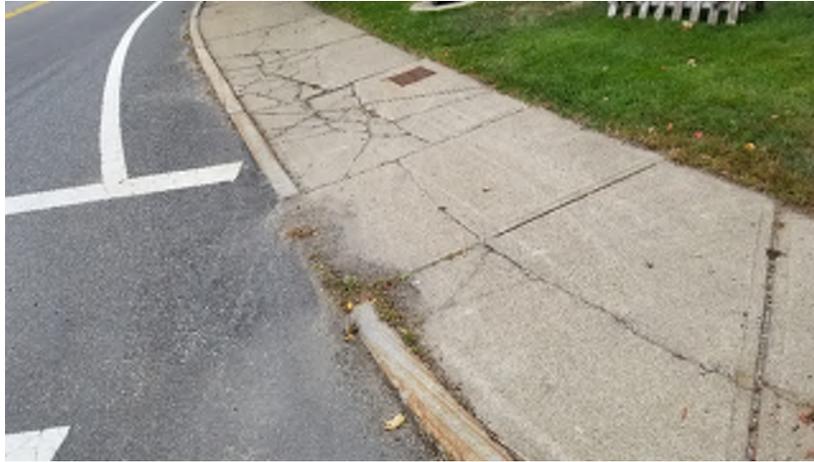
3. Lack of Detectable surfaces on curb ramps: As shown in Figure 4, curb ramps, at this intersection, lack detectable surfaces, therefore not meeting ADA compliant requirements.

Figure 4: Curb ramp conditions at Massachusetts Ave & Lancaster Ave

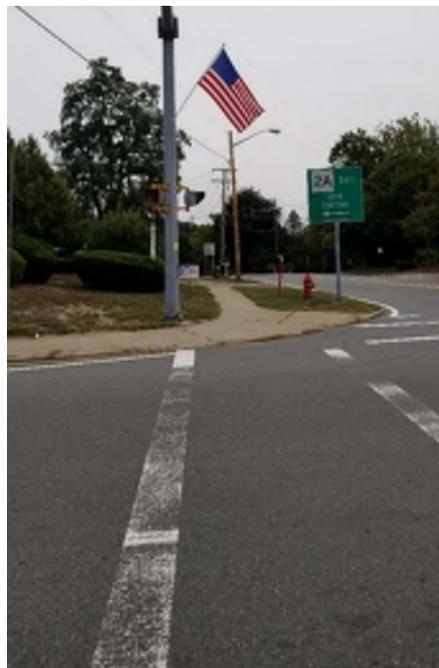
4. Faded Crosswalks: Since the crosswalks are fading, pedestrians may not necessarily walk safely across the road. It may increase vehicular and pedestrian conflicts, especially for turning vehicles. Therefore, it is highly recommended to use high visible crosswalks for the intersection near the school.

Figure 5: Crosswalk conditions at Massachusetts Ave & Lancaster Ave

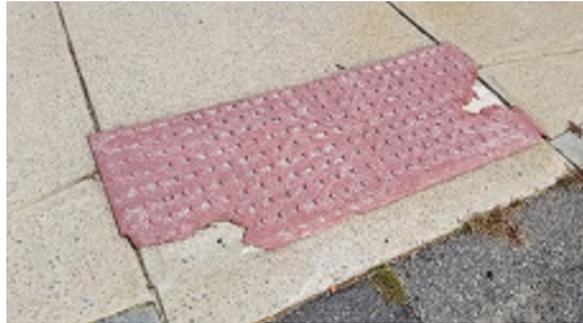
1. Detectable surface on curb ramp in poor conditions: Only one curb ramp out of two at this intersection has detectable surface and is in very poor condition, as shown in Figure 6.

Figure 6 Detectable surface at Massachusetts Ave & School Dr.

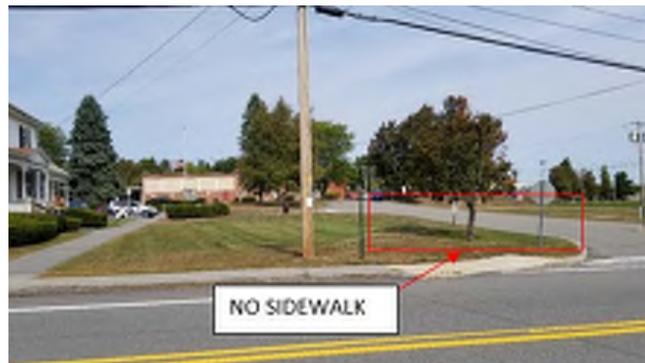
2. Curb ramps are not flush with roadway pavement
3. Poor pavement conditions around curb ramps
4. No continuous sidewalks to safely access the school: As shown in Figure 7, pedestrians have to share the roadway with vehicles beyond the school entrance, since there is no continuous sidewalks. This will increase vehicular and pedestrian conflicts and make extremely unsafe situation for both pedestrians and vehicles.

Figure 7: Sidewalk at Massachusetts Ave & W. School Driveway

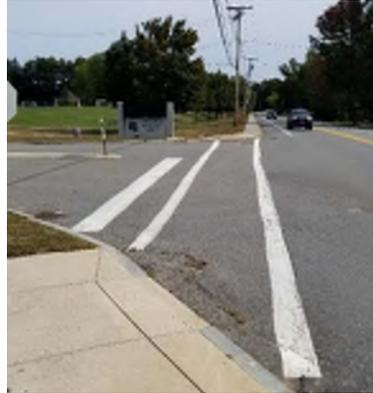
5. The stop bar is too close to the crosswalk. As per MUTCD, it is recommended to have minimum 4 feet gap between the stop bar and crosswalk. As shown in Figure 8, that gap is less than 4 feet, which increases the possibility of pedestrian and vehicular conflicts.

Figure 8 Crosswalk at Massachusetts Ave & School Driveway

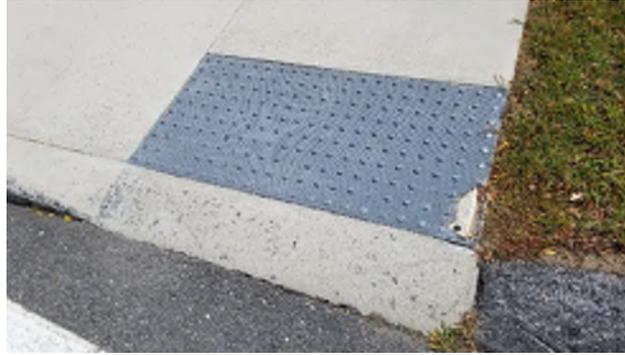
1. Curb ramp has broken detectable surface (shown in Figure 10)
2. Need one-way signs (MUTCD R6-1L): It is a T-intersection. If the eastbound is one way, it needs to show one-way sign (MUTCD R6-1L).

Figure 10 Detectable surface at Memorial Drive & School driveway

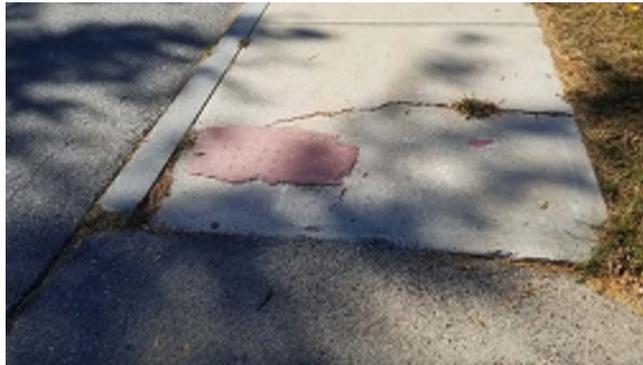
1. Detectable surface on curb ramp in poor conditions: The detectable surface on curb ramp has been nearly deteriorated as shown in Figure 11. The entire ramp needs reconstruction.

Figure 11 Detectable surface at Massachusetts Ave & West School Driveway

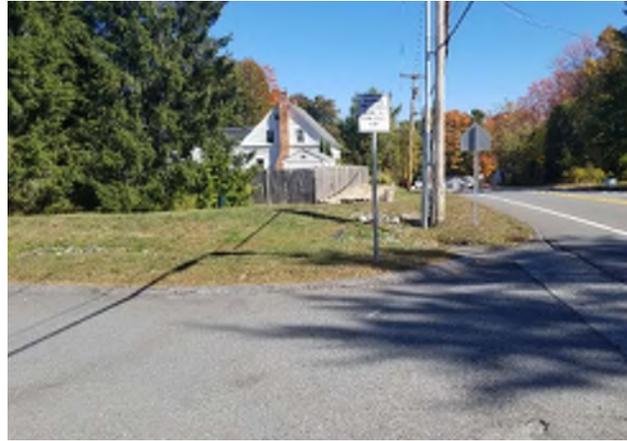
2. Lack of sidewalks on east side of driveway: There are no sidewalks on the east side of School Driveway. Pedestrians share the roadway with vehicles, which increases the vehicular and pedestrian conflicts.
3. Roadway curbs in poor conditions: The curbs within the school entrance are in poor conditions, broken or missing, and will require reconstruction.

Figure 12: Curbs at Massachusetts Ave & West School driveway

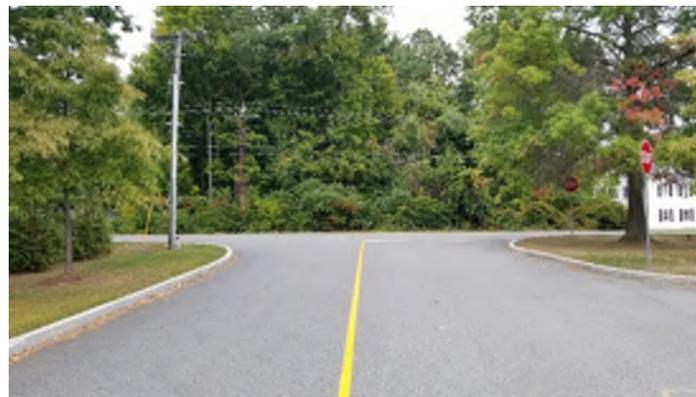
1. Lack of Sidewalks: Pedestrians are unable to safely walk up to this intersection unless they use the travel lanes. There are also no curb ramps and no crosswalk at this intersection.

Figure 13: No sidewalk at Oak Ave & W. School Driveway

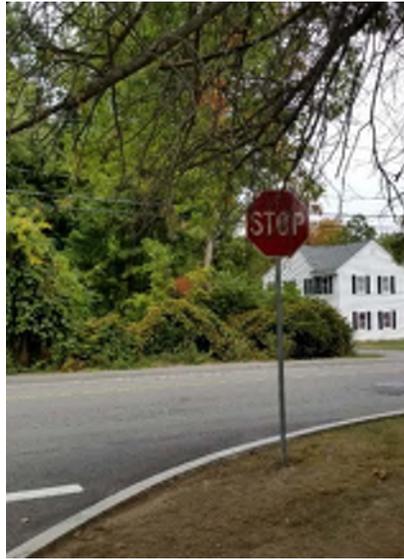
2. Lack of visibility for Stop Signs: As shown in Figure 14, the stop sign is hidden by the tree branches and has a high offset distance from the roadway. Drivers will be unable to see the STOP sign and it will be hazardous to turn onto Oak Avenue. Therefore, the STOP sign may need to be relocated closer to the intersection.

Figure 14: Stop sign at Oak Ave & W. School driveway

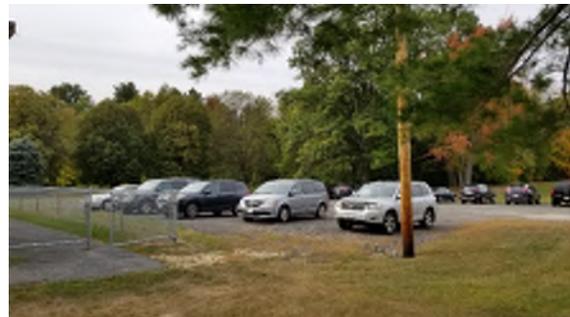
This parking lot is mainly used for high school staffs or students. As shown in Figure 15, it is unpaved and unstriped, with a capacity of roughly 20 vehicles. But it is observed to be fully occupied with just 13 vehicles. Due to each vehicle occupying more than 10 ft-wide space. The number of parked vehicles are consistent during the school hours but after that (3pm), the number of parked vehicles dropped significantly.

Figure 15 North Side parking lot

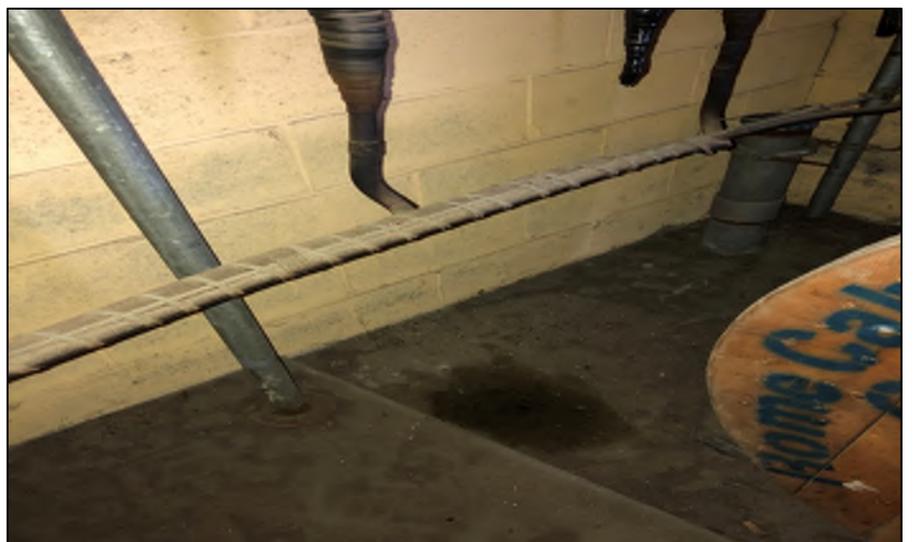
Photo 8: Surface staining under old oil-filled switchgear equipment associated with the High School in the Electrical Room.

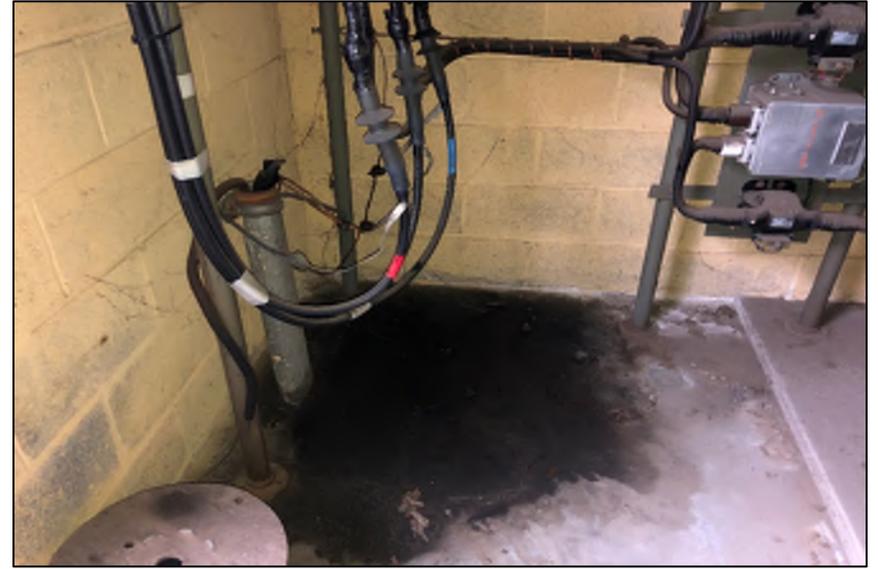
Photo 10: Surface staining under old oil-filled switchgear equipment associated with Passios School.

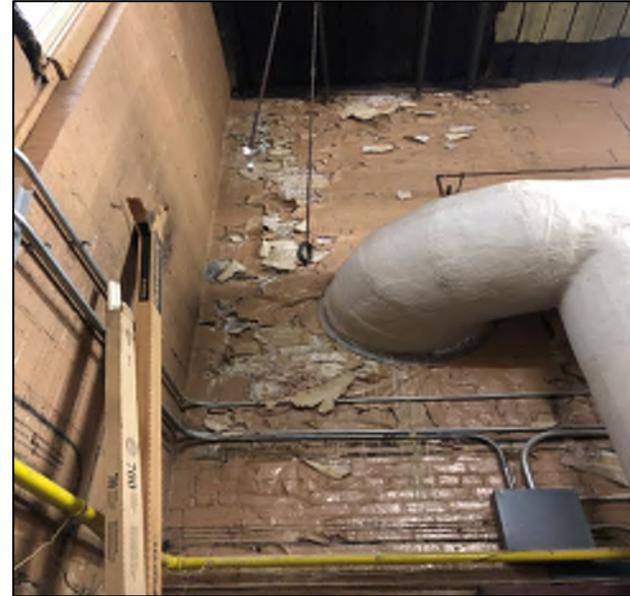
Photo 14: Paint peeling observed on the interior wall of the Boiler Room associated with the brick chimney (above the old incinerators).

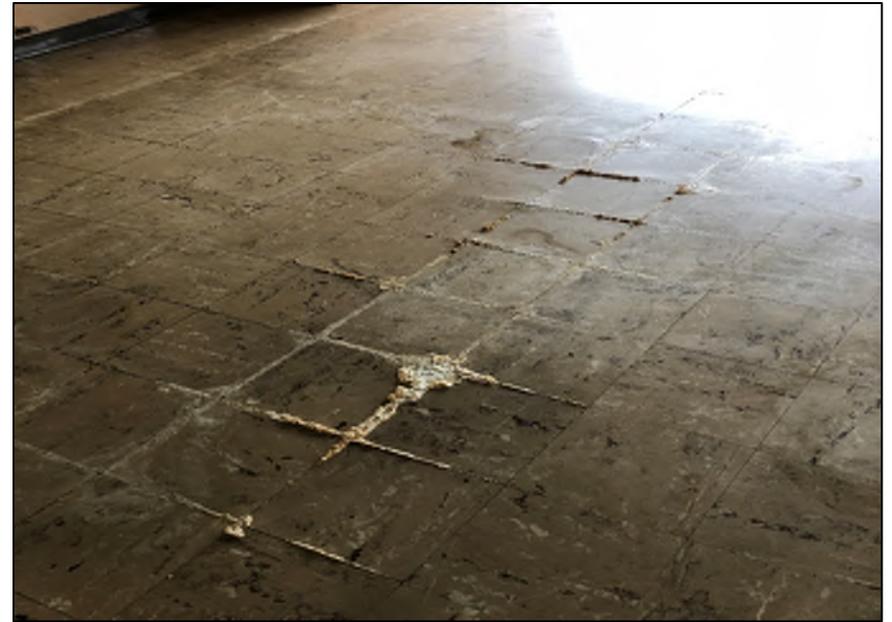
Photo 34: Damaged floor tile in Classroom 22.
