# Lunenburg Municipal Buildings

*Municipal Building Design Committee Meeting*  
**2.4.2025**

**TAYLOR & BURNS**  
ARCHITECTS

# LUNENBURG MUNICIPAL BUILDING DESIGN

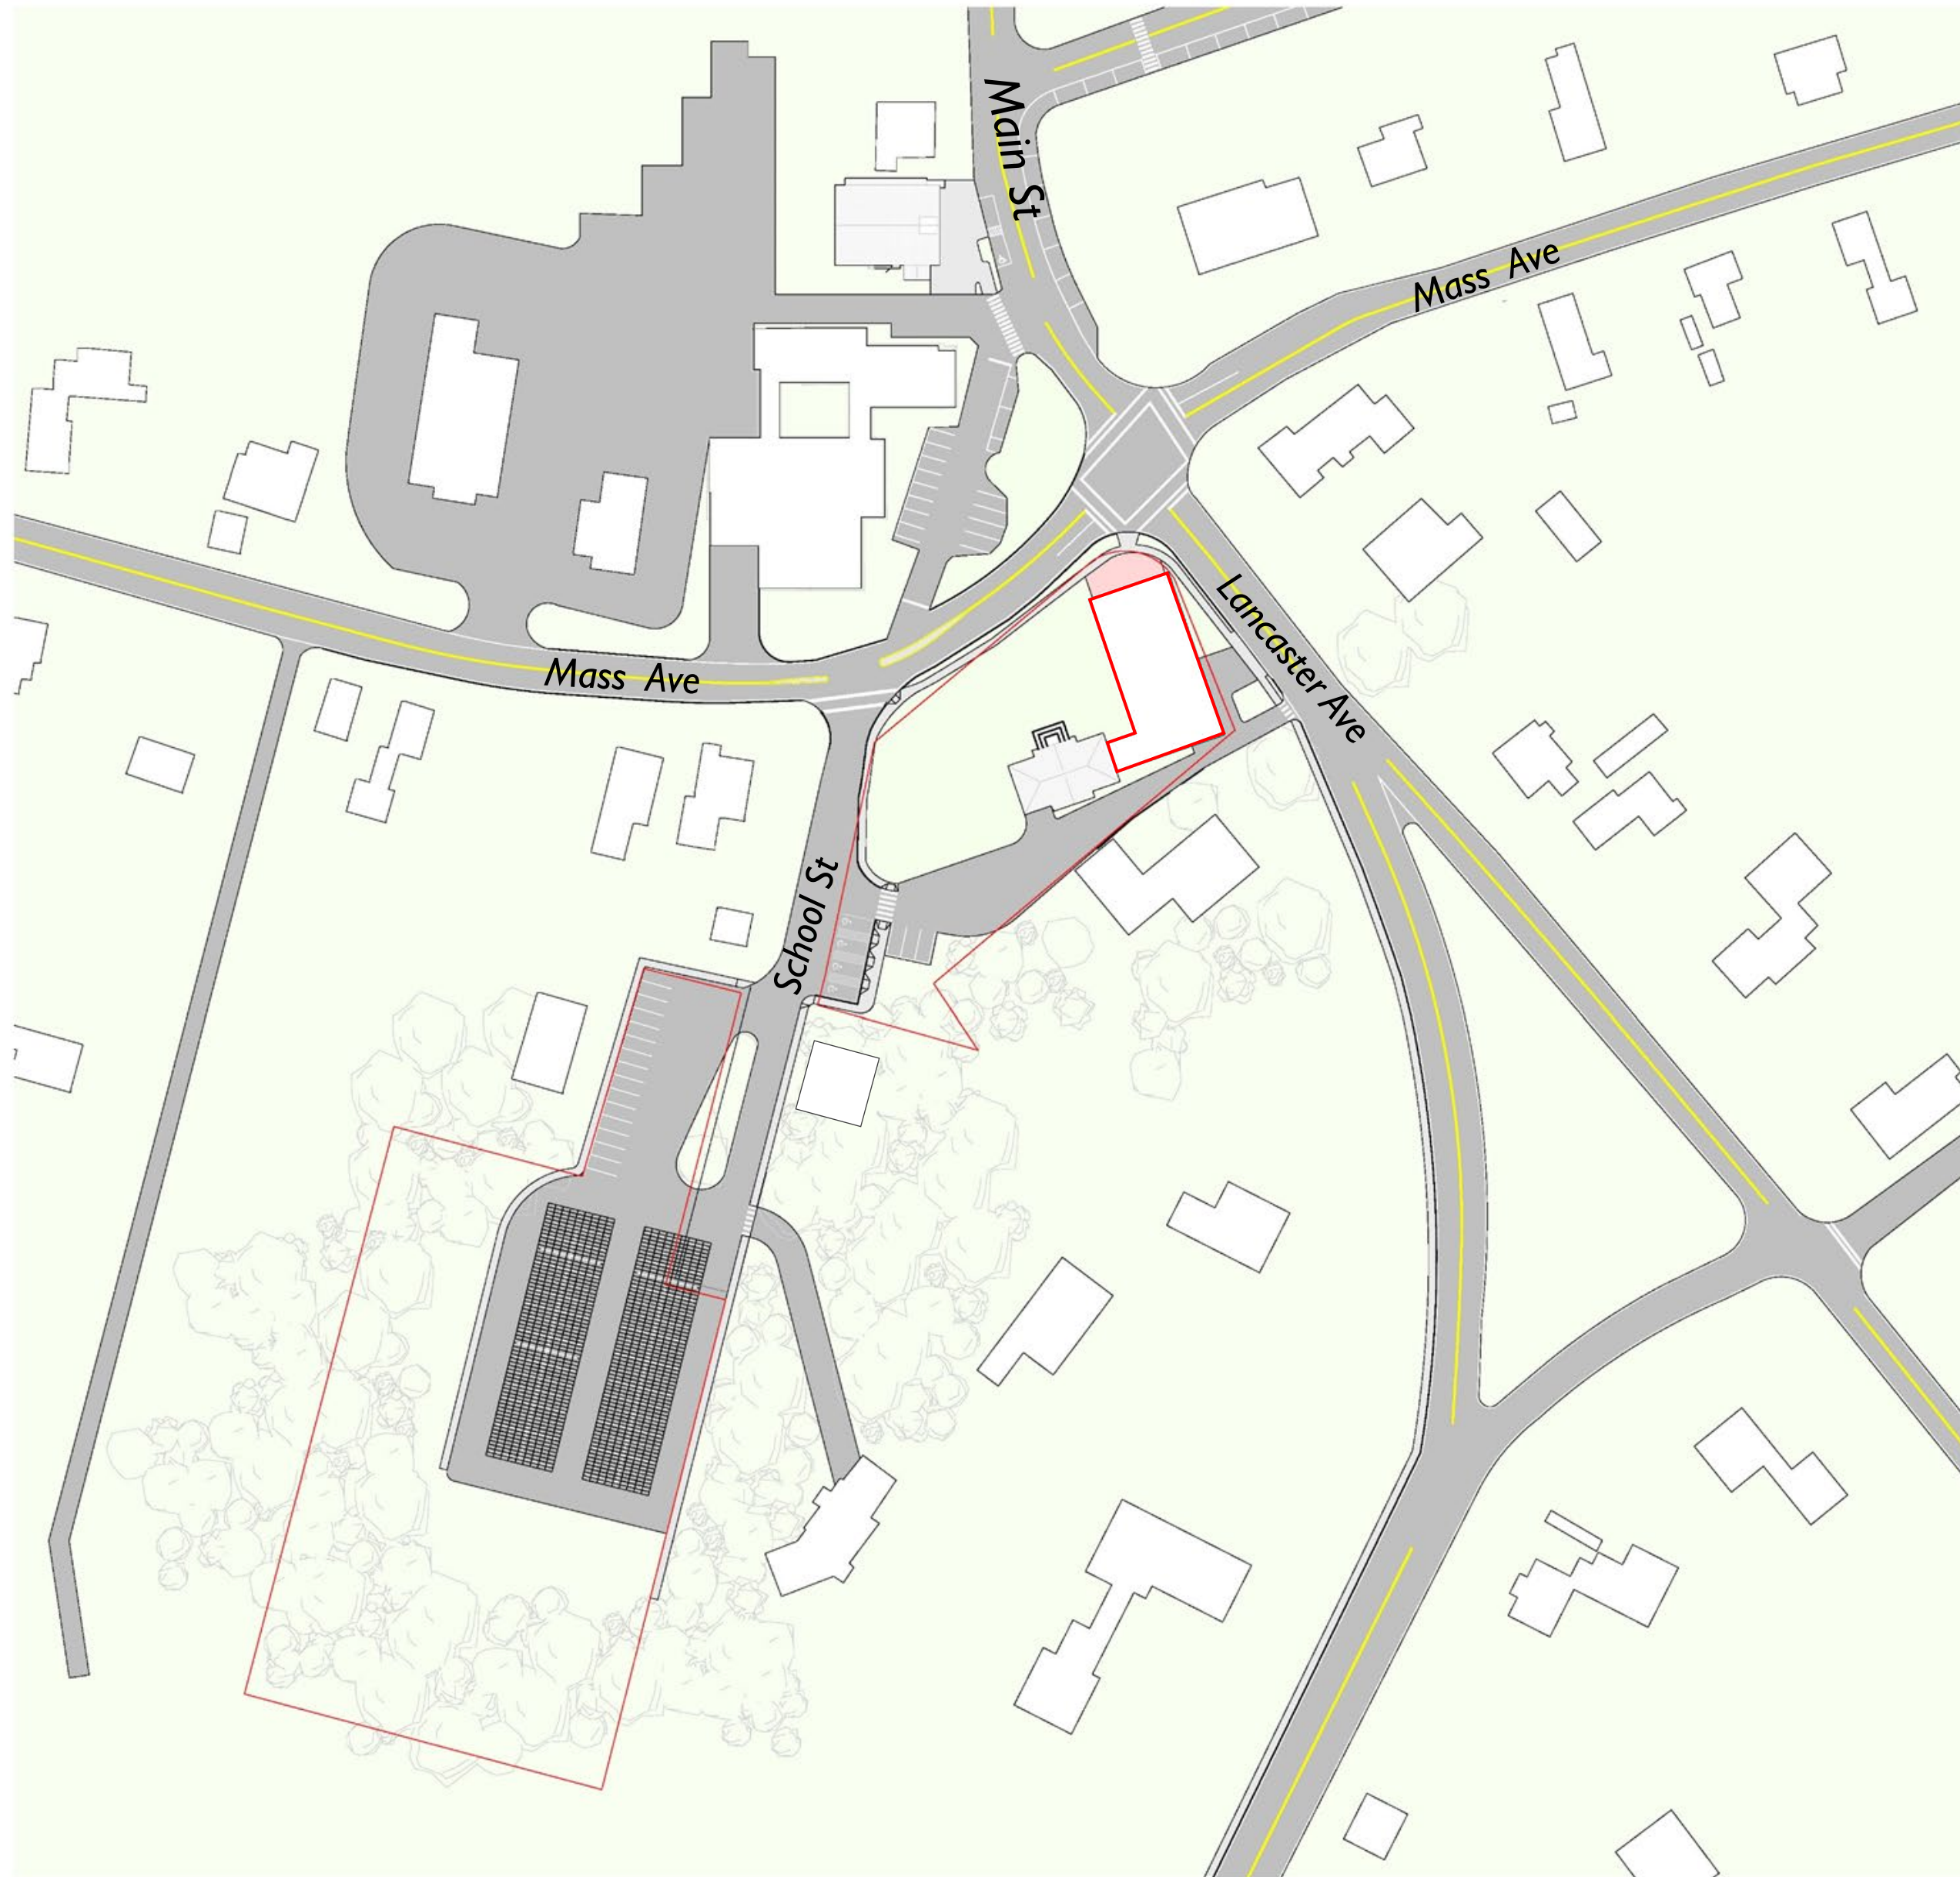
# ALTERNATE SITE PLAN STUDIED

## Reasons Why it Doesn't Work

1. Insufficient space on Lancaster Ave for proposed Town Hall footprint
2. Twice the distance from main parking at School St to alternate Town Hall entry
3. 1965 Ritter addition represents 1,500 SF of well-built space, with a value of +/- \$750,000
4. 1909 Ritter Memorial has inaccessible floor levels, difficult to align with new accessible Town Hall addition

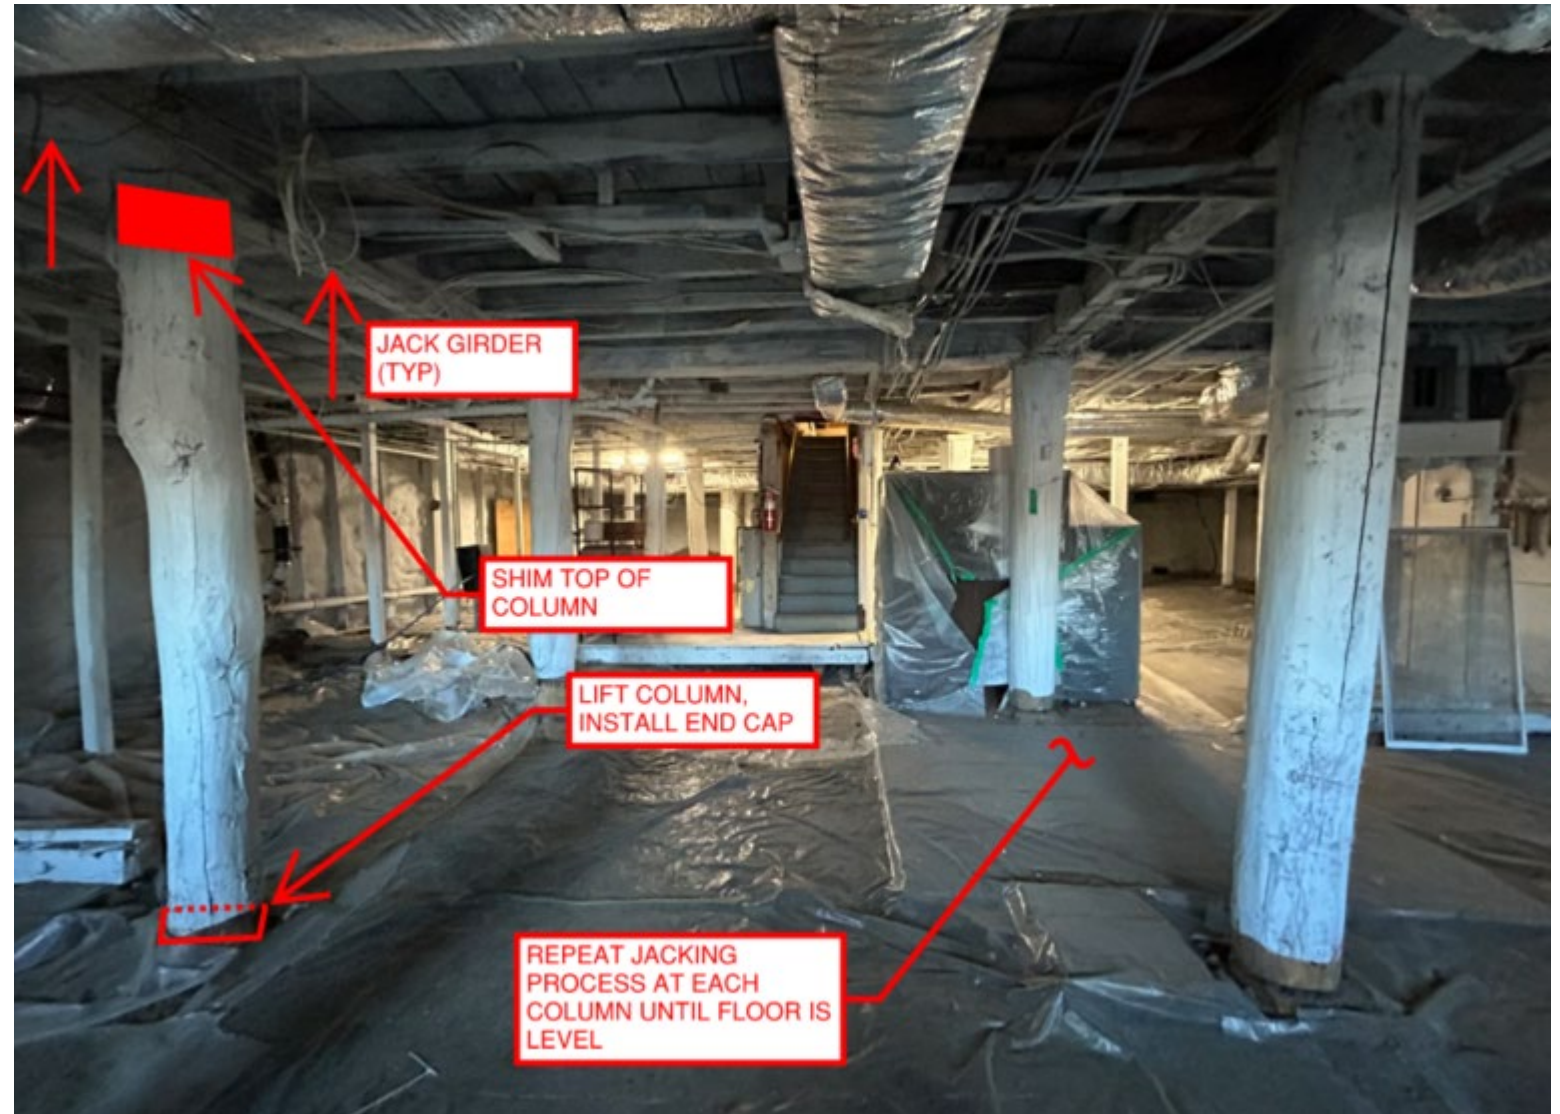
- Level survey of girder bearings
- Jack girders
- Lift column
- Install moisture protection at column base
- Lower columns
- Install shims on top of columns
- Remove jacks
- Repeat at other columns

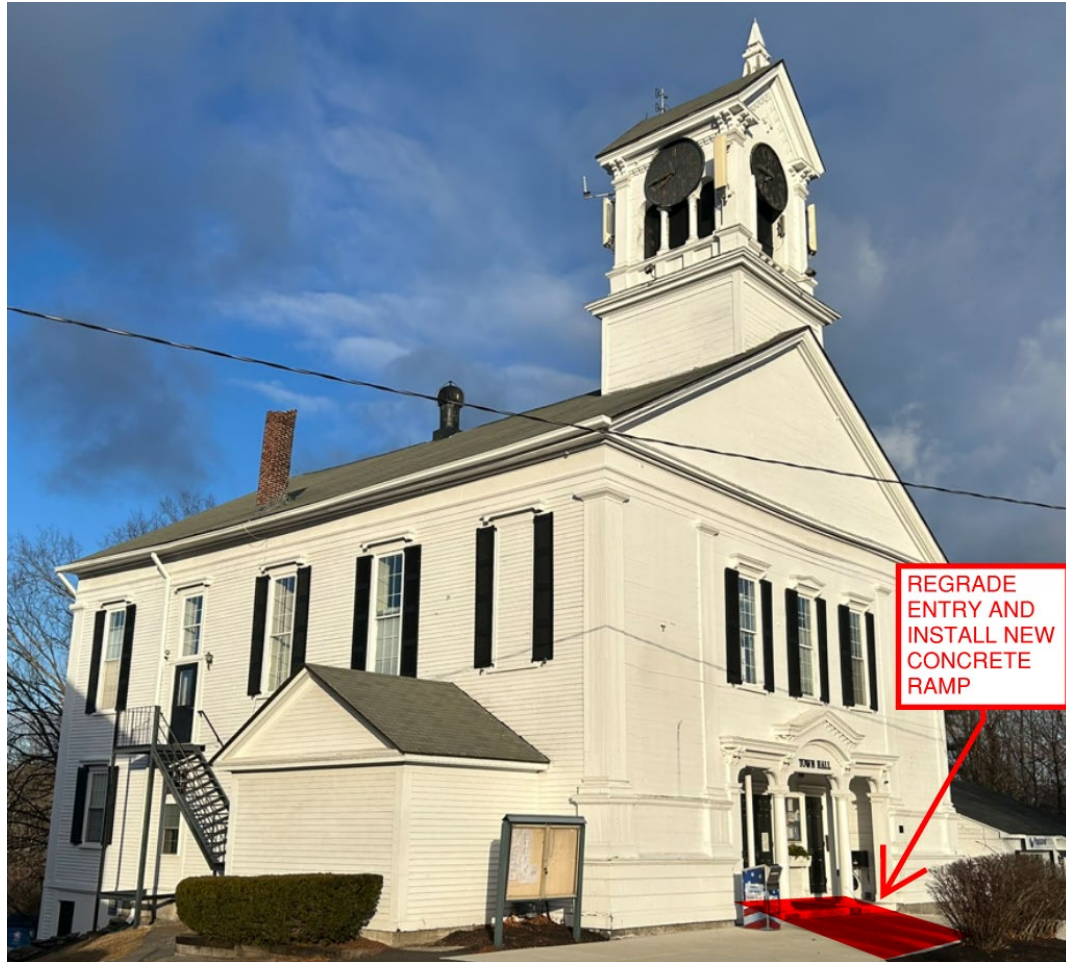
## Entry Accessibility

PLAN VIEW

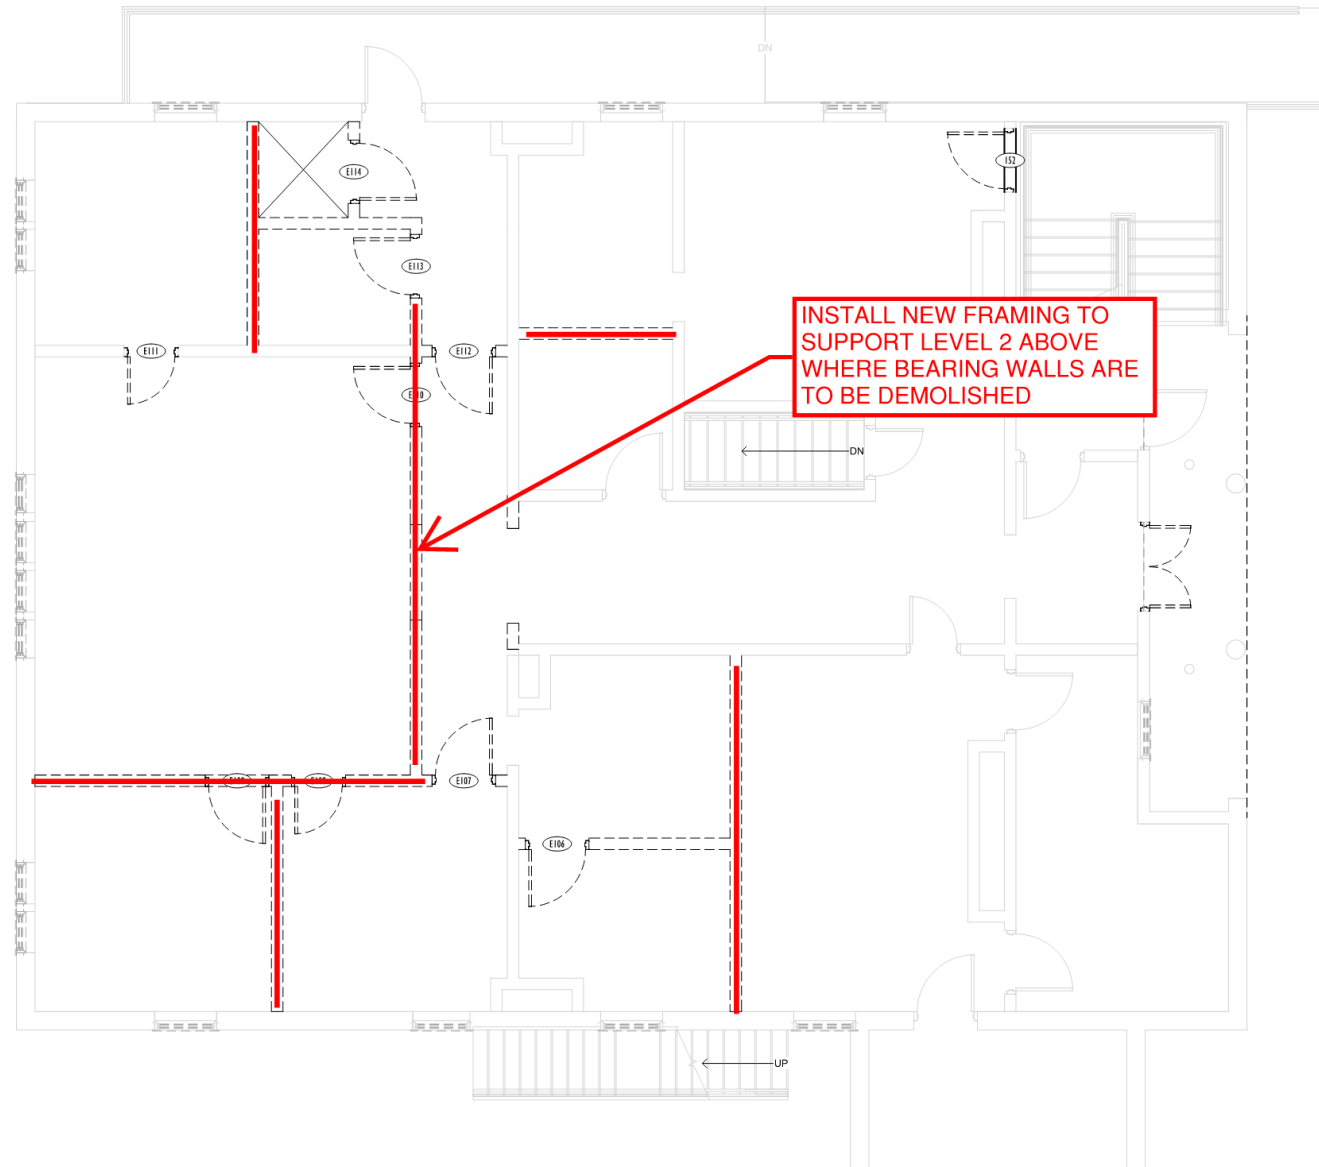
## First Floor Programmatic Updates

- Add girders and posts to replace removed bearing walls
- Some first floor framing adjustments may be necessary to support the new posts
- Squeaky floors
  - Remove flooring finish
  - Screw wood floor to the joists

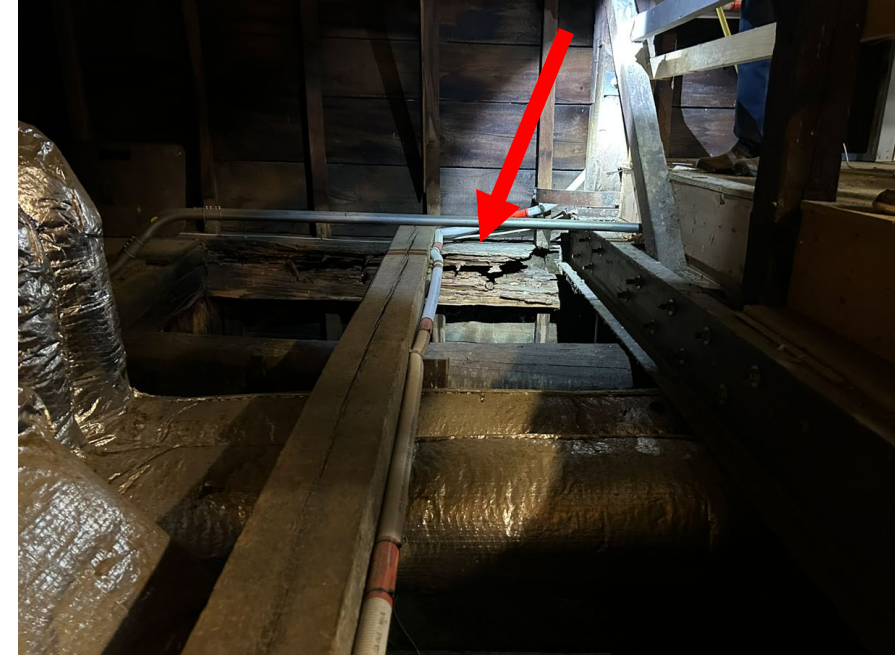
Rotted spandrel beam

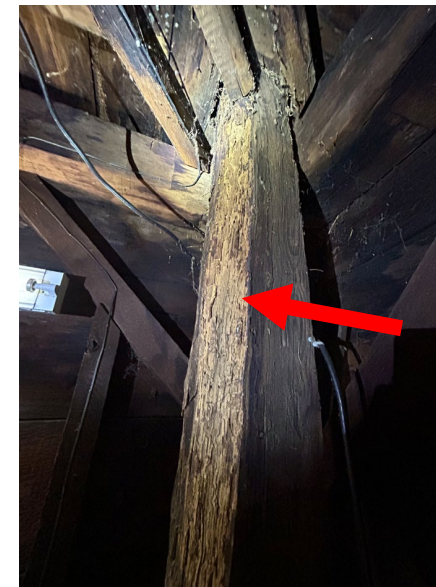
Rotted post

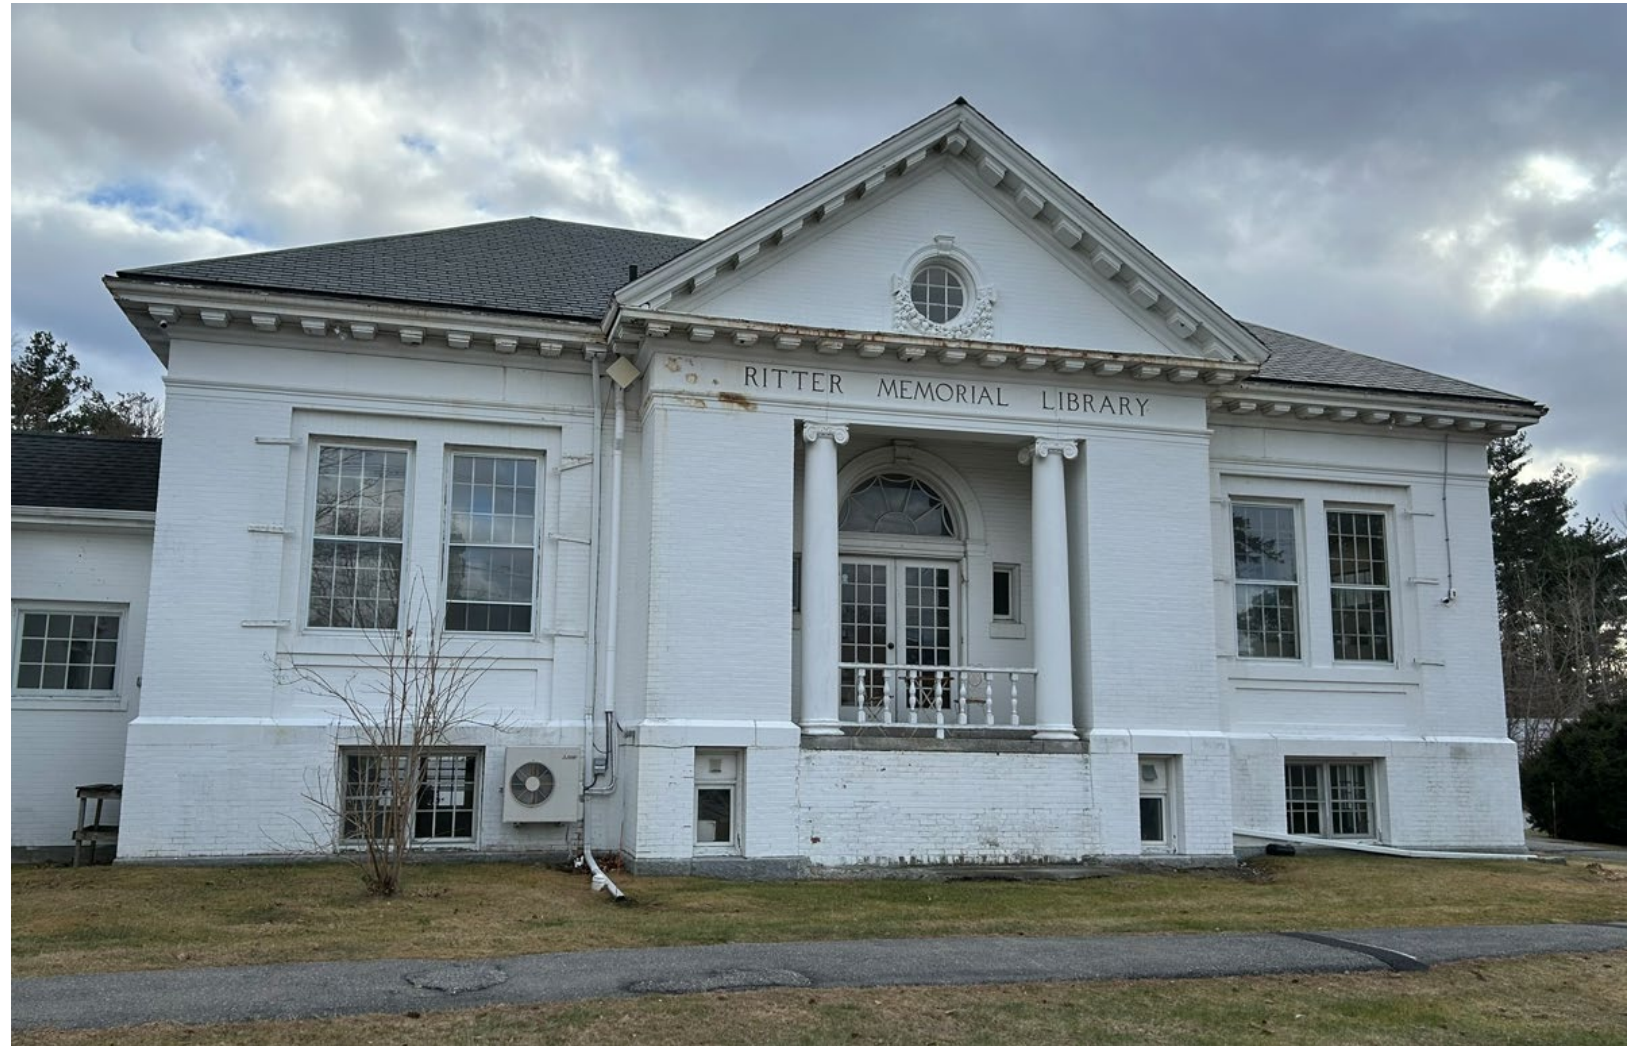
## Renovations

- Wall removal
- Attic protection

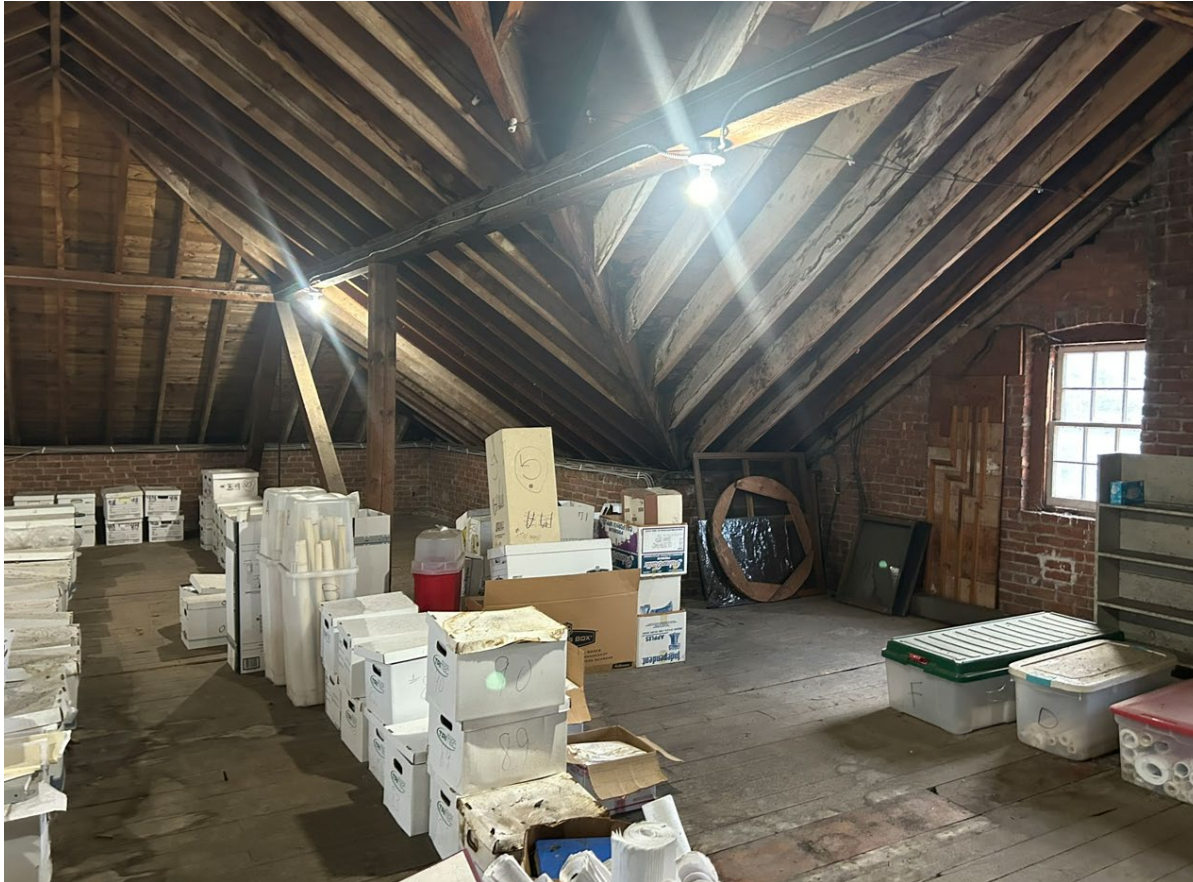
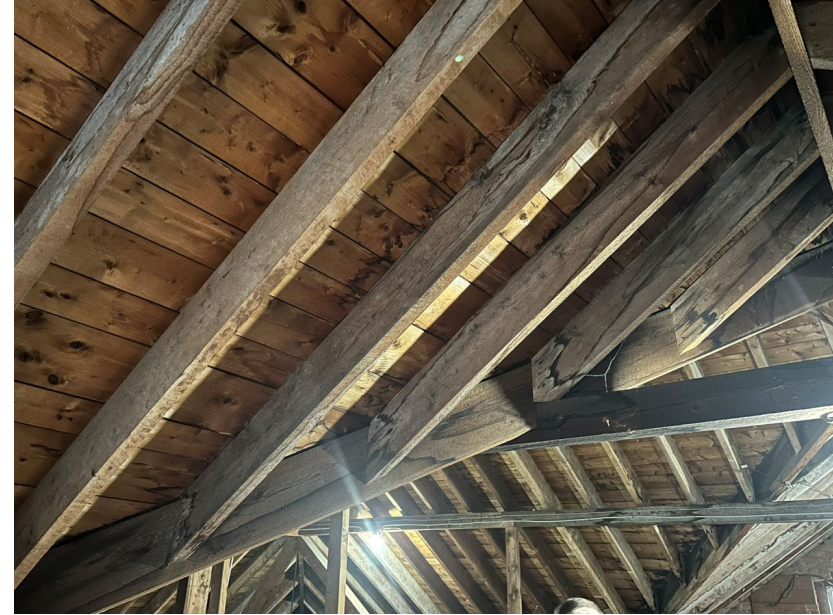
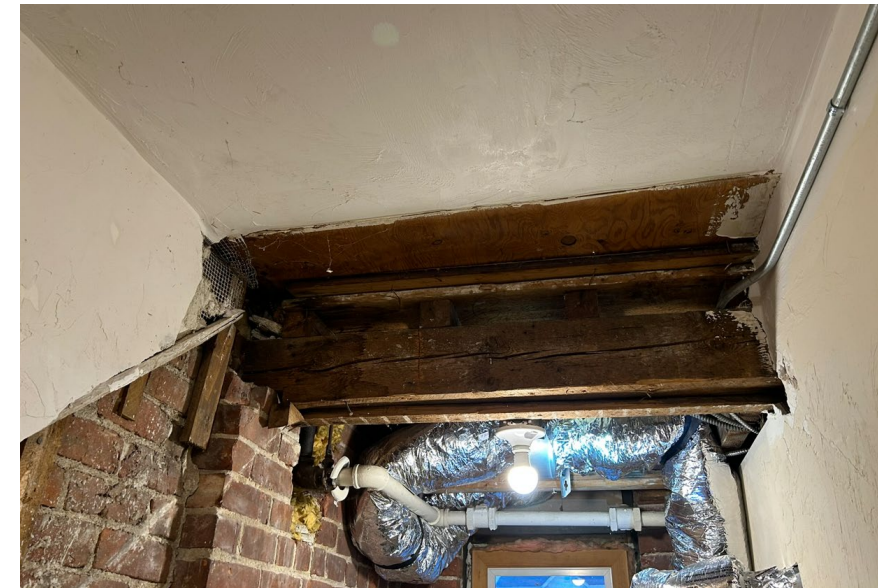
## Renovations.

- Some end of member deterioration  
Coat ends with Bora-Care

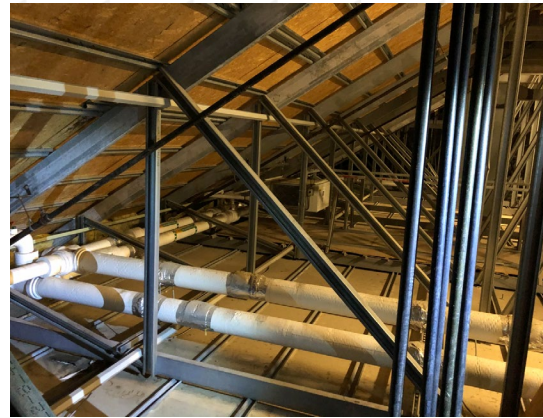
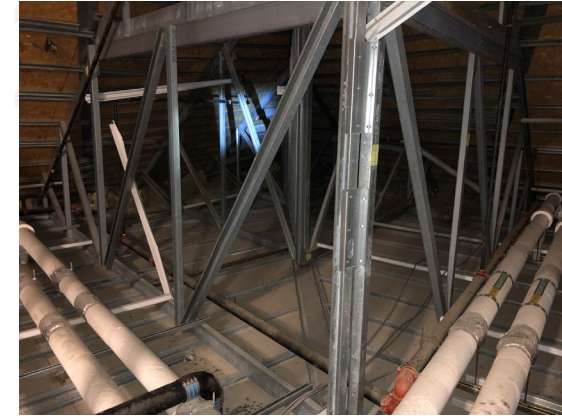
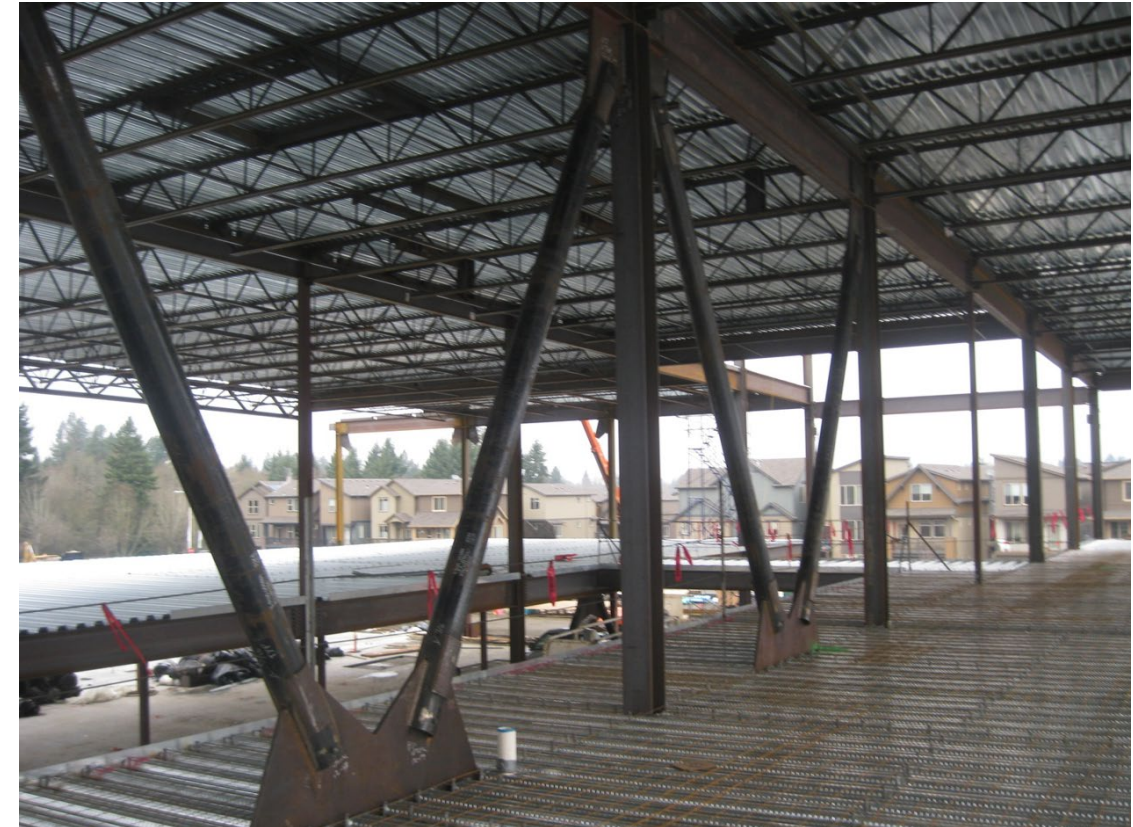
## Steel Composite Frame Construction

- Concrete foundation
- Steel building frame
- Steel braced frame for stability
- Concrete slab on composite steel deck
- Concrete elevator pit with masonry shaft wall
- Steel joist roof with steel girders and untopped steel deck
