Illicit Discharge Detection and Elimination (IDDE) Plan

Town of Lunenburg, Massachusetts

**Prepared June 30, 2019
Revised June 30, 2021**

Comprehensive Environmental Inc.
41 Main Street
Bolton, MA 01740

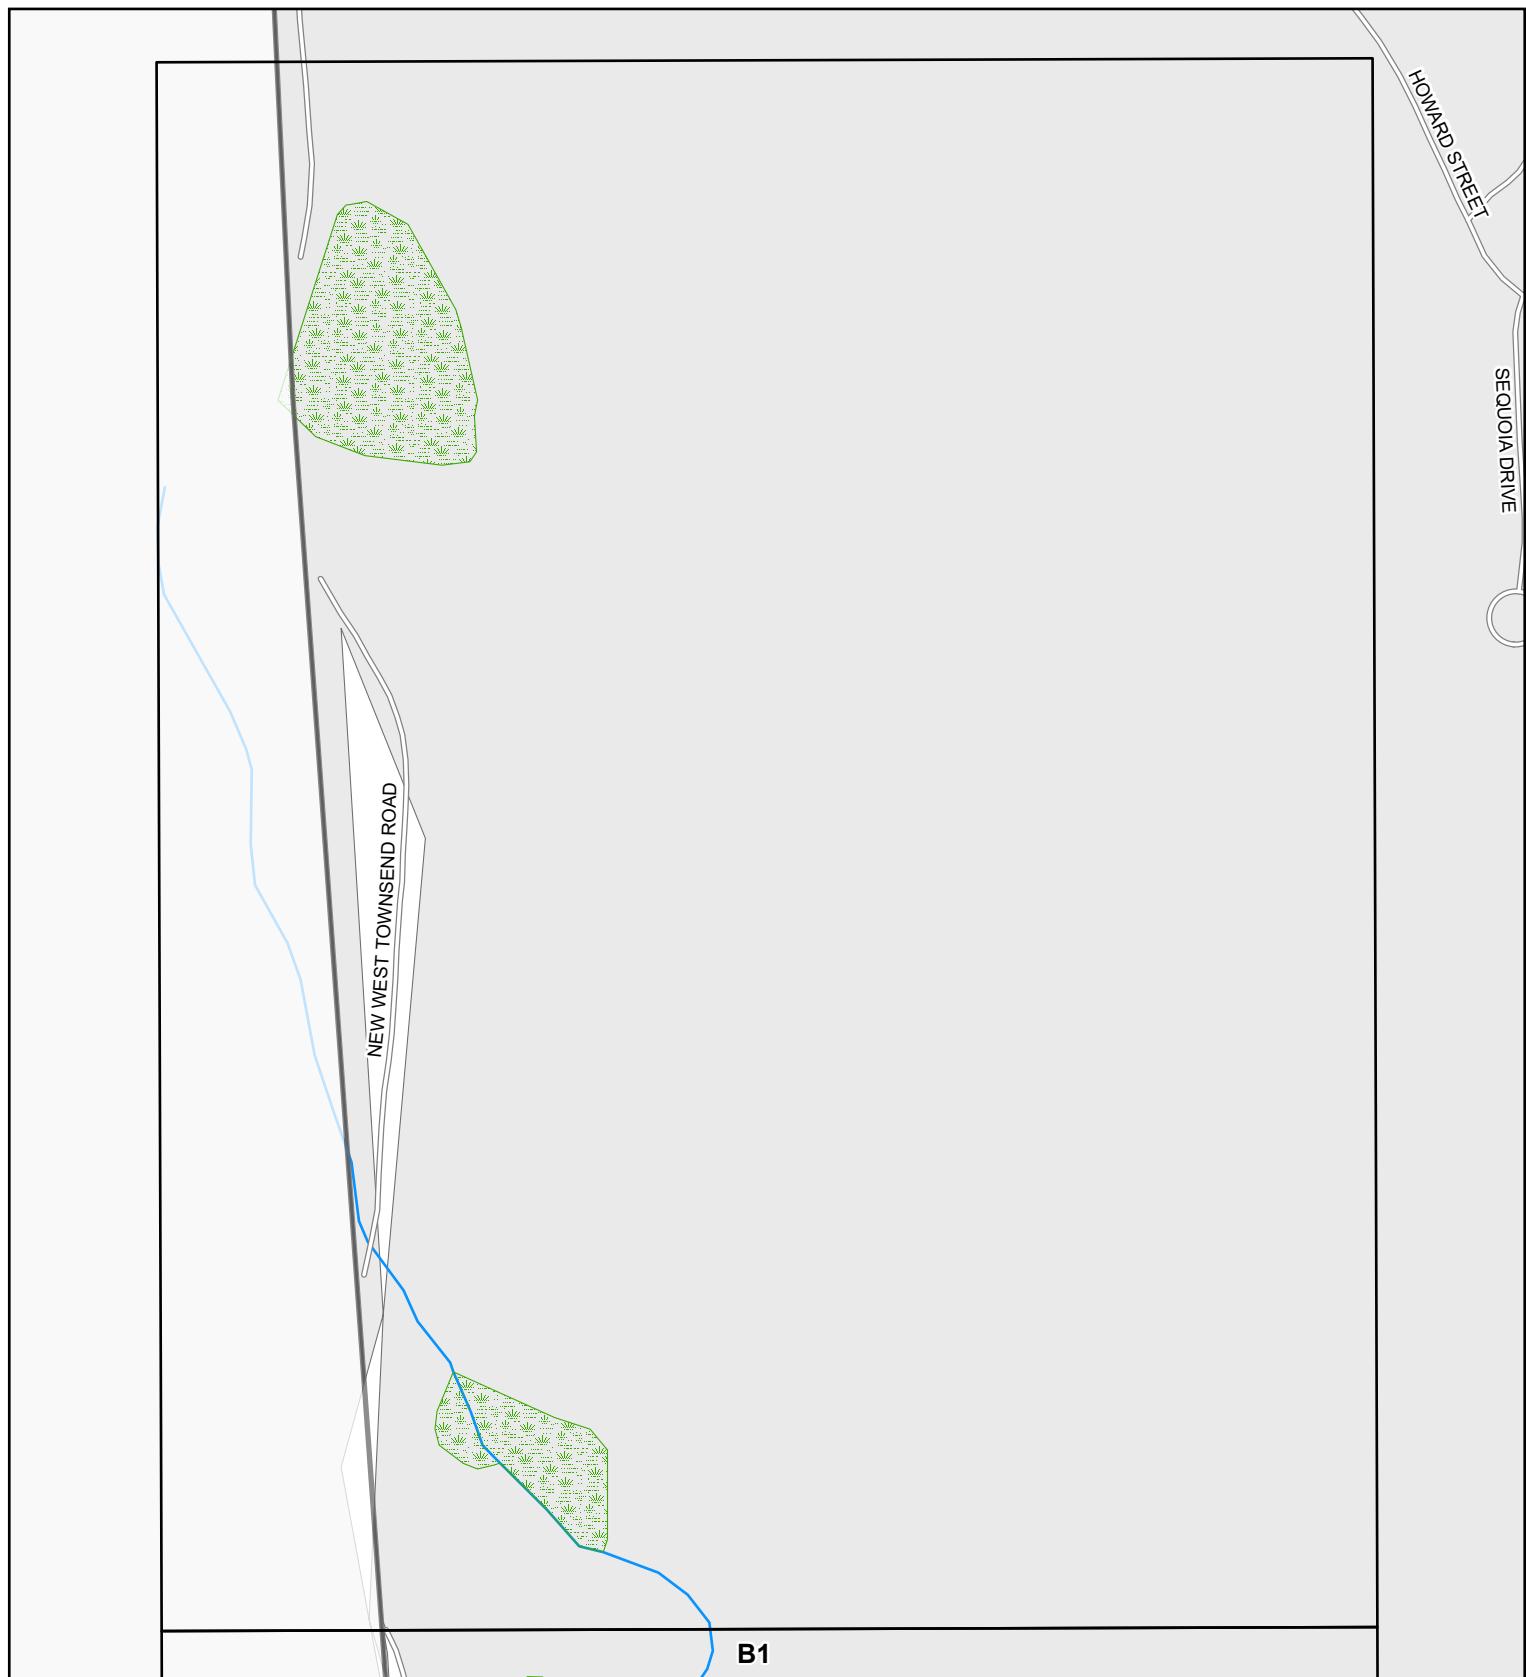
Stormwater Map

Legend

Prioritized Outfalls
