Thomas C. Passios Elementary School

1025 Massachusetts Avenue
Lunenburg, MA 01462

Property Condition Assessment

February 6, 2018

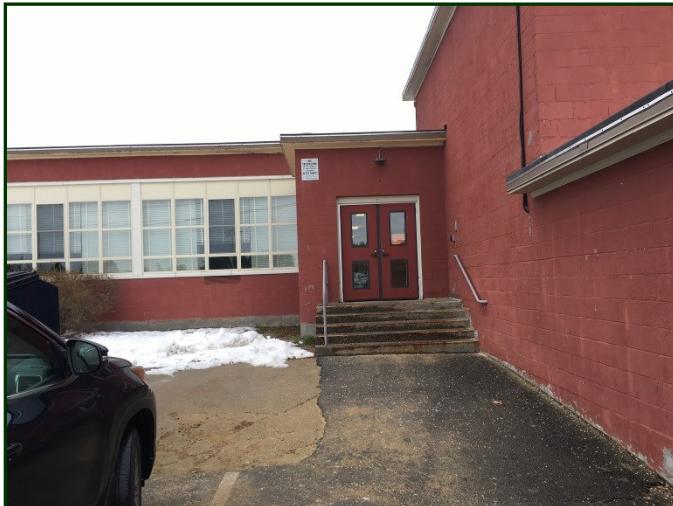
Photo #1: East side entry door near Cafeteria.

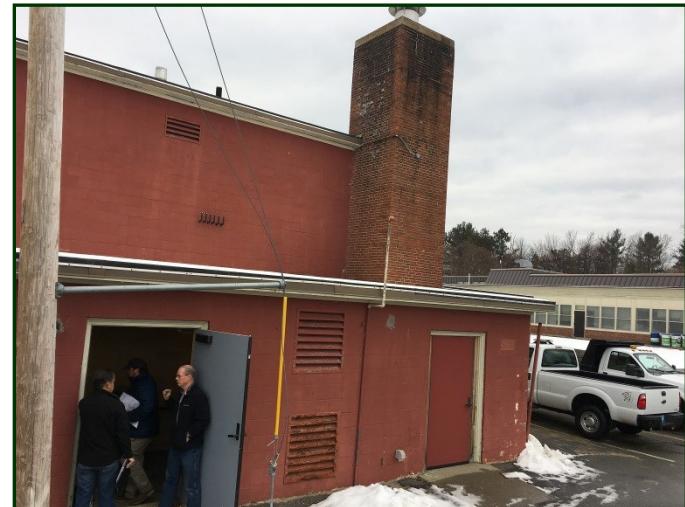
Photo #4: Mechanical area entry door on the east side.

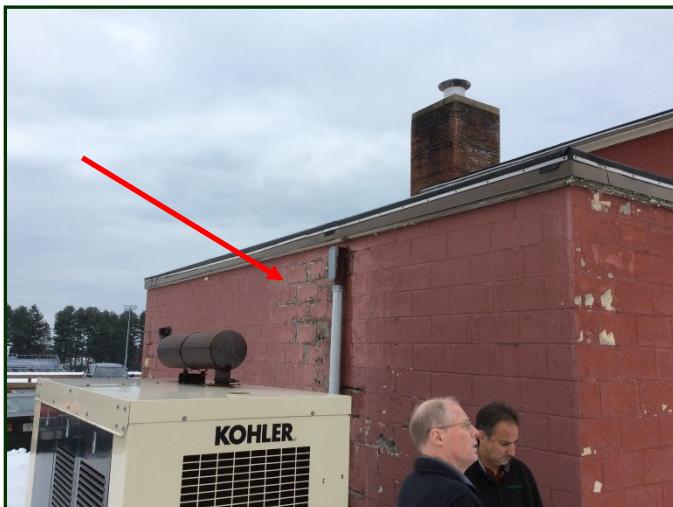
Photo #5: North facing wall of the maintenance area at the generator. Note the peeling paint next to the conduit.

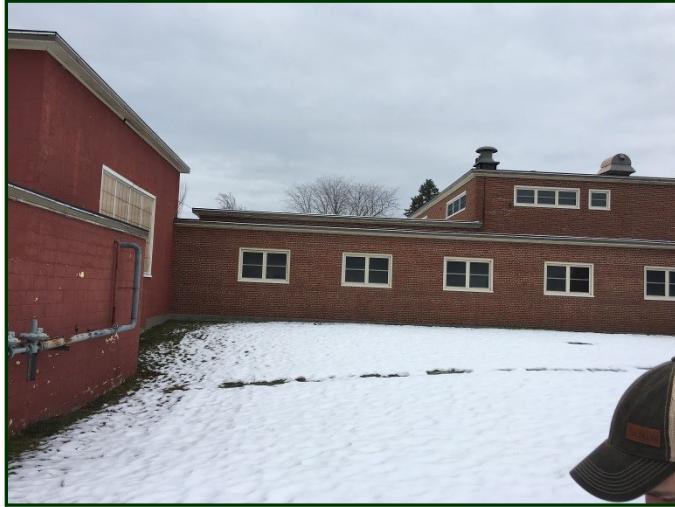
Photo #11: East Courtyard looking south.

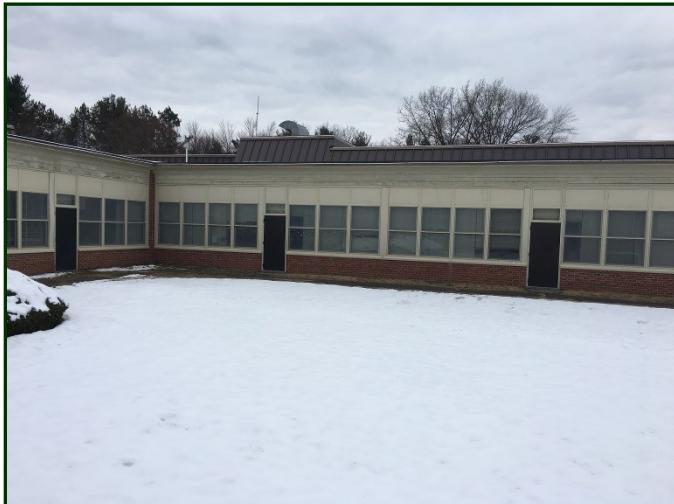
Photo #13: Overall view of the metal window system at the northwest corner of the east courtyard.

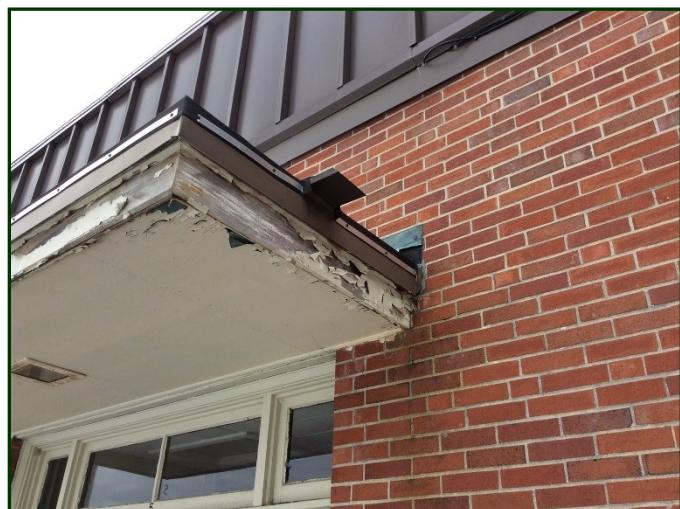
Photo #18: Detail of the entry canopy. Note the exposed wood and peeling paint.

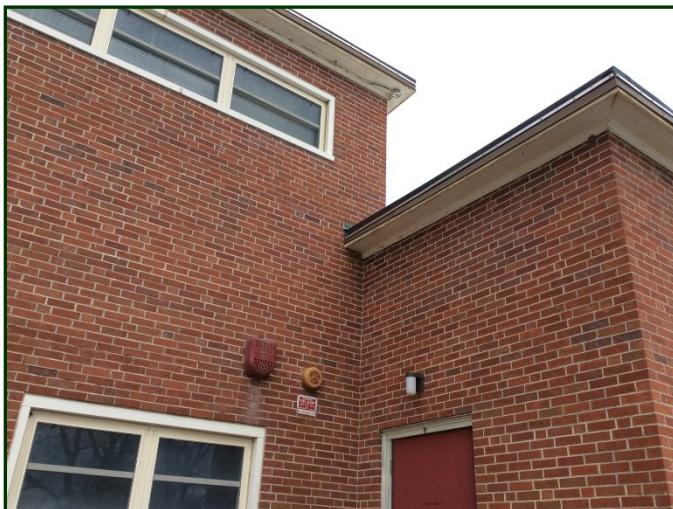
Photo #23: The roof to wall intersection at the east side of the south façade where the Gym meets the Cafeteria.

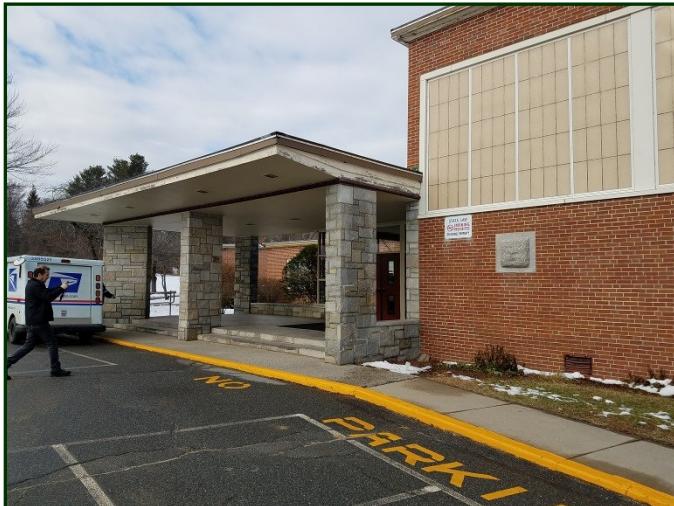
Photo #25: The main entry on the south façade.

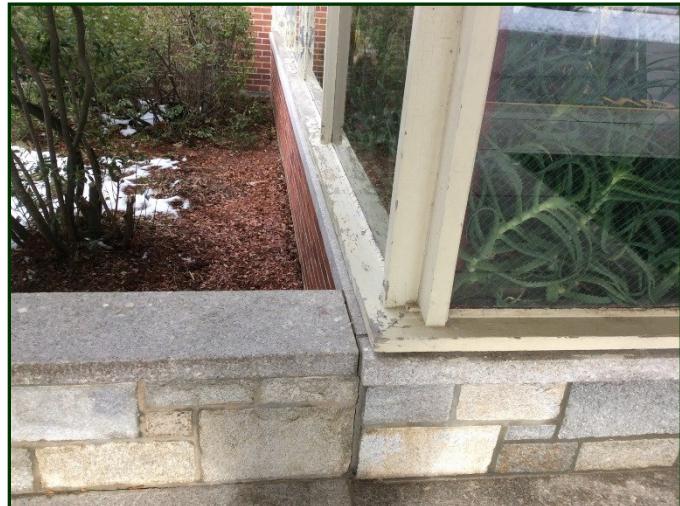
Photo #26: Detail of the wood window sill at the main entry.

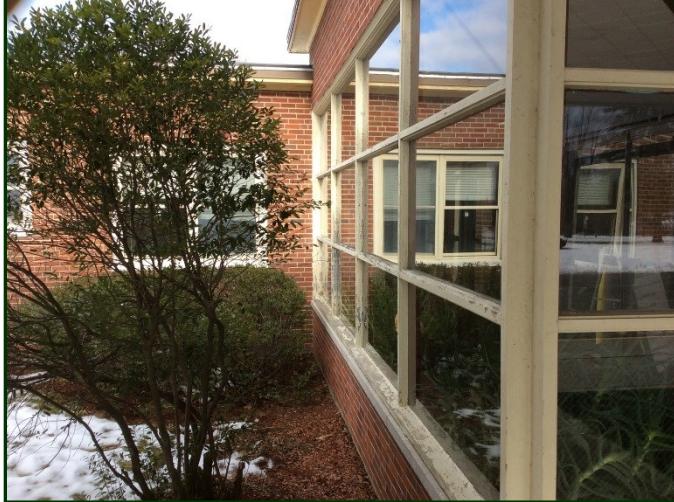
Photo #27: Wood framed glass vestibule. Note the peeling paint.

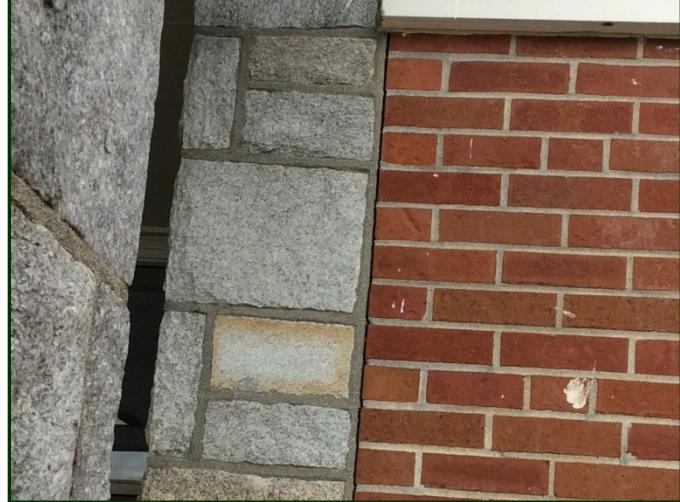
Photo #28: Detail of the separated mortar joint at the stone/brick transition at the main entry.

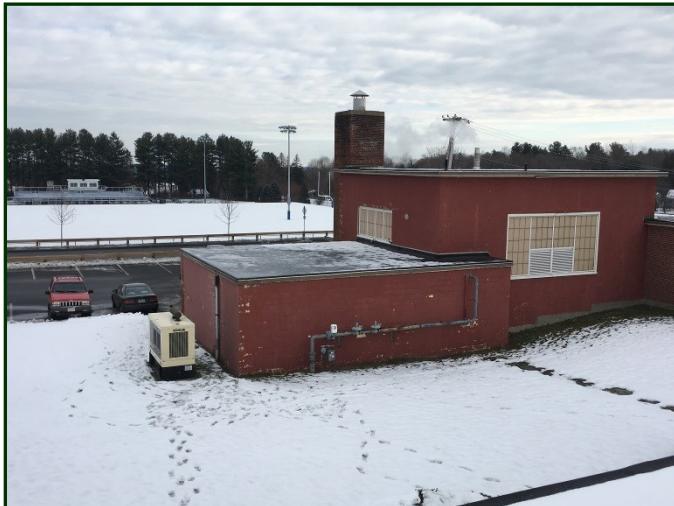
Photo #37: Roof at the garage.

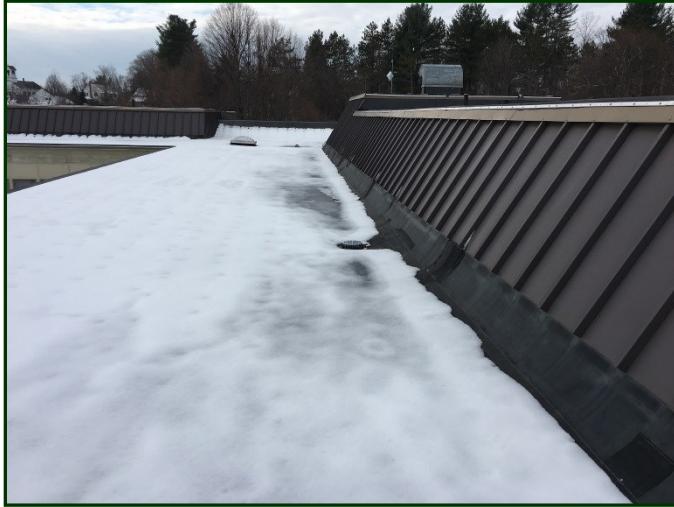
Photo #39: The north wing roof looking west.

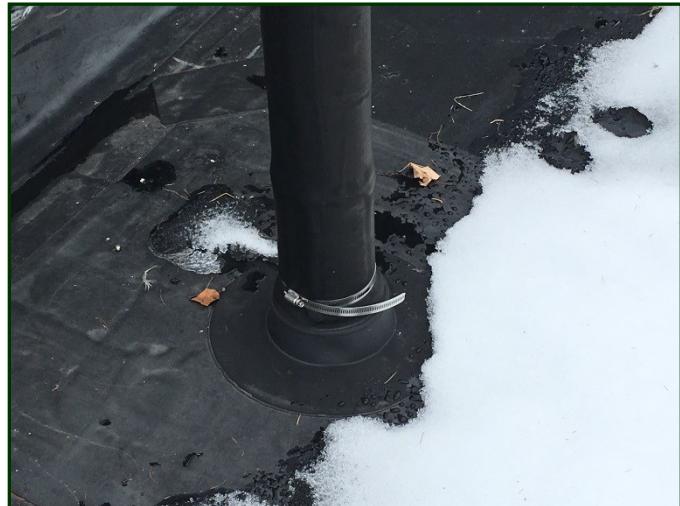
Photo #44: Detail of the pipe boot shown in photo 43.

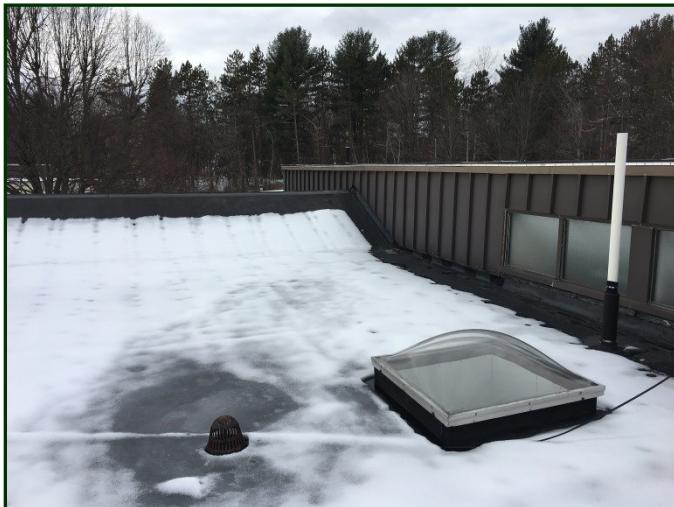
Photo #45: The EPDM roof at the north wing of the building.

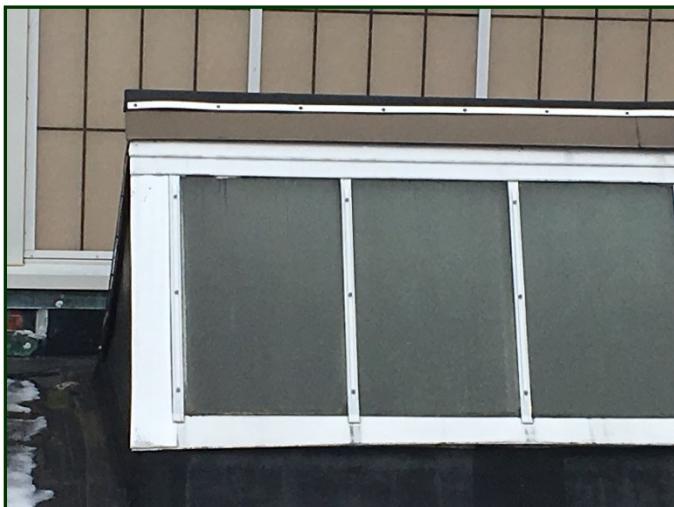
Photo #47: Detail of the main corridor clerestory windows that were clad in metal panel and topped with EPDM membrane.

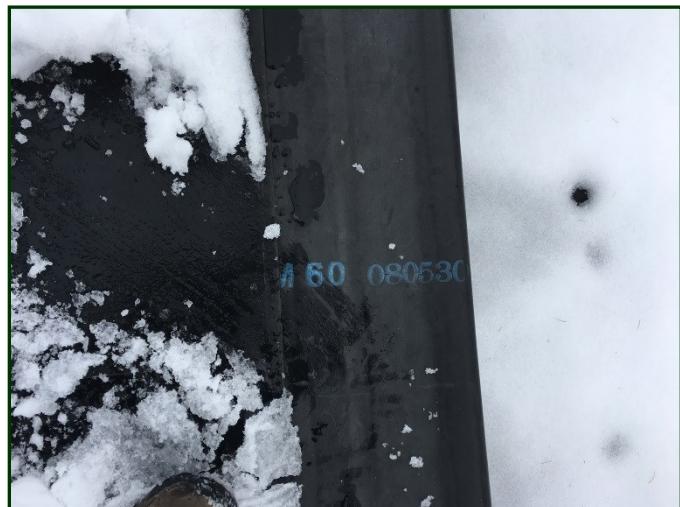
Photo #48: Detail of the EPDM membrane showed the partial manufacturer's mark on the membrane that indicated the 60 mil thickness.

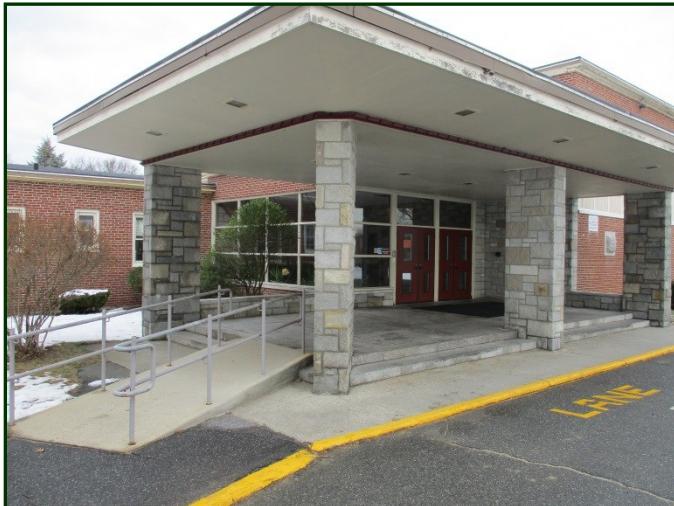
Photo #49: Main front (south elevation) building entrance.
Note accessible ramp

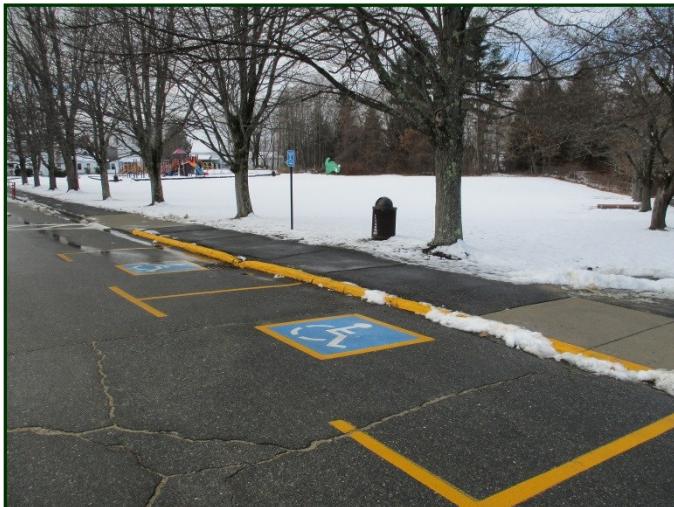
Photo #98: Asphalt-paved driveway with random cracking - south side of building (looking west)

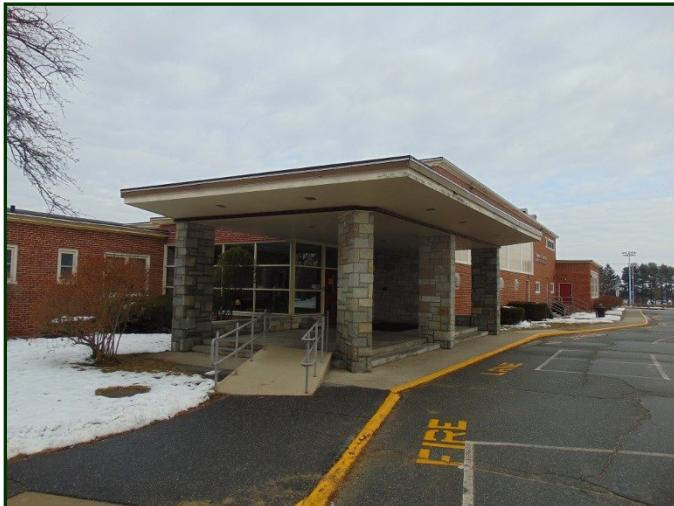
Photo #109: View of the front (south) elevation of the Passios School.

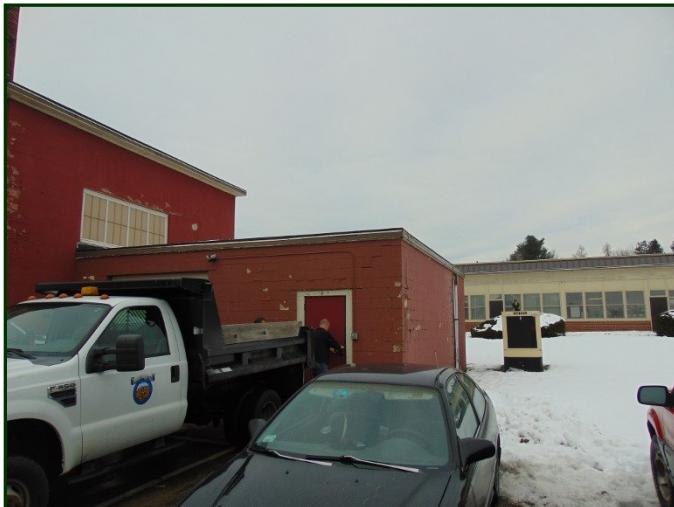
Photo #111: View of the maintenance shop on the east side of the building.

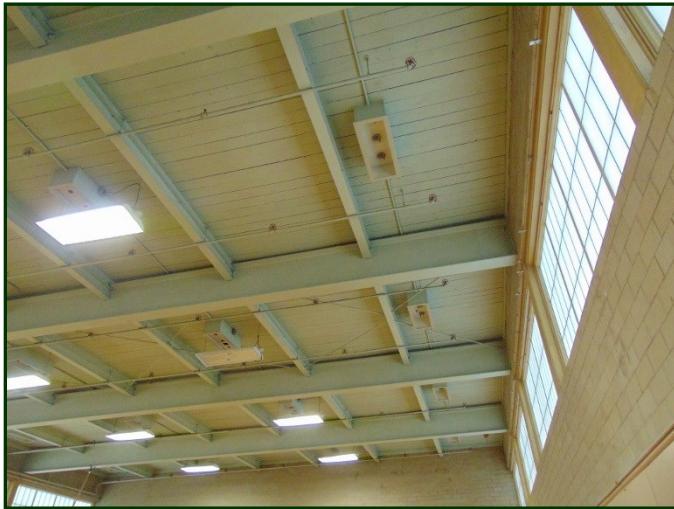
Photo #115: View of the typical roof structure. Photo taken in the gymnasium.

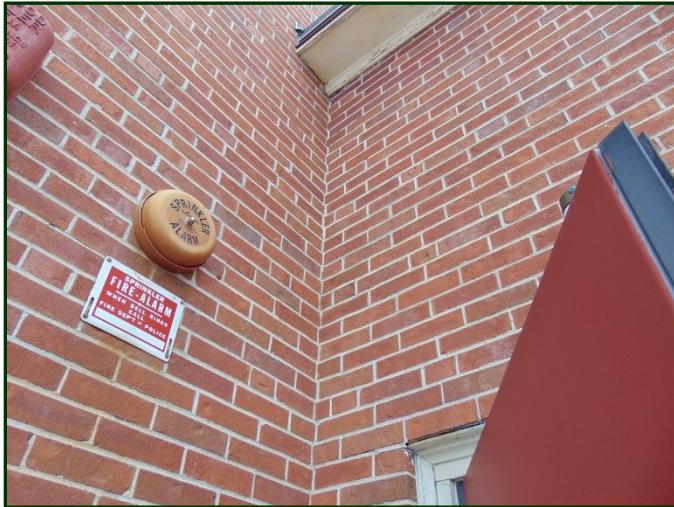
Photo #117: View of the brick exterior opposite the interior step crack. Note no visible cracks in the masonry.

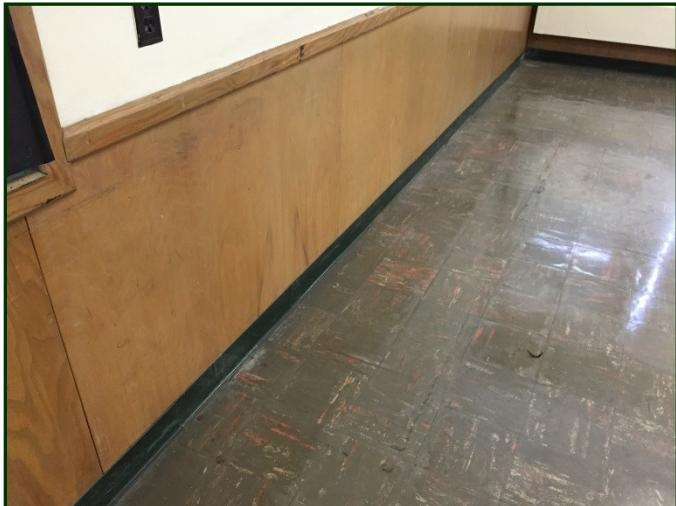
Photo #125: Photograph depicts general view of asbestos-containing 9" Floor Tile and Covebase within Classroom

At the time of the assessment, the suspect ACMs identified were observed to be in fair condition. Please refer to Attachment A which includes photographic documentation of the suspect ACMs identified during the assessment.

Prior to any renovation or demolition activities, sampling of suspect ACMs that may be disturbed would need to be conducted in applicable areas to determine asbestos content. A comprehensive ACM survey is required to be conducted to comply with the Environmental Protection Agency (EPA) National Emission Standard for Hazardous Air Pollutants (NESHAPs) 40 CFR Part 61. Until these materials have been sampled and determined to be non-asbestos containing, these materials should be managed in place as presumed asbestos-containing materials (PACMs).

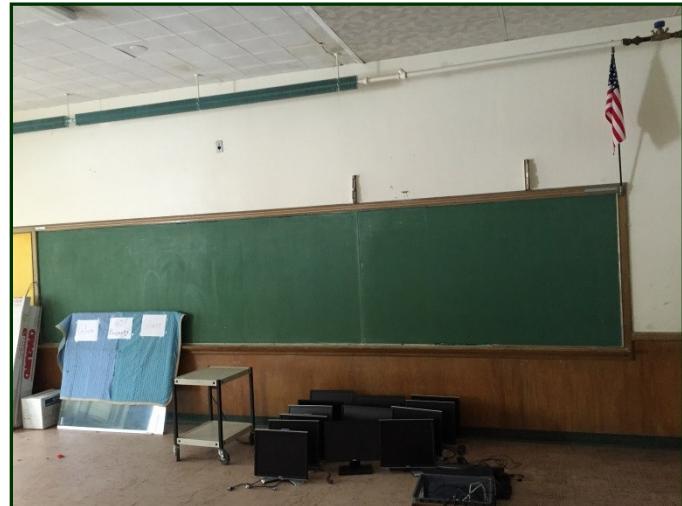
Photo #126: Photograph depicts general view of suspect asbestos-containing Chalkboards within Classroom

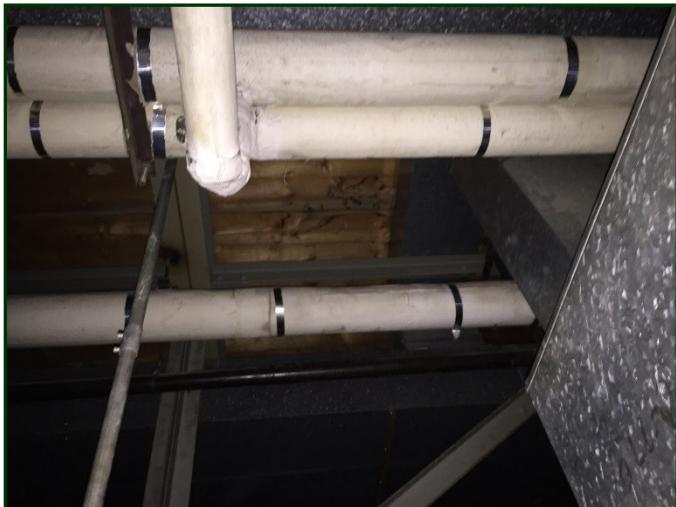
Photo #127: Photograph depicts general view of asbestos-containing pipe insulation above ceiling area in hallway

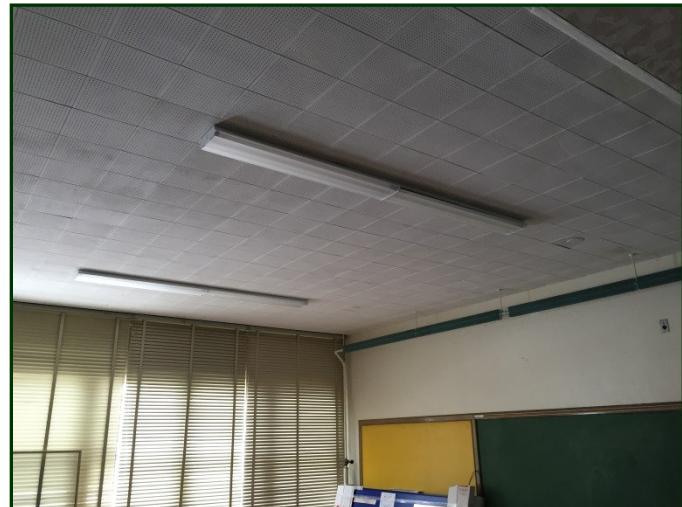
Photo #128: Photograph depicts general view of fluorescent lights within Classroom

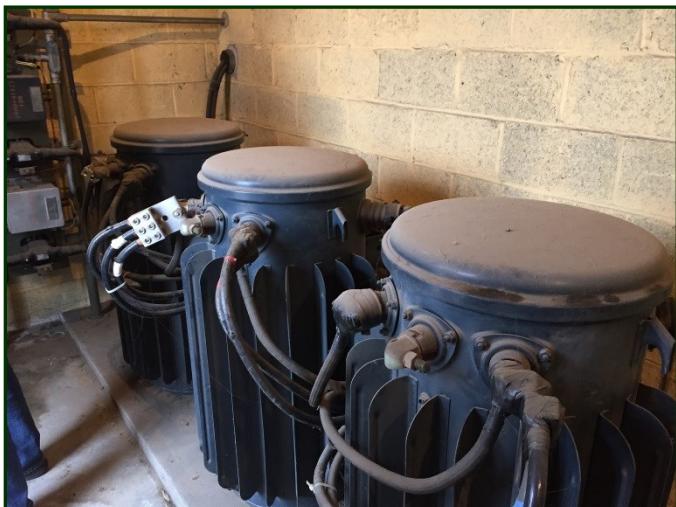
Photo #129: Photograph depicts general view of transformers within the Site Building

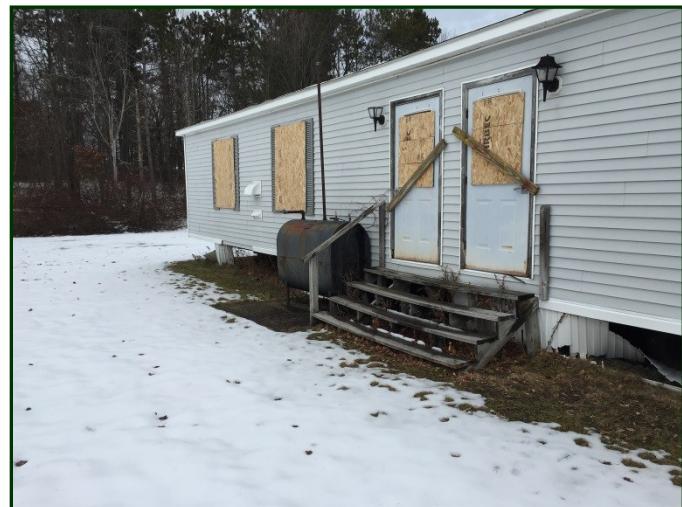
Photo #130: Photograph depicts general view of 275-Gallon Oil AST and Portable Classroom

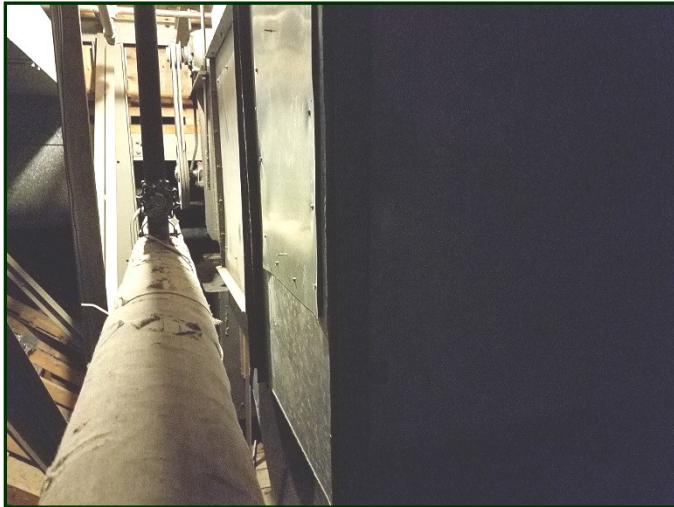
Photo #133: Typical main ventilation AHU above ceiling of corridor. Note no adequate space for routine maintenance

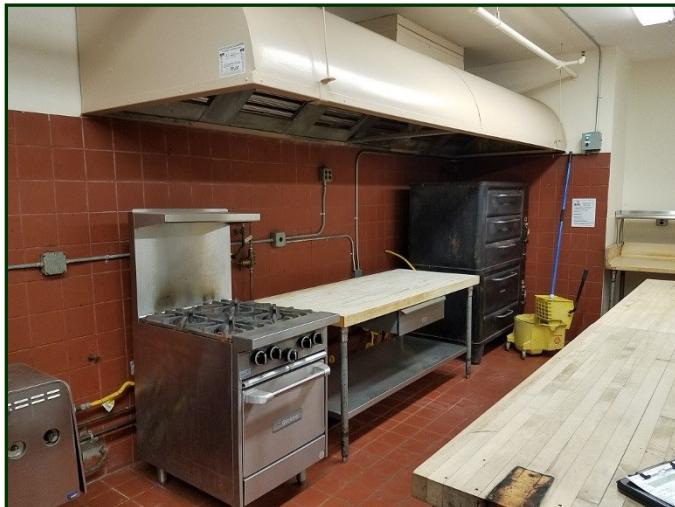
Photo #145: Kitchen hood in cafeteria. Not in use

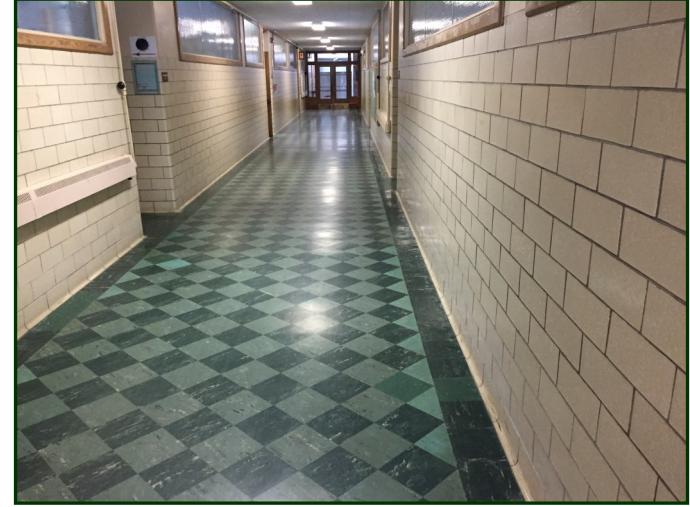
Photo #6: Photograph depicts general view of asbestos-containing 9" Floor Tile within Hallway

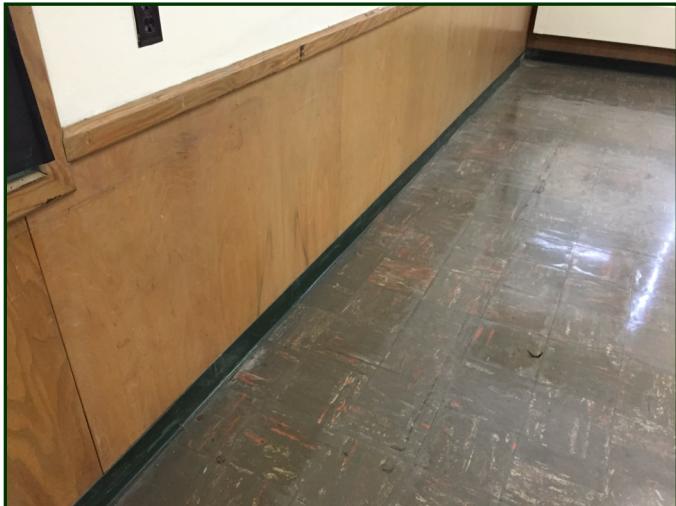
Photo #7: Photograph depicts general view of asbestos-containing 9" Floor Tile and Covebase within Classroom

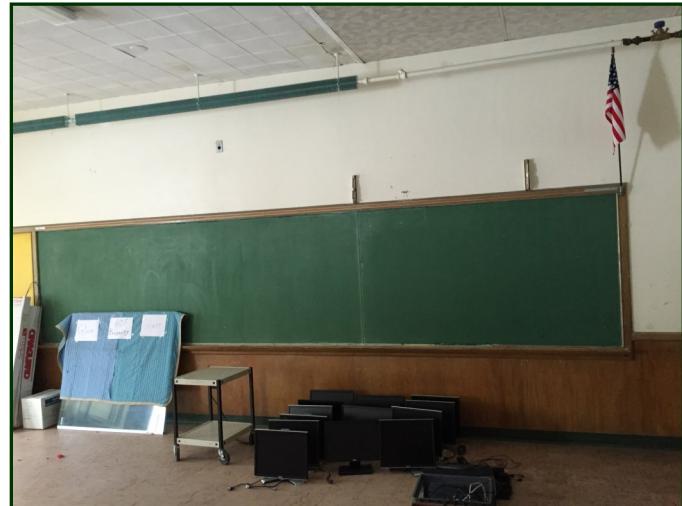
Photo #8: Photograph depicts general view of suspect asbestos-containing Chalkboards within Classroom

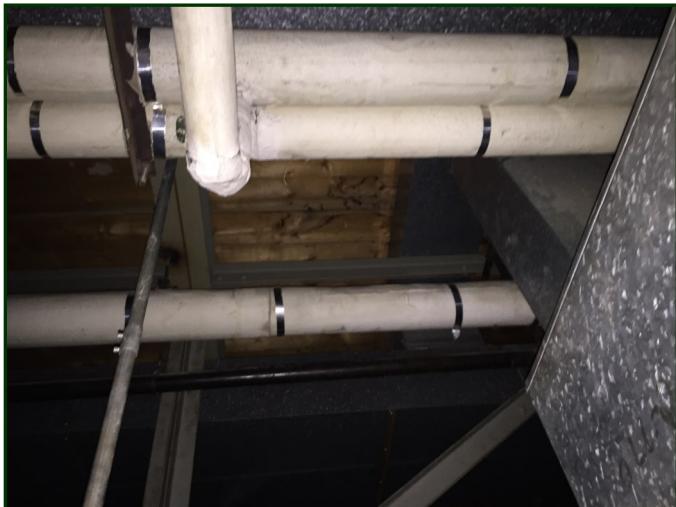
Photo #9: Photograph depicts general view of asbestos-containing pipe insulation above ceiling area in hallway

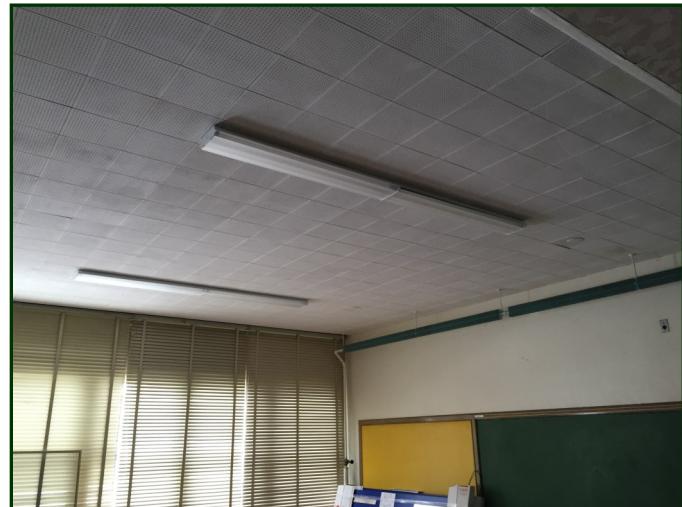
Photo #10: Photograph depicts general view of fluorescent lights within Classroom

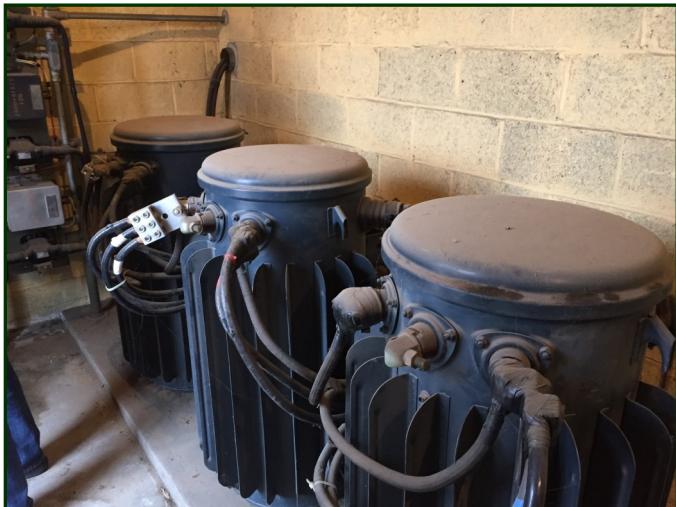
Photo #11: Photograph depicts general view of transformers within the Site Building

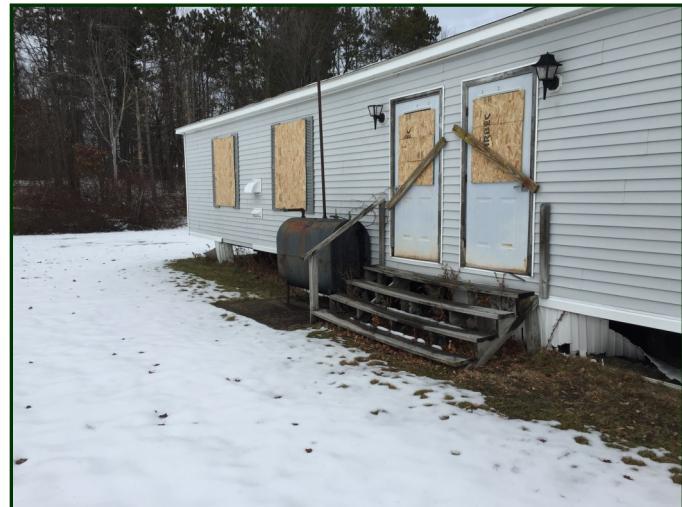
Photo #12: Photograph depicts general view of 275-Gallon Oil AST and Portable Classroom
