## Final Report for Design Services for the Reuse of the TC Passios Building, Lunenburg, MA

**Prepared For:**  
The Town of Lunenburg, MA

**Prepared by:**  
DiGiorgio Associates, Inc.  
529 Main Street, Suite 3303  
Boston, MA 02129

**March 19, 2021**

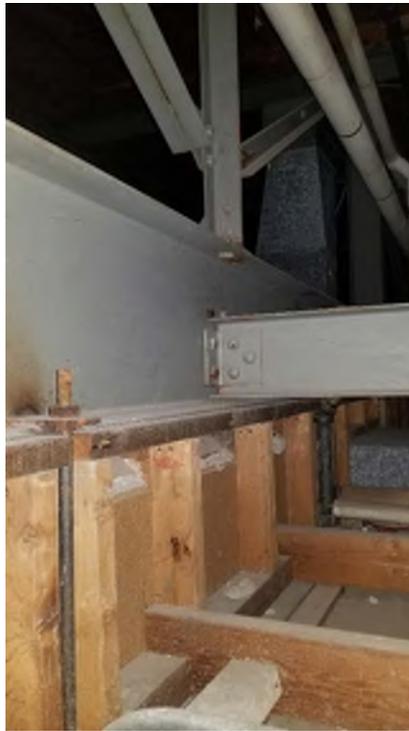
**Photo 2** Wood framed ceiling hung from structural steel above corridor.

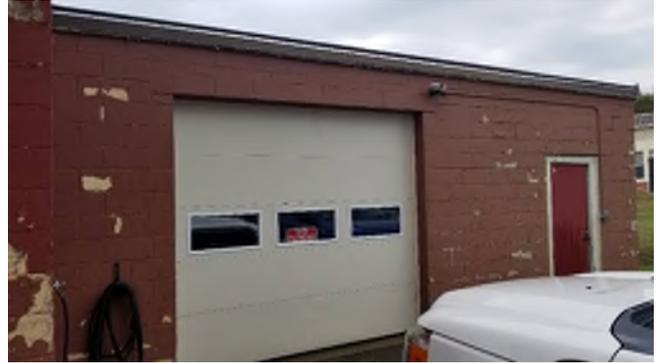
**Photo 12** Maintenance garage.

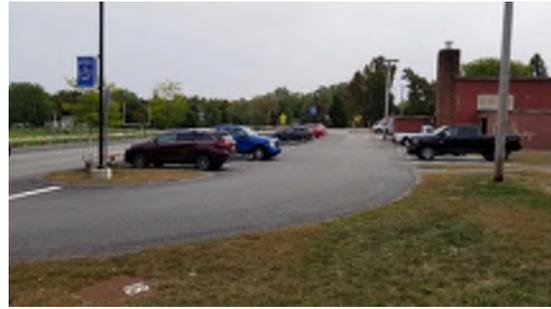
Figure 16 Main Parking Lot

This parking lot is located on the west side of the school building. As shown in Figure 16, it is paved and striped, with a capacity of roughly 26 parking spaces. This parking lot is mainly used by people for recreation. It was observed in the field that people parked here and took a considerable walk to the High School. It was also observed that parents or students parked here for after school and sport activities.

The occupancy of this parking lot is generally around 50% from 9am to 3pm. The number of parked vehicles are not consistent, which might indicate this parking lot is used for short term parking. As per Table 3, the highest occupancy is at the time from 10am to 12pm. After school hour (3pm), the number of parked vehicles dropped significantly.

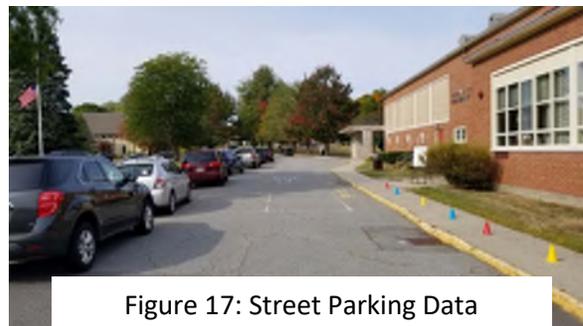
Figure 17: Street Parking Data

As shown in Figure 17, There are approximately 17 parking spaces for street parking around building entrance, among which there are 7 striped parking spaces. This parking lot is mainly used for drop-of and pick-up students. Different from the other two parking lots, this one has school buses and large vehicles. As per Table 4, the time from 10am to 1pm had generally high parking occupancy which are over 70% of the

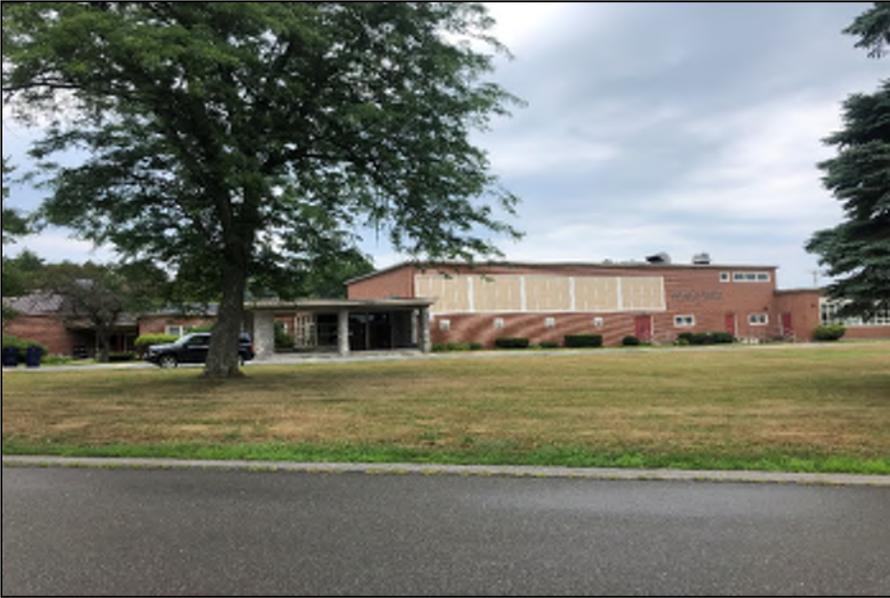
Photo 1: Front view of the Thomas C. Passios Elementary School (and main entry on the south façade).

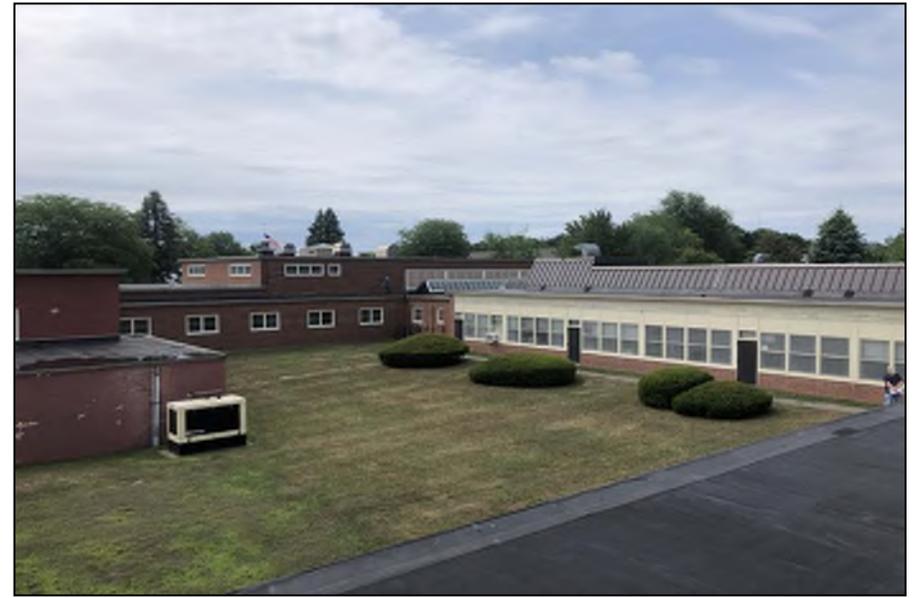
Photo 2: View of the east side of the building from the roof, facing southwest.

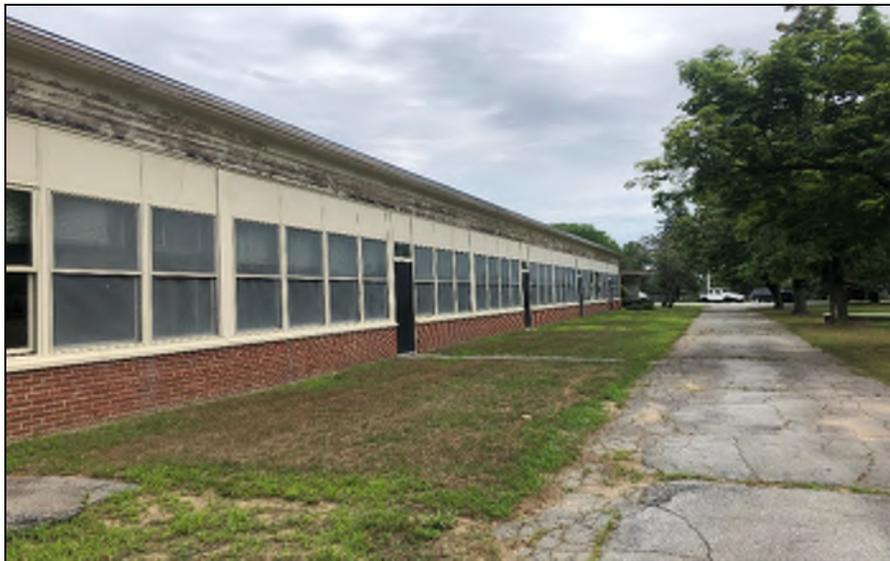
Photo 3: View of the southwest portion of the building.

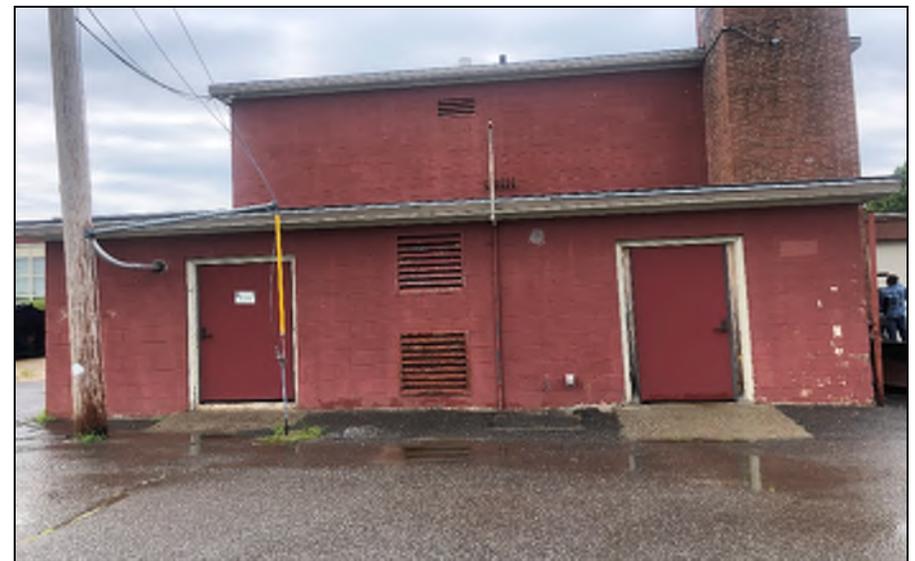
Photo 4: View of the Electrical/Transformer Room entry door (left) and the Old Generator Room entry door (right) on the east side of the building.

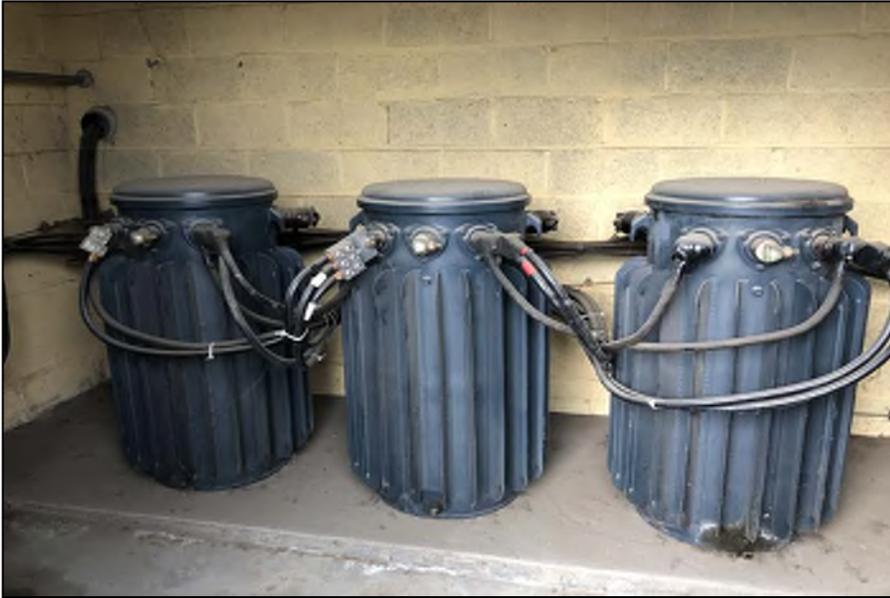
Photo 5: Blue transformers in the Electrical/Transformer Room.

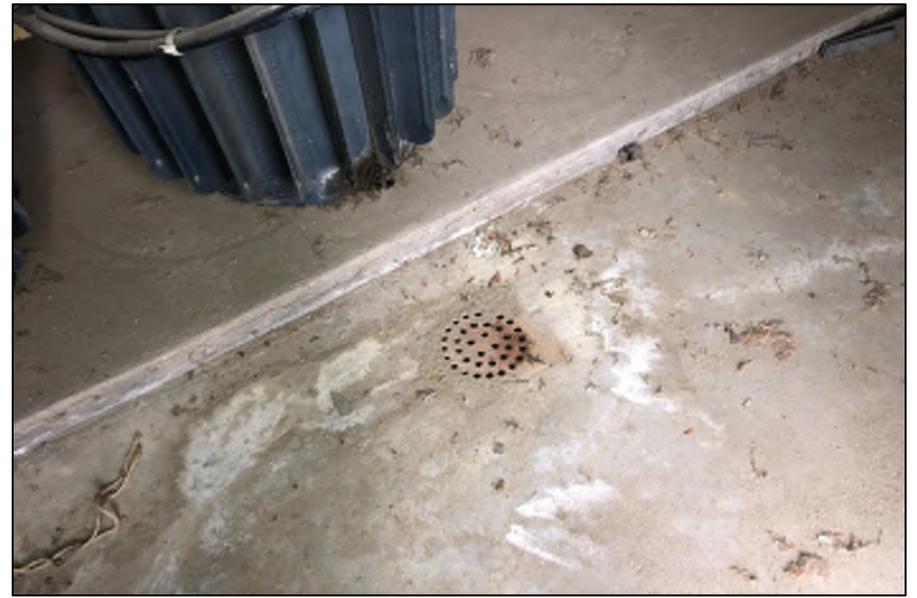
Photo 6: Floor drain adjacent to the blue transformers in the Electrical Room.

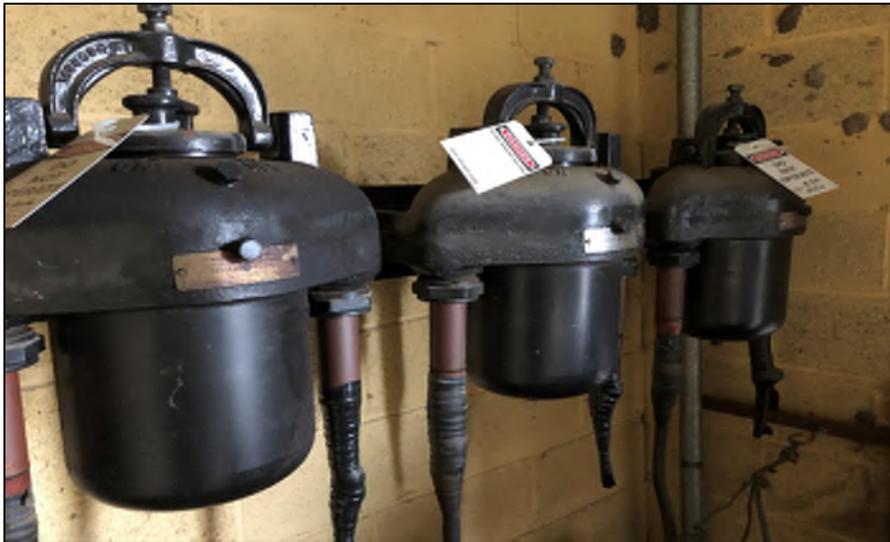
Photo 7: Old oil-filled switchgear equipment associated with the High School.

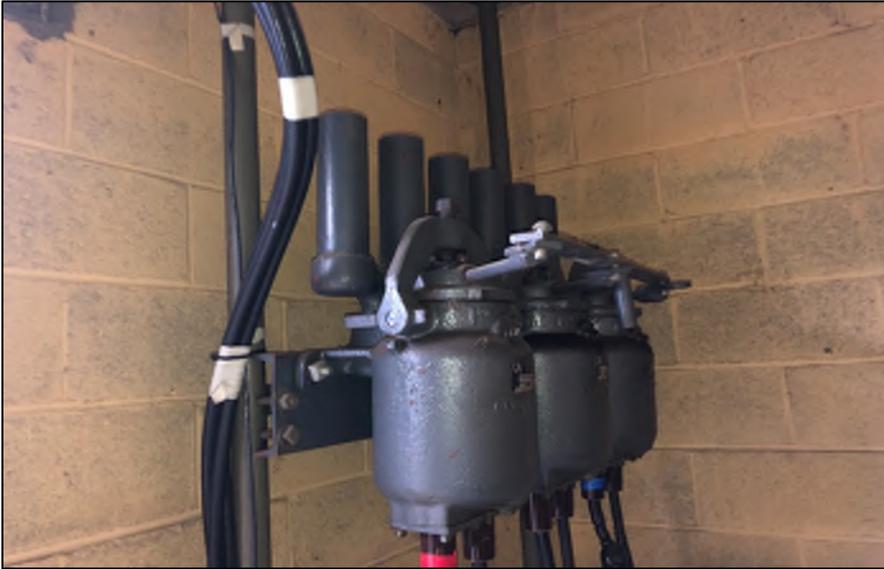
Photo 9: Old oil-filled switchgear equipment associated with Passios School in the Electrical Room.

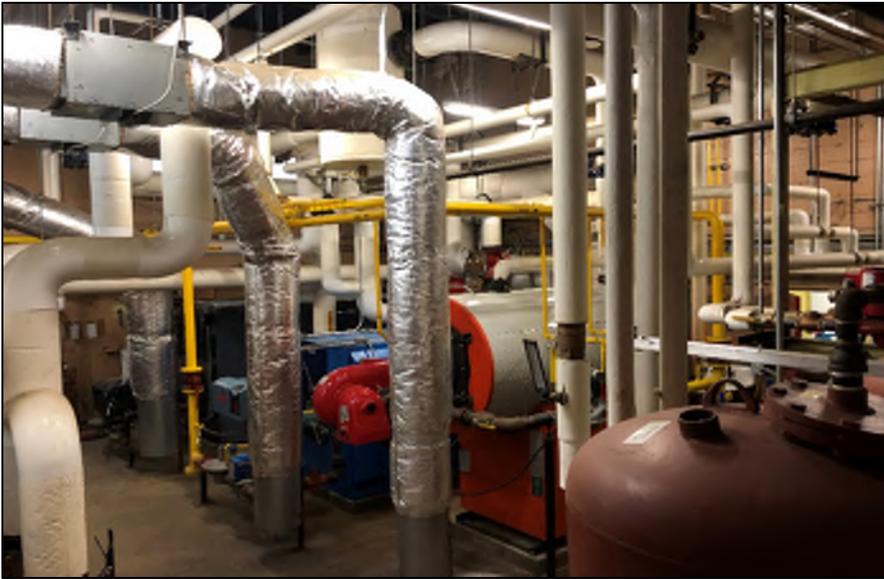
Photo 11: General view of the Boiler Room.

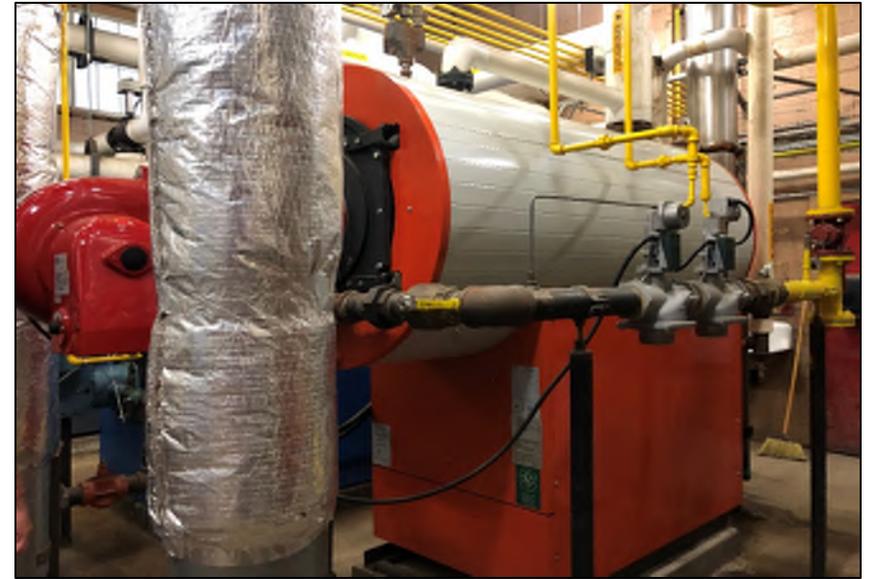
Photo 12: Boiler 1 (Viessmann) – Primary boiler for the Passios School.

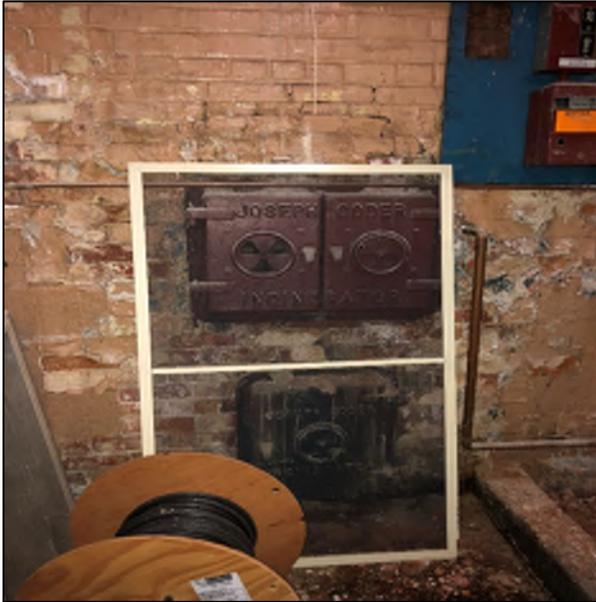
Photo 13: Close-up view of the old incinerators near the old oil pump switches in the Boiler Room.

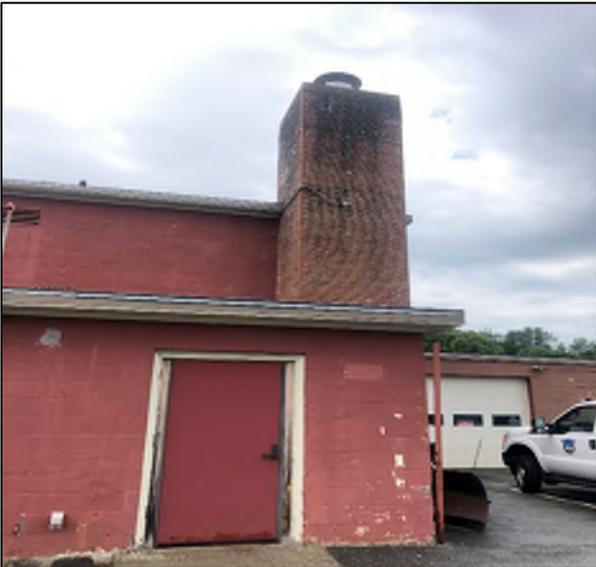
Photo 15: Close-up view of the Boiler Room chimney on the east side.

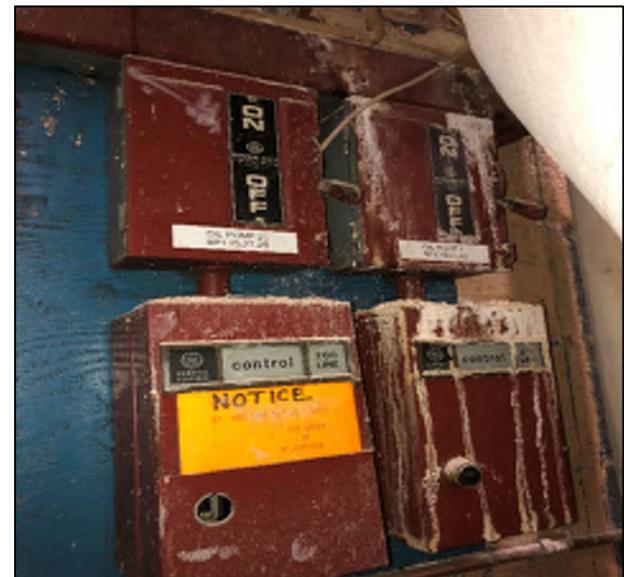
Photo 16: Old oil pump switches near the incinerators in the Boiler Room.

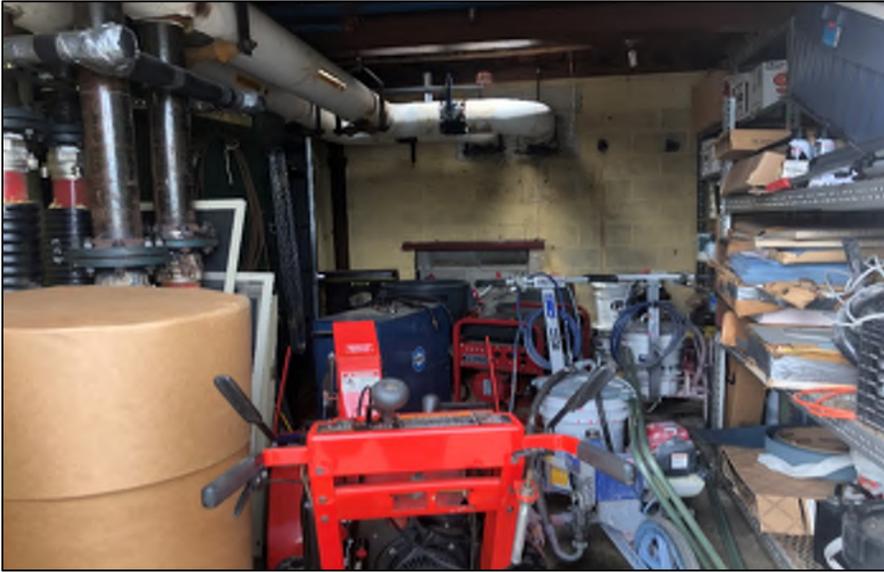
Photo 17: Old Generator Room Storage (adjacent to the Boiler Room & Main Electrical Room) containing typical hazardous waste.

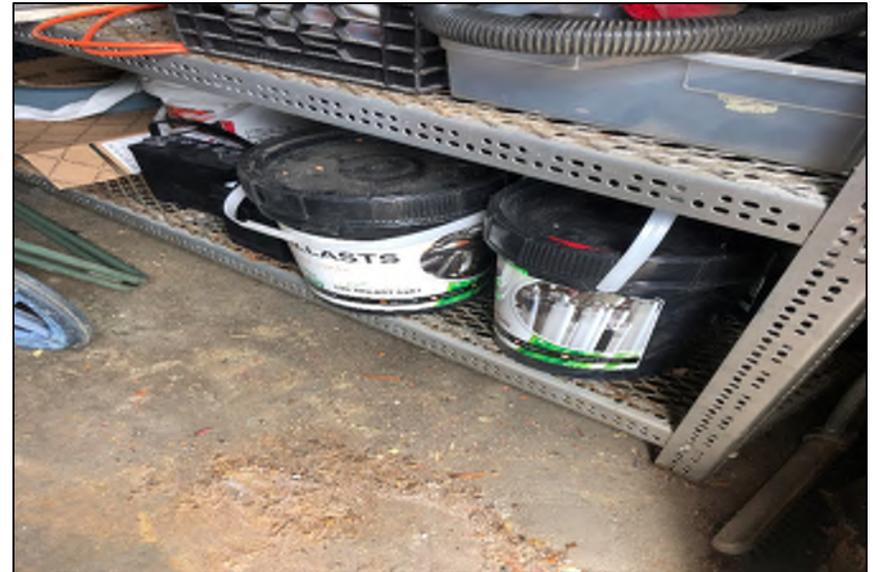
Photo 18: Old ballasts stored in the Old Generator Room.

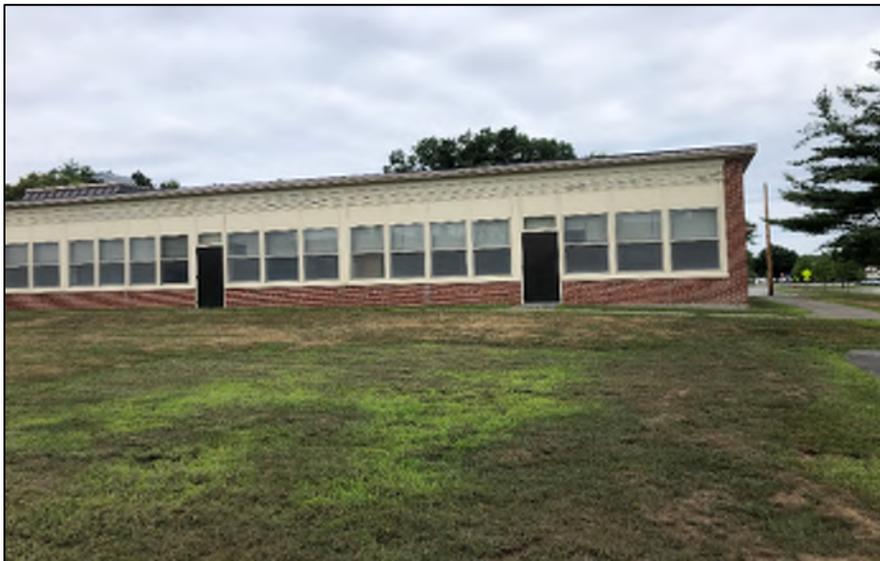
Photo 19: Approximate location of the former 10,000-gal and 20,000-gal USTs on the east side of the Passios School.

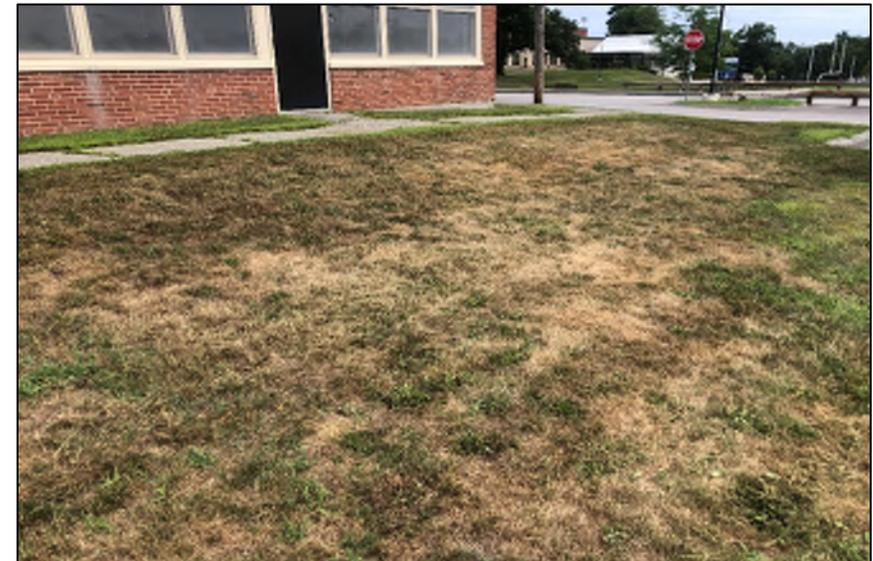
Photo 20: Close-up view of the approximate location of the former 10,000-gal and 20,000-gal USTs on the east side of the Passios School.

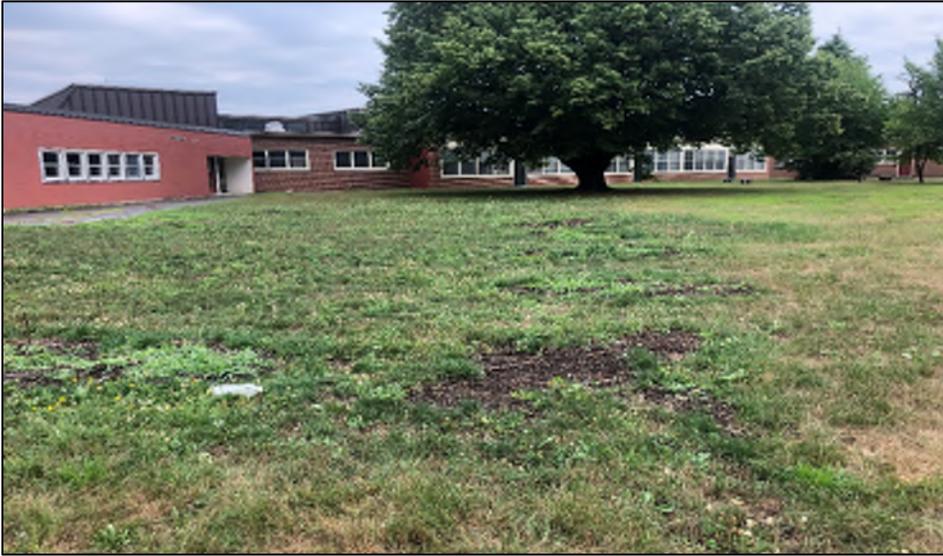
Photo 21: Approximate location of the former modular classroom associated with a 275-gallon AST adjacent-west of the Passios School.

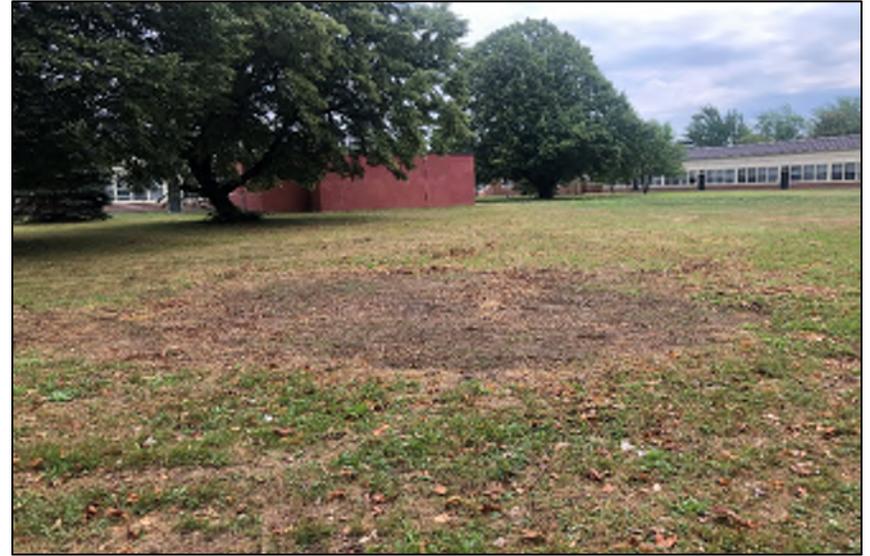
Photo 22: Stressed vegetation adjacent to the existing soil stockpile north of the Passios School.

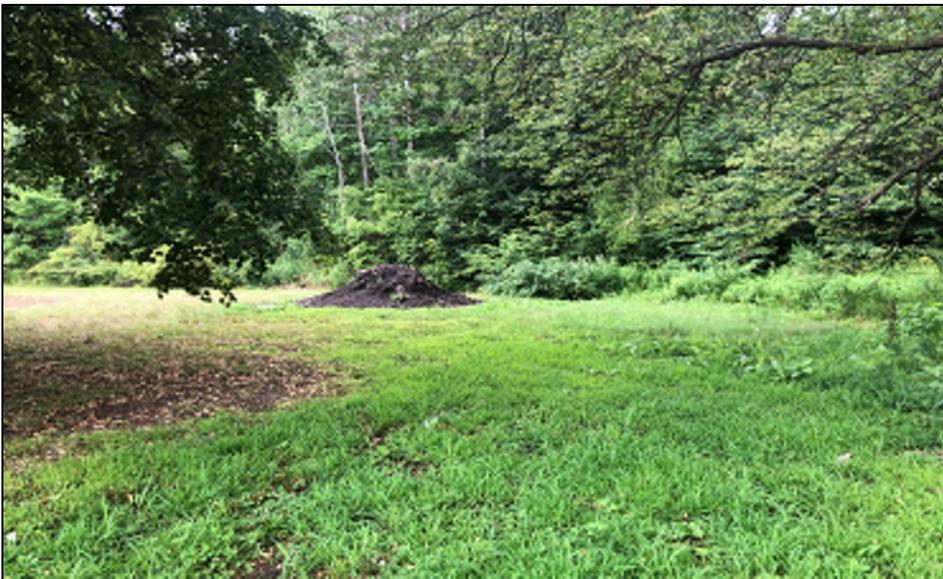
Photo 23: Existing soil stockpile and wooded area northwest of the Passios School.

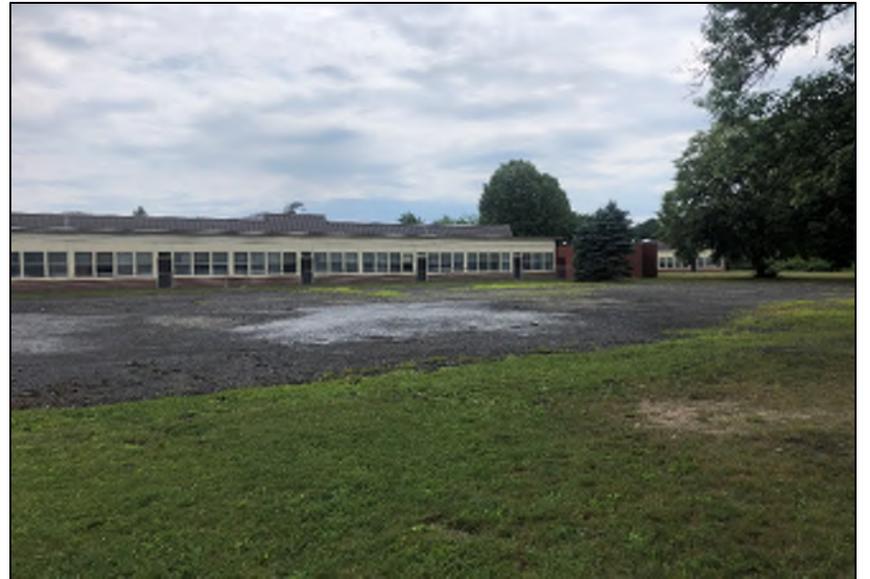
Photo 24: Gravel lot behind the Passios School, near the existing soil stockpile.

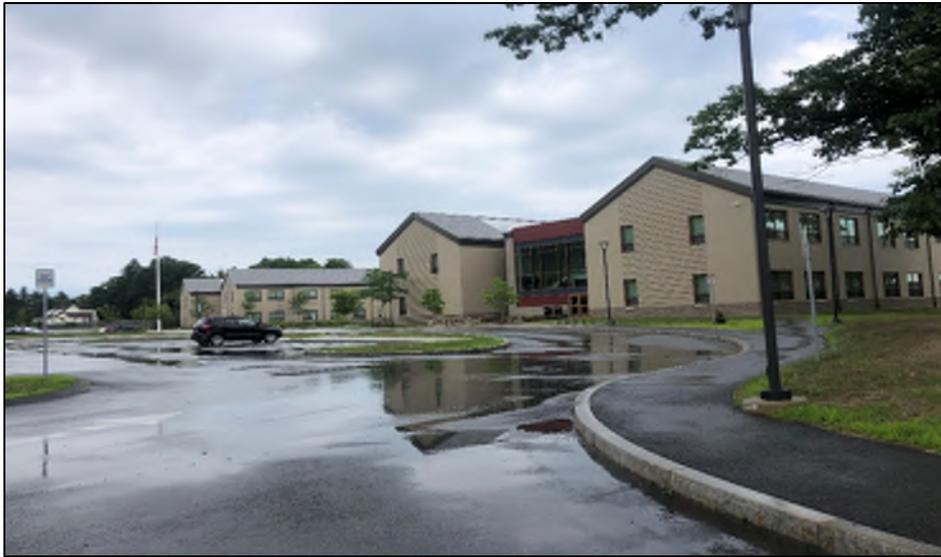
Photo 25: View of the west façade of the High School on campus.

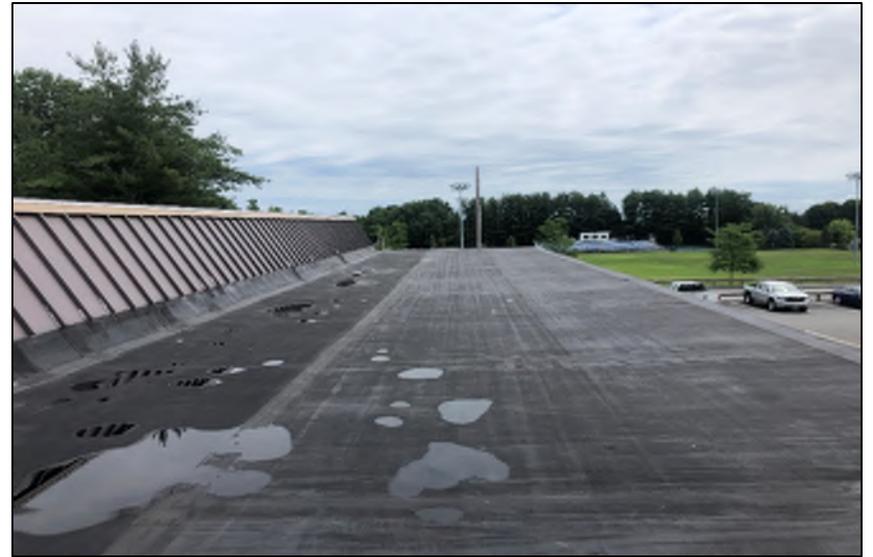
Photo 26: View of the Thomas C. Passios School roof, facing east.

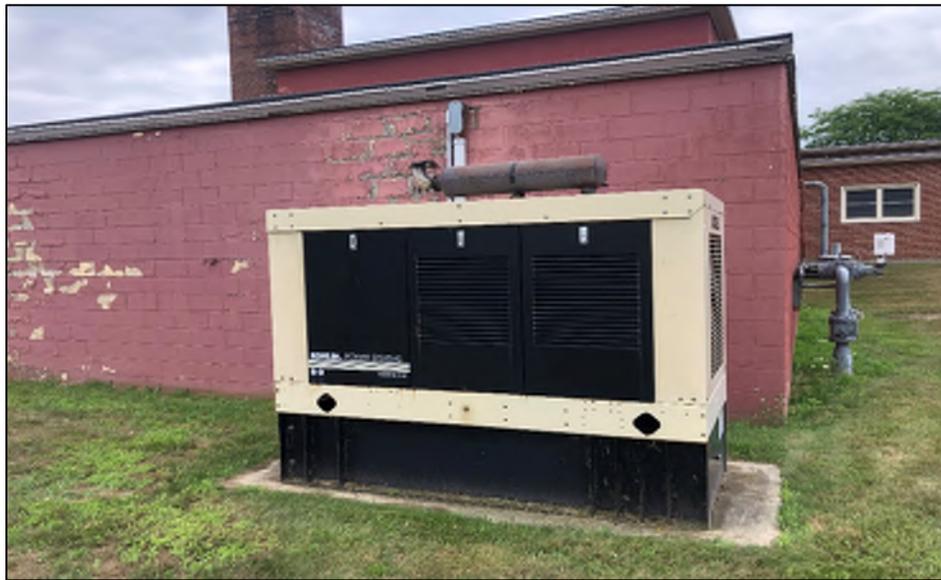
Photo 27: Generator near the Maintenance Garage on the east side of the building.

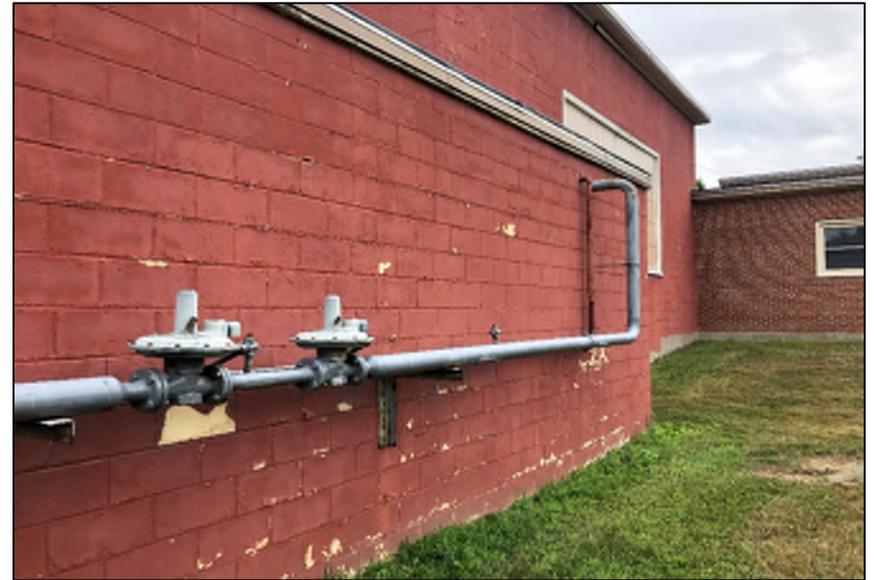
Photo 28: Natural gas piping on the side of the Maintenance Garage.

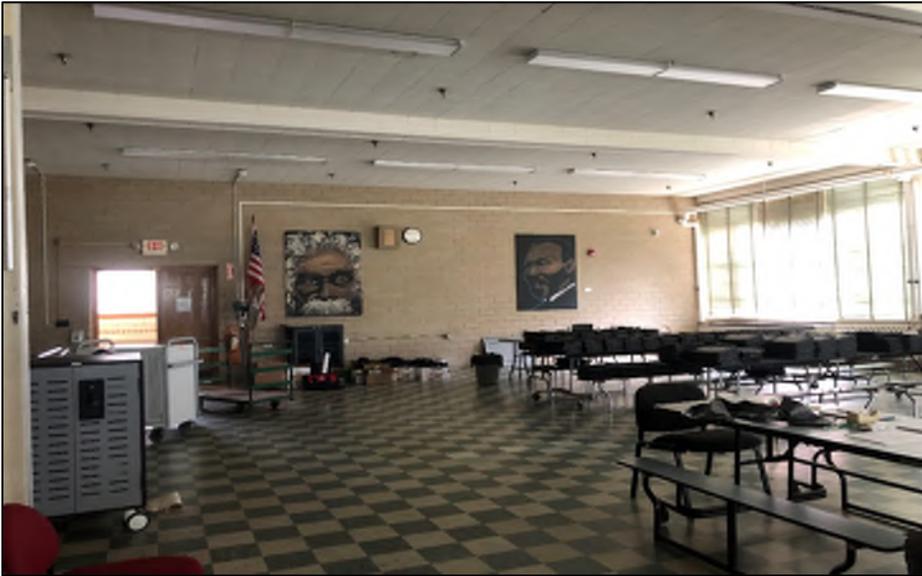
Photo 29: General view of the cafeteria in the Passios School.

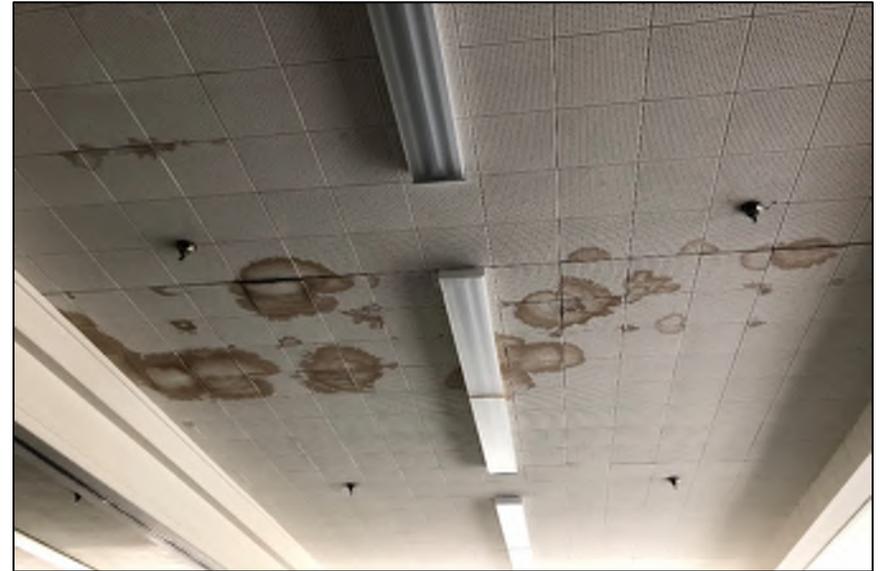
Photo 30: Cafeteria ceiling.

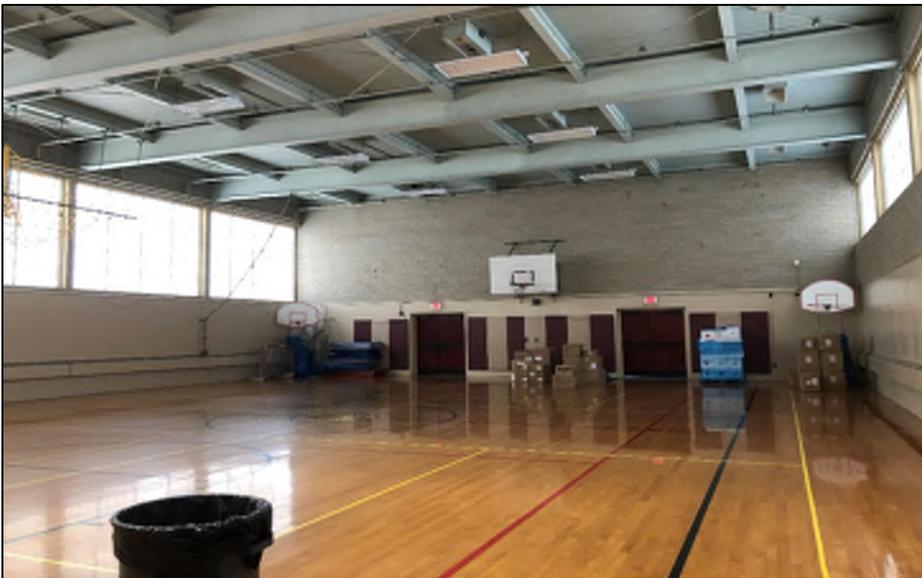
Photo 31: General view of the gymnasium.

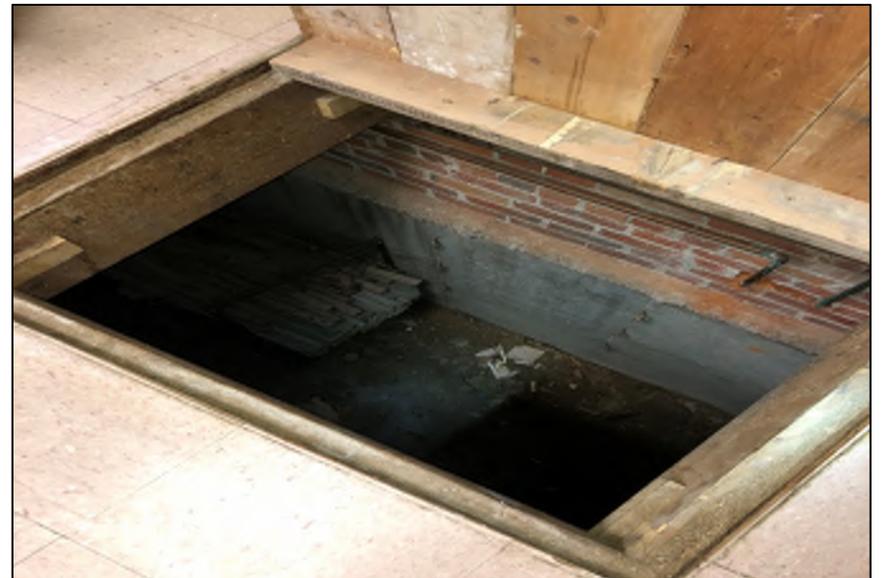
Photo 32: Crawlspace located in the mezzanine adjacent to the gymnasium.

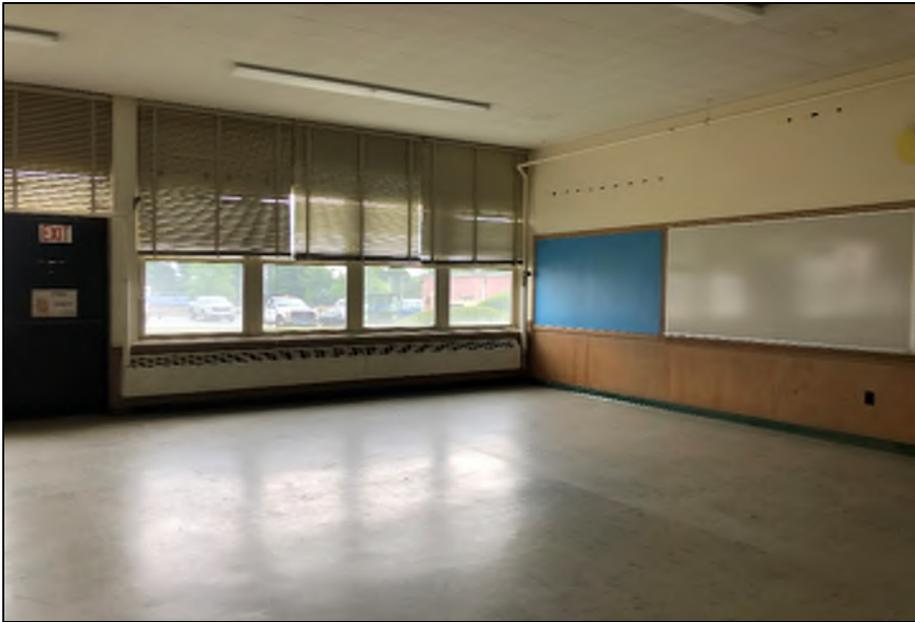
Photo 33: General view of a classroom in the Passios School.

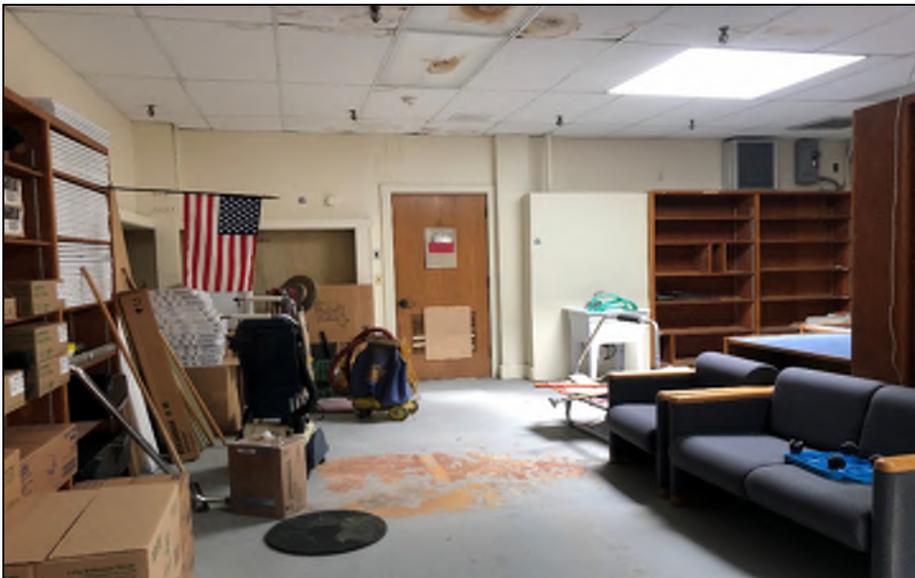
Photo 35: General view of the Janitor's Shop.

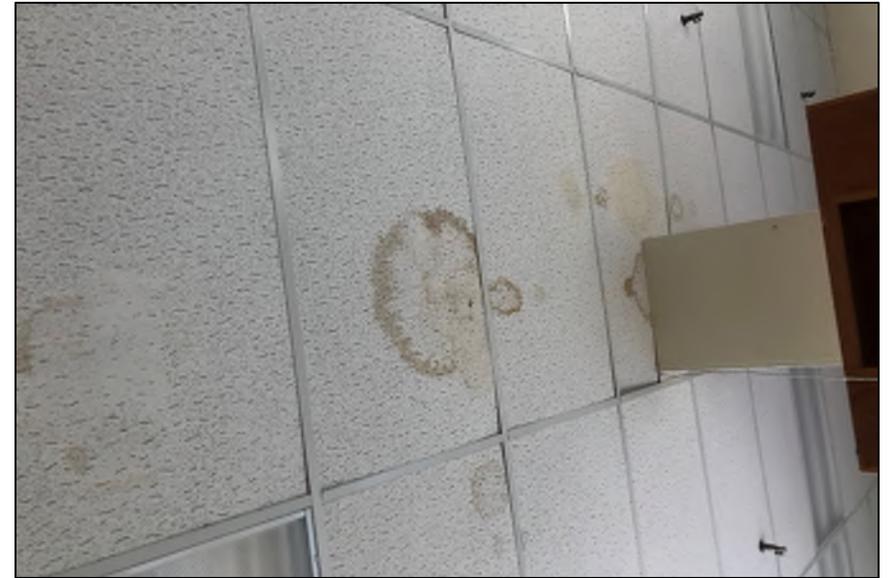
Photo 36: Janitor's Shop ceiling.

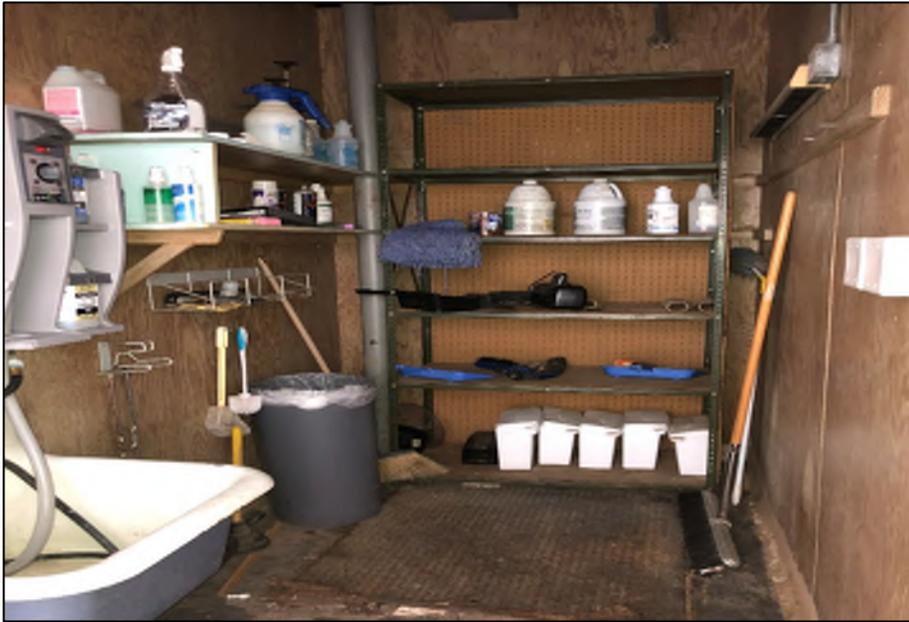
Photo 37: General view of the Janitor's Closet.

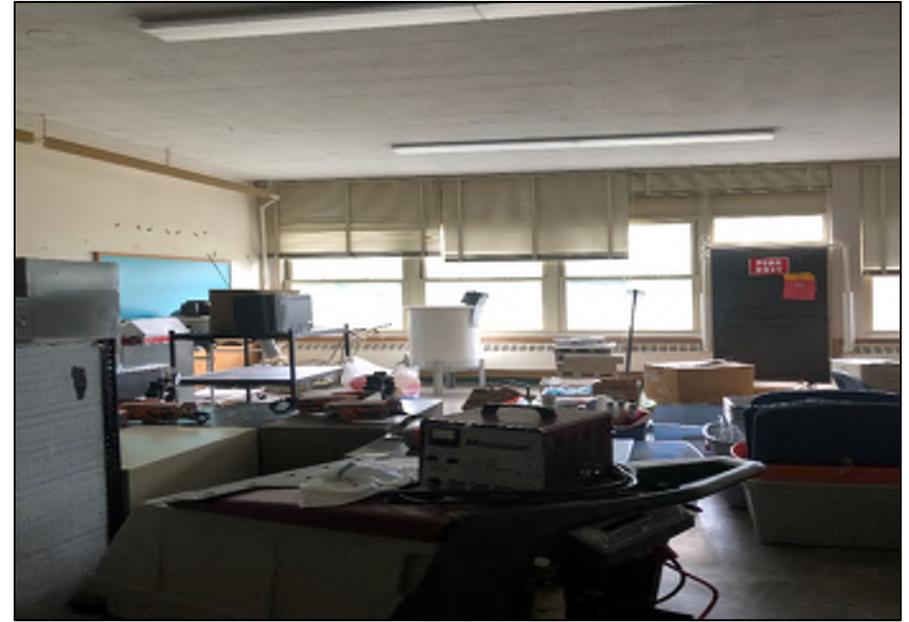
Photo 38: General view of Classroom 10, with view of paint mixer drum in back of classroom near windows.

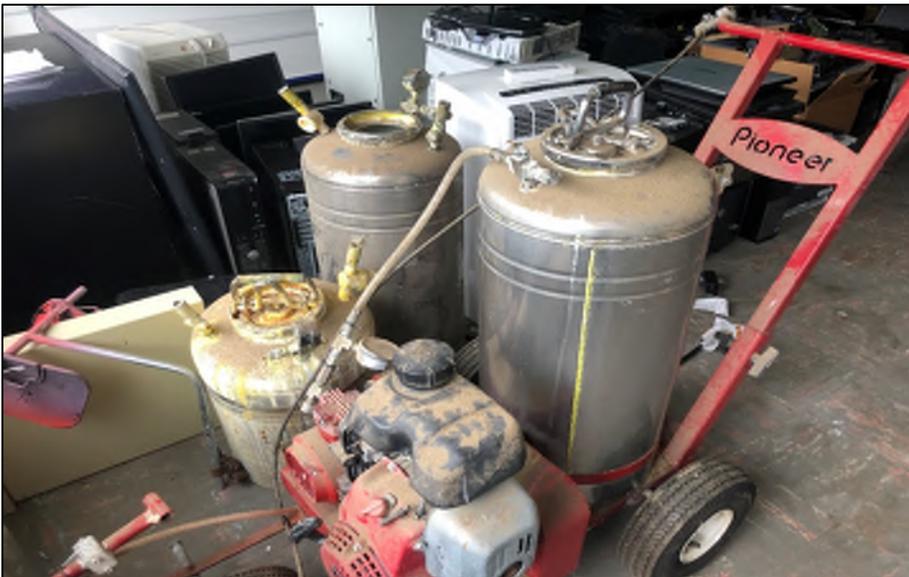
Photo 39: Close-up view of the unlabeled "line painters" in Classroom 10.

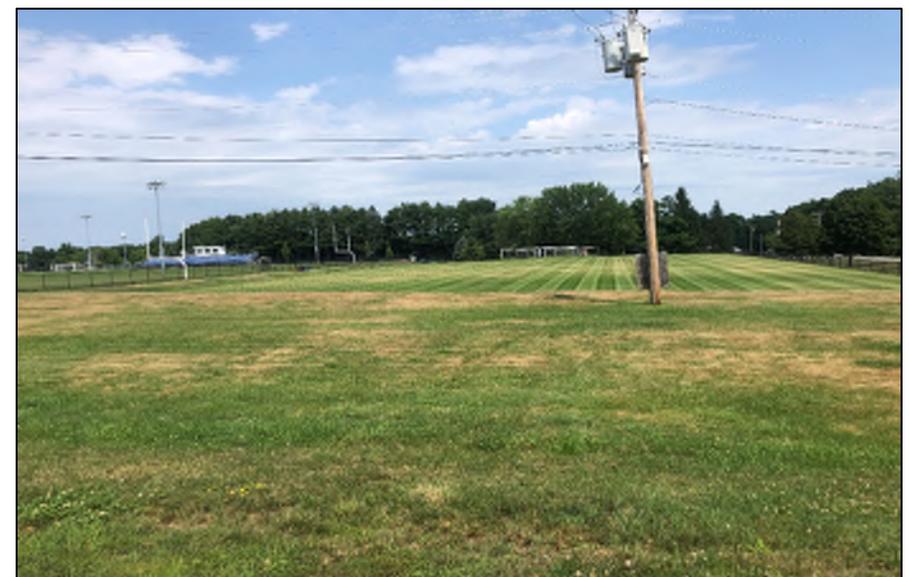
Photo 40: Athletic field across from the Brooks House.

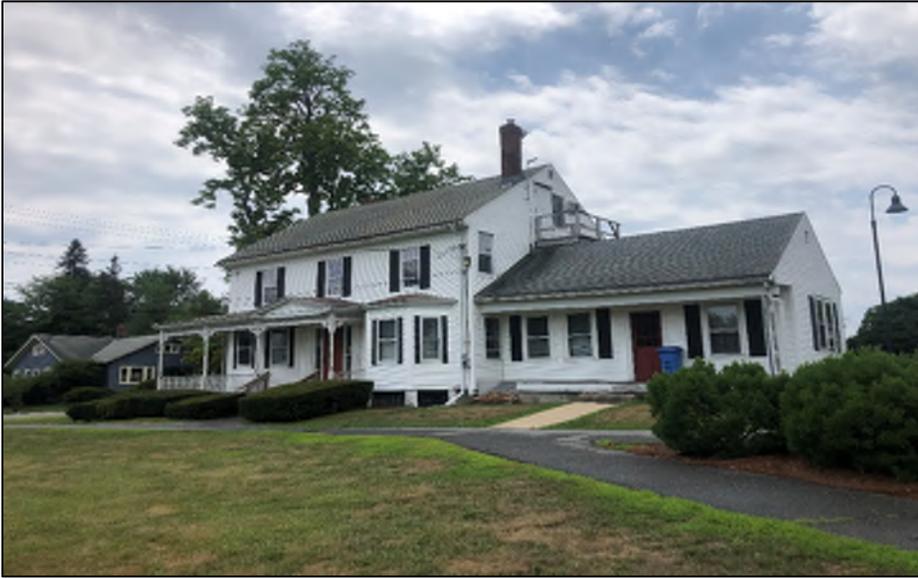
Photo 41: Brooks House.

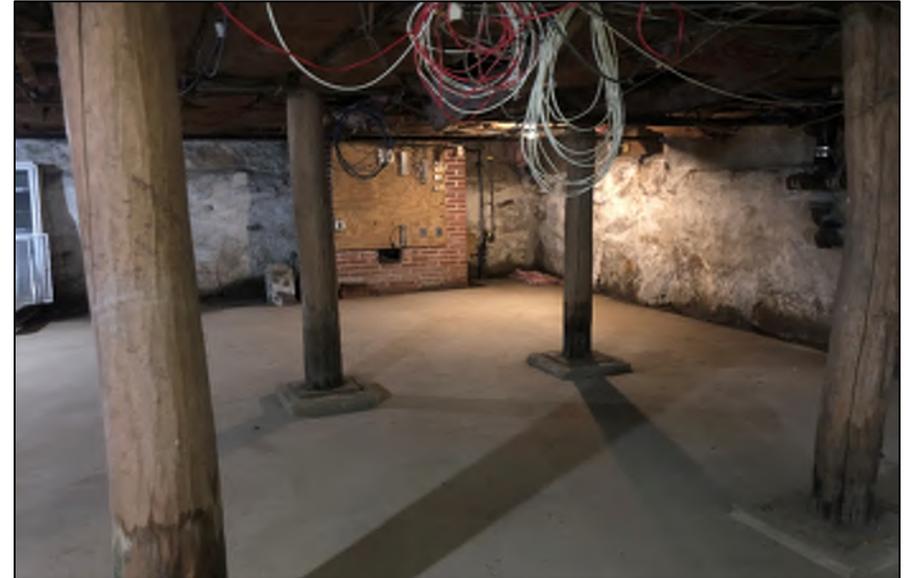
Photo 42: General view of the basement in the Brooks House and the old sealed-off fireplace.

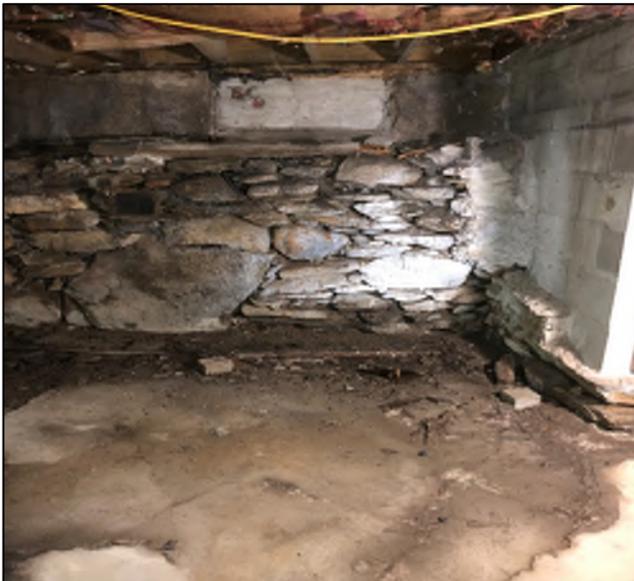
Photo 43: Former location of the 275-gallon AST in the basement of the Brooks House.

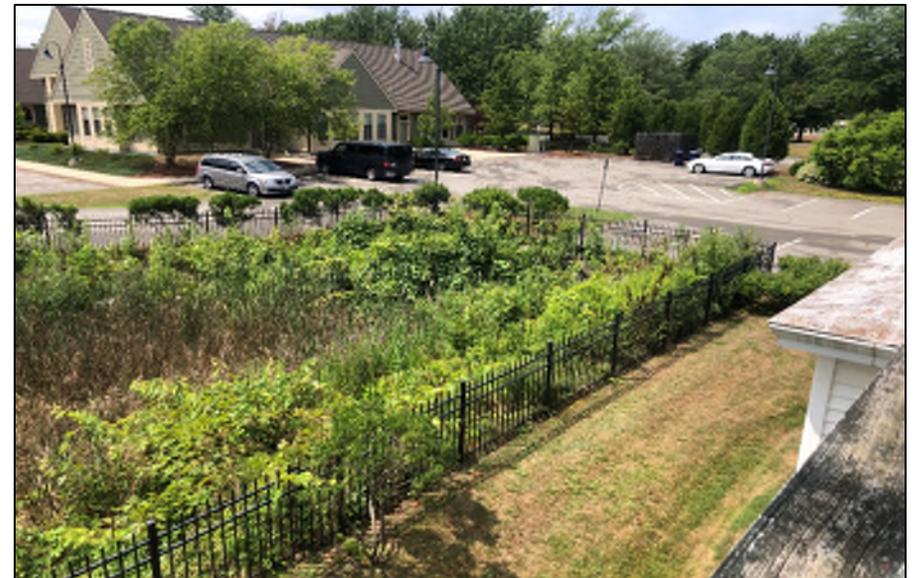
Photo 44: Catch basin behind the Brooks House and view of the Lunenburg Public Library.
